Geologic Report on the Slide near Budge Drive, Jackson, Wyoming to the Jackson Town Council by the Geologists of Jackson Hole

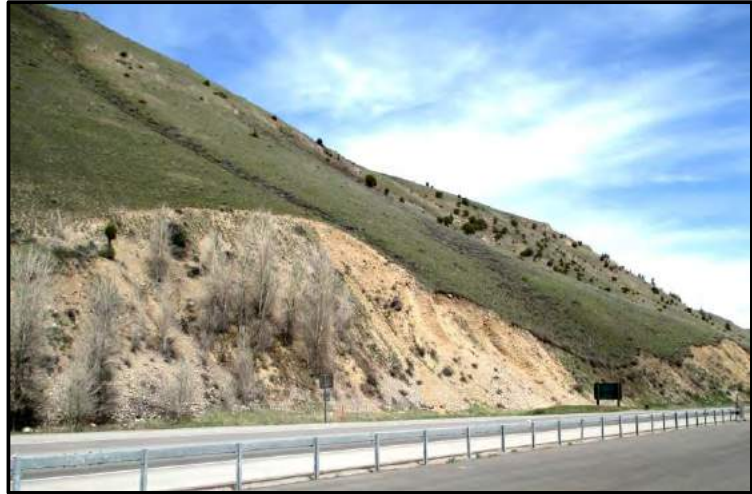
Figure 3: East slope of East Gros Ventre Butte just north of the Jackson town line along Highway 89 showing a typical slope and removal of buttress material to build the highway.

The buildup of these colluvial-alluvial aprons is clearly observed, for example, along Highway 89 just north of the town boundary (Figure 3) where the road cuts through several colluvial-alluvial debris fans. Figure 3 shows that part of the rocks and debris holding up the original slope has been removed in the process of building Highway 89, decreasing the stability of the whole slope, making it more at risk for land slumping or sliding. The angle of repose of the cut face is now dependent on the internal coherency of the poorly consolidated debris. Any removal of rock and soil debris (colluvium) from the lower slope of colluvial-alluvial aprons to grade a highway or create a building pad compromises the stability of the whole slope. The result is that over time an altered slope such as that seen in Figure 3 is much more likely to settle or slide in order to re-establish a more stable configuration with respect to gravity.

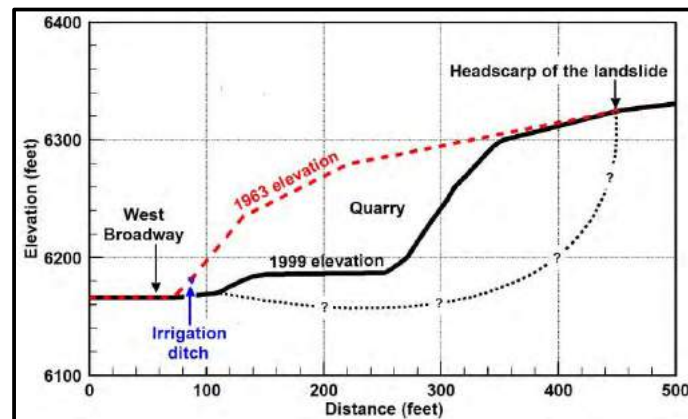
Figure 4: Topographic cross-section from south to north from West Broadway just east of Budge Drive through the house destroyed at the top of the headscarp of the landslide. The dashed red line shows elevations in 1963. The black line shows elevations in 1999 after quarrying.

A more detailed topographic profile is shown in Figure 4 from West Broadway northward to the house at 1045 Budge Drive that was destroyed straddling the headscarp of the landslide. The black line is based on one-foot 1999 topographic data and the dashed red line on the 1963 USGS topographic map with 40-foot contours. The dotted black line with question marks in it shows a rough approximation of the slip surface along which the rocks and debris above most likely slid dramatically in April, 2014. Note that the cross-section of rock quarried is approximately equal to the cross-section of rock that has recently slid.

The fractures surrounding the Budge Landslide of 2014, described below, are symmetric about the cut face on the north side of this quarry, strongly suggesting that the removal of more than 14 million cubic feet of rock and related debris weakened the slope, increasing the risk of slope failure. Much smaller amounts of rock and debris were removed to build Gros Ventre Drive at the time of quarrying and to realign this road to become Budge Drive in 2002 soon after the Town of Jackson annexed the region. Small amounts below the west edge of the landslide were removed in 2003 to develop the Hillside Building. Still 8 feet more was removed in 2011 to prepare to build the Walgreens store. But more than 90% of the material removed was during quarrying from the late 1950s through the 1970s, so that it is quite reasonable to conclude that the slope failure observed in 2014 would have been highly unlikely to have occurred had this quarry not been excavated.

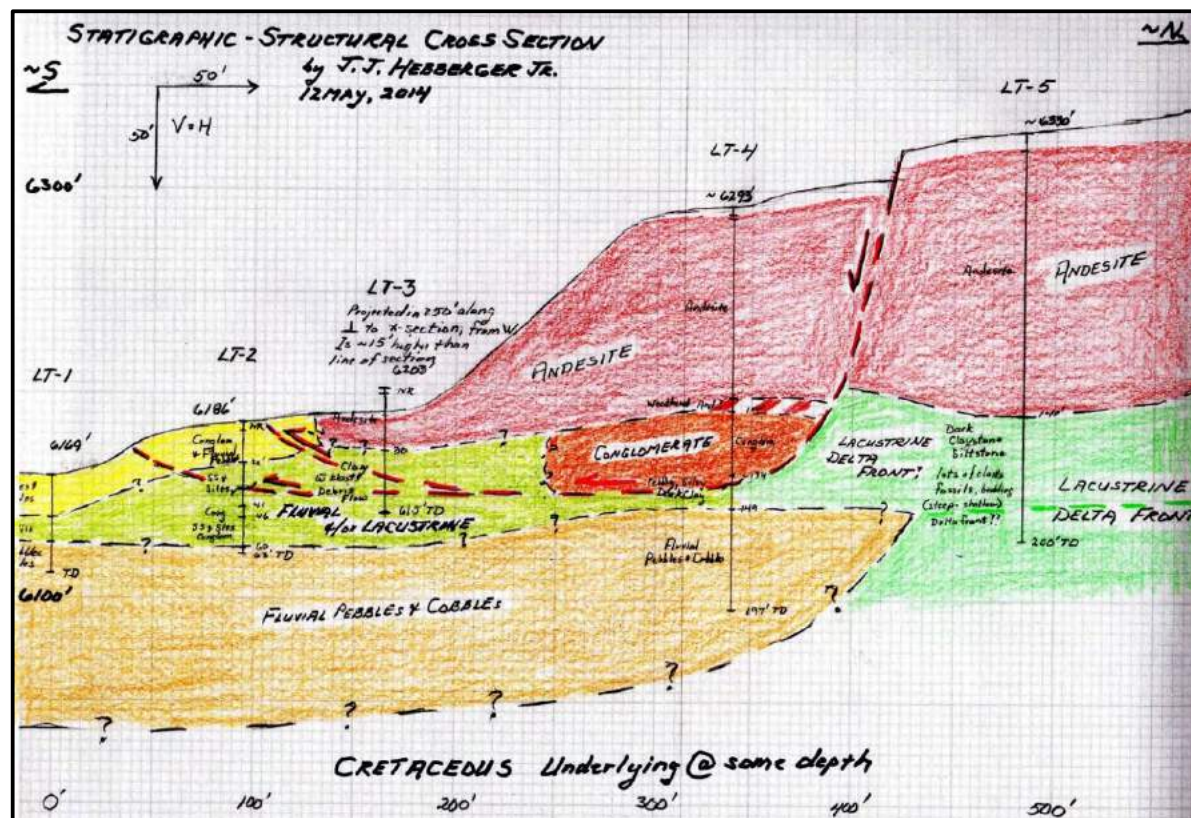
Figure 10: Initial interpretation of the core and surface data from LT-1, 2, 3, 4, & 5 core holes.

The location of the slide (fault) surface for the present day slide block may reactivate a portion of the slide surface of the ancient slide block, but this appears largely because the ancient slide block came to rest on relatively impermeable and clay rich sediments (of the "Lacustrine Delta Front" facies). It is clear that the slide surface encountered in LT-4 and as depicted in Figures 10 and 11 is located at the base of the conglomerate that forms part of the old slide block, and therefore on top of the more clay-rich sedimentary layer below. But this is the only part of the ancient slide surface that could have been reactivated. The headscarp of the current slide block is in the middle of the ancient slide block that is largely andesite, is located approximately half way between core holes LT-4 and LT-5 (see Figures 10 and 11), so only the lower part of this old slide block is involved in the present day slide. The current slide has not caused ground movement at the LT-5 location and so the old slide surface, which is at approximately 140 foot depth in LT-5 at the contact between the andesite and the Lacustrine Delta Front, has not been reactivated.

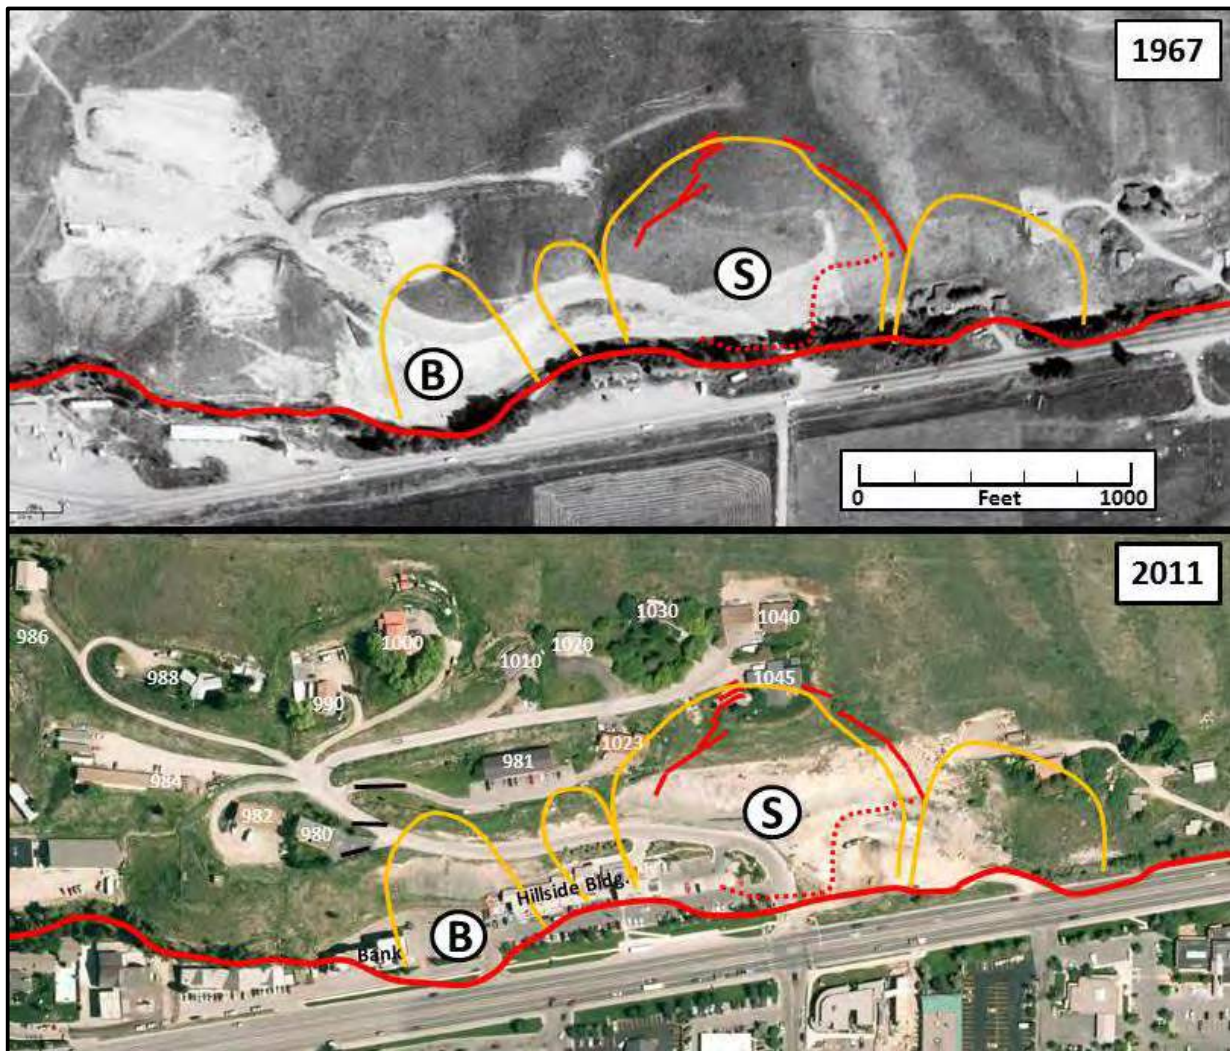
The long red line in Figure 12 traces The Little Gros Ventre Irrigation Ditch dug by the original homesteaders of this region before 1910. The ditch runs from where Flat Creek flows under West Broadway at an altitude of 6195 feet to fields west of Highway 22 just north of the intersection with West Broadway at an altitude of 6180 feet. This ditch is shown most clearly by the row of mature trees seen in the 1955 aerial photo (Figures 6 and 7). Parts of the ditch were piped underground as development increased north of West Broadway. The system was last used in 1987 and large parts were removed in 2003 with the development of the Hillside Building at 945 West Broadway. The depth of the ditch is unknown but was most likely shallow since it must have been dug by hand or by horse-drawn implement. This creates an excellent reference for ground level elevation prior to development. Water in the ditch formerly flowed in the vicinity of Budge Drive at an elevation of approximately 6187 feet (average of the elevations at both ends). This is 10 feet above the southern edge of the Walgreen building currently at an elevation of 6177 feet, which is ten feet

Figure 12: Air photographs of the Budge Drive region taken in 1967 and 2011. The long red line marks the position of the irrigation ditch as shown in Figure 7. The orange arcs show the location of the geomorphic anomalies shown in Figure 7. The dashed red line shows the southern limit of deformation observed in April, 2014. The short red lines show ground fracturing observed in April, 2014.

On November 15, 2013, an opening crack was discovered along the upper west part of the developing slide (Figure 12) and reported to the town. Residents of 1045 Budge Drive moved out soon thereafter. In early December, 2013, local residents reported a 2 to 3 inch crack in the concrete retaining wall just north of lower Budge Drive according to the Jackson Hole News and Guide. Workers installed a steel net over the cliff in December in order to make it more difficult for rocks to fall out into the parking lot. By December 16, 2013, several cracks had opened up in the driveway and crawl space at 1045 Budge Drive.

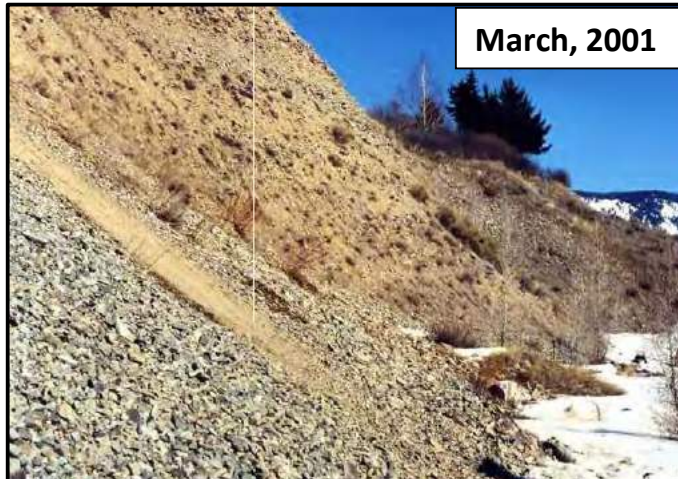
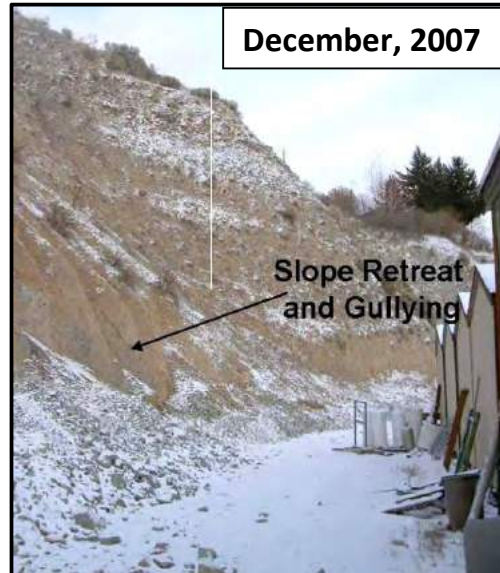
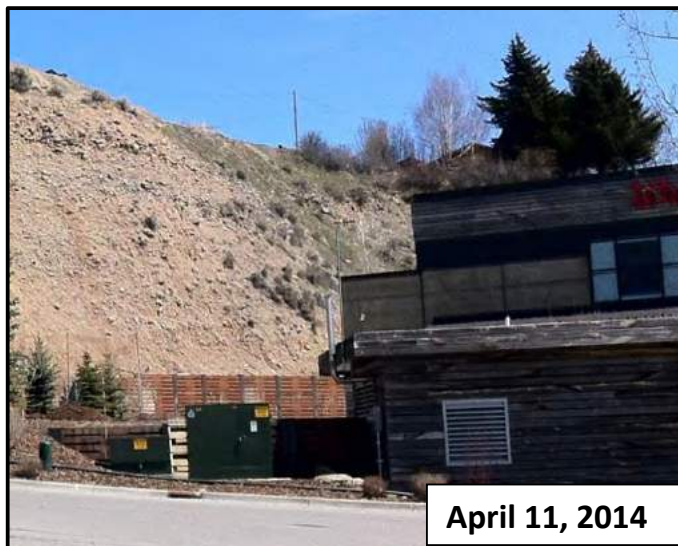
Figure 13: Photos of the northeast corner of the property developed for Walgreens. Note the trees in the upper right corner of each photo for comparison of views. Upper two pictures from the Geotechnical Report by Womack and Associates December 20, 2007. Photo to left by Ulrich. Lower photo from the website of the Town of Jackson.

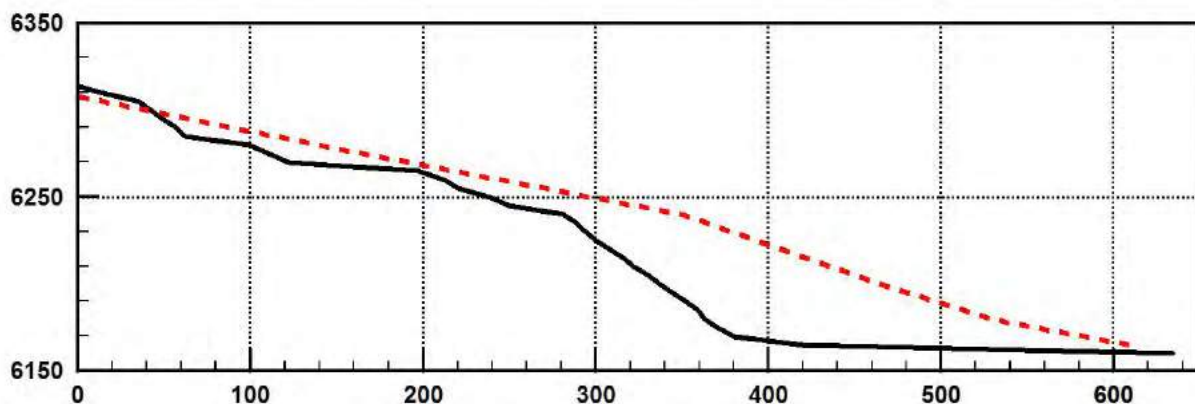
Figure 14: Topographic profile north-northwest to south-southeast through the circled B in Figure 12. The black line shows 1999 topographic data. The dashed red line shows topographic data from the 1963 USGS Jackson Quadrangle map.

and its parking area to the East shown by the circled B in Figure 12. Figure 14 shows a profile through the circled B in Figure 12. The area of the cross-section removed is approximately 10,000 square feet. Assuming a width of 500 feet, the volume removed approaches 5 million cubic feet. The remaining slope is unsupported except for a 7-foot high retaining wall at its base.

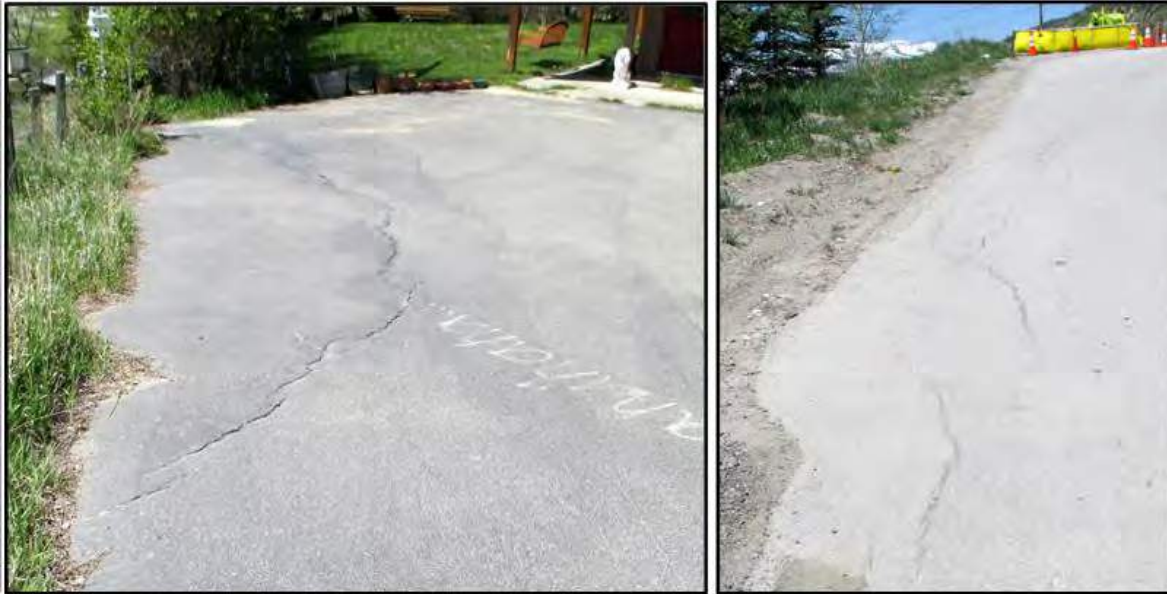
Figure 15: Crack in the driveway at 980 Budge Drive (left) and just to the north along Budge Drive (right) that were first observed in 2009 shortly after a malfunction of the sprinkler system for the condominiums at 981 Budge Drive caused considerable water to flow down the hill. Views looking west.

Small cracks in the pavement (Figure 15 and 16, black lines in Figure 12) were first observed by the residents at 980 Budge Drive near the south edge of their driveway, in Budge Drive itself just to the north, and in the driveway to 981 Budge Drive during 2009, shortly after some malfunction with the sprinkler system at the condominiums at 981 Budge Drive caused considerable water to flow down the hill. These cracks have not been observed to grow since 2009 but should be monitored, at least by carefully sealing them to prevent inflow of water and then keeping a watch out for new or renewed cracking. Budge Drive just north of the circled B and nearby homes appear to have a higher risk of slope failure than anywhere else on the hill after the Budge Slide is stabilized. Increased stabilization of this area together with developing systems to divert and control runoff should be considered as part of efforts to stabilize the Budge Slide.

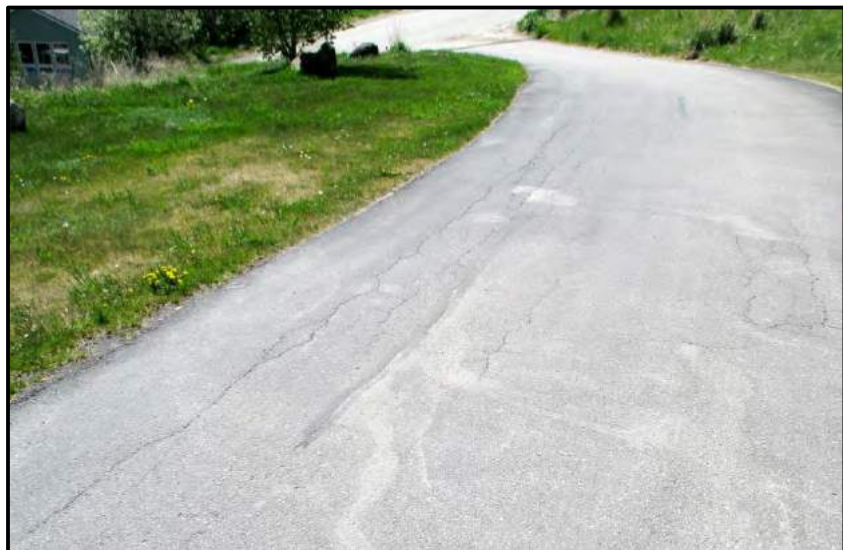
Figure 16: Cracks in the driveway to the condominiums at 981 Budge Drive, looking west.

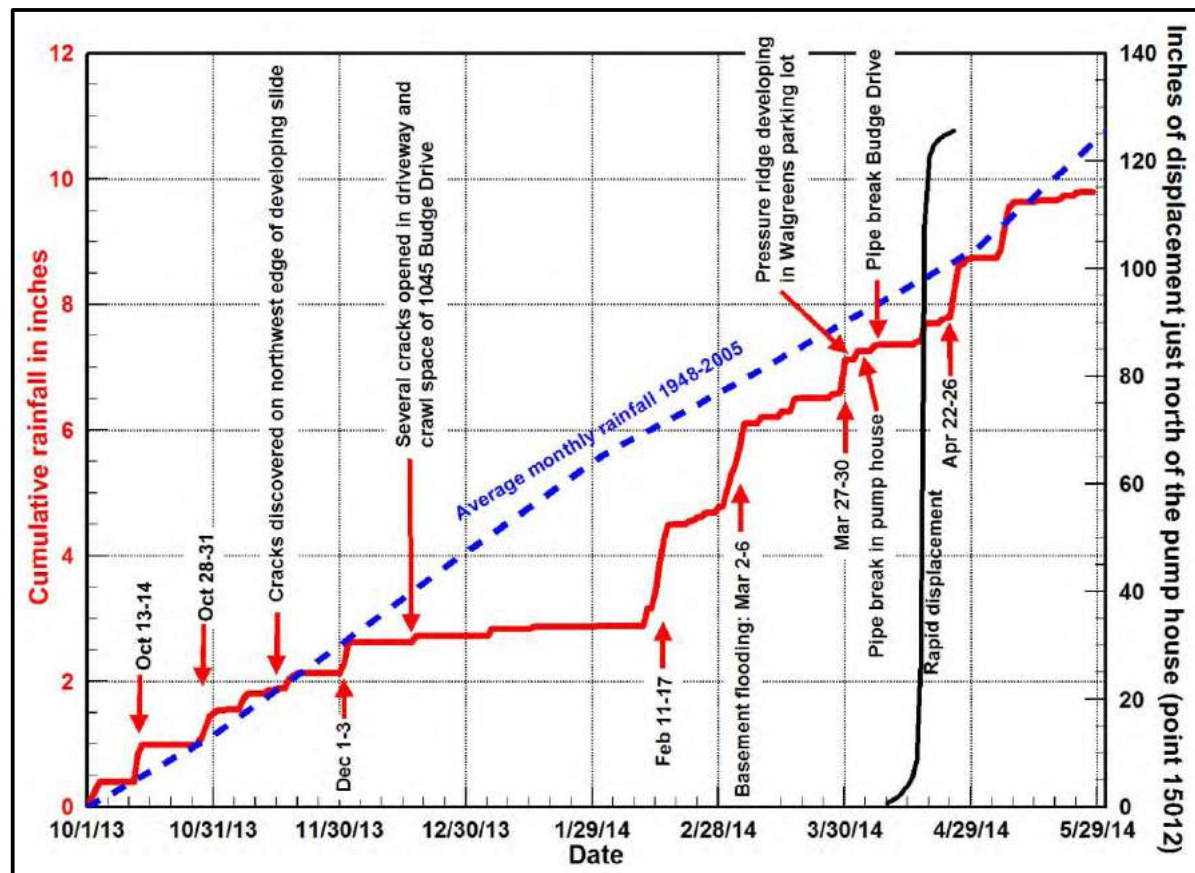
Figure 18: Rapid displacement of the town pump house southward toward West Broadway occurred after a much more rapid increase in spring rainfall than normal compounded by rapid melting of record snow cover over frozen ground causing the worst flooding of basements along Budge Drive remembered by residents who had lived there for many decades.

The red line in Figure 18 shows the cumulative rainfall measured on the north end of East Gros Ventre Butte from October 1, 2013 through May 30, 2014. The dashed blue line shows the cumulative average rainfall per month for this period. These data cover the period from August, 1948, through 2005 for the Town of Jackson (Western Regional Climate Center, 2014). Rainfall at a rate more than twice average began on February 11, 2014. From March 2 to 6, a particularly warm rain fell, melting snow still covering the hillside above Budge Drive. Residents say the ground was still frozen so that there were “sheets” of water from both rainfall and rapid snow melt flowing down the hill. At 7:30 am on March 6, residents at 1030 Budge Drive, just above and slightly west of the slide, put laundry in their washing machine in a dry basement. When they returned at 11 am to fetch the laundry there was two inches of water in the basement. Such flooding was reported from homes east of the slide to homes west of Budge Drive. Residents of the hillside for more than four decades could not remember similar flooding.

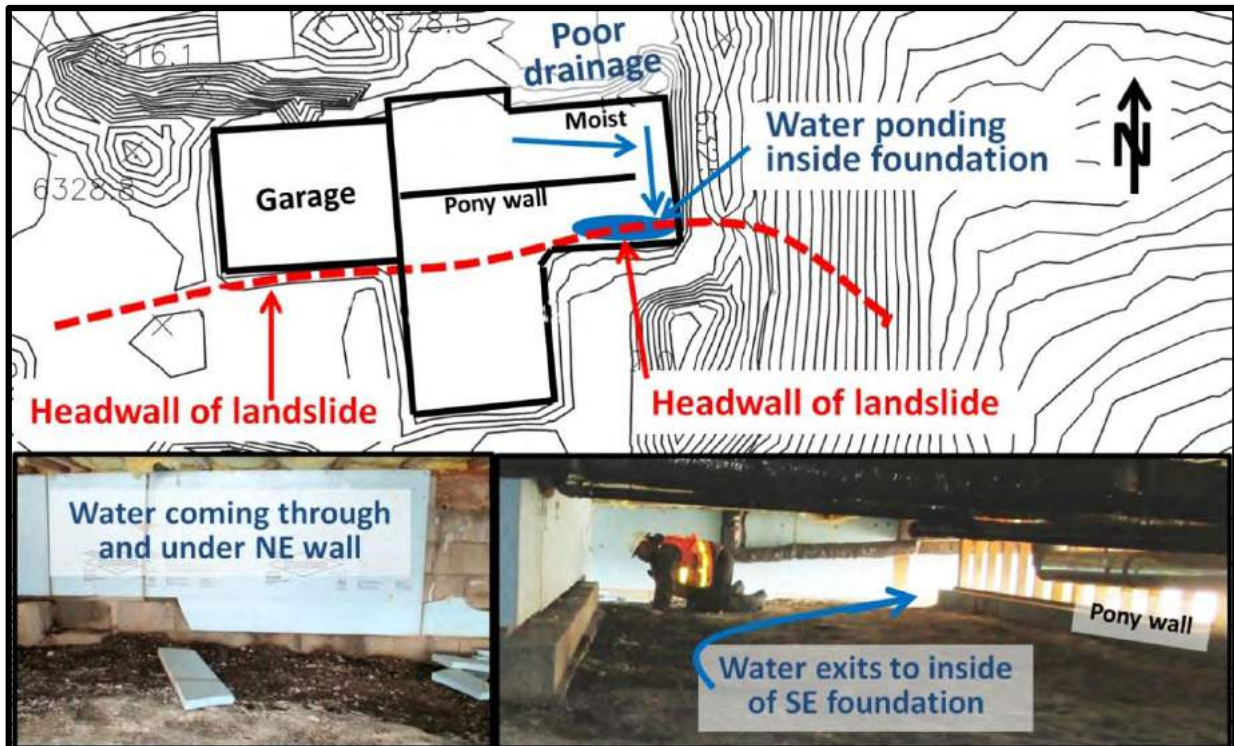
From April 13 to April 17, 2011, water leaked at 1045 Budge Drive while the owners were out of town on vacation. They returned to find a very wet crawl space and no clear evidence of this water flowing down the hill. The leak occurred before the water reached the water meter, but Bob Norton at Nelson Engineering calculated, based on records at the Town of Jackson pump house at the base of Budge Drive, that 200,890 gallons of water was leaked. This is a considerable amount of water that would cover a football field (300 feet by 160 feet) to a depth of 6.7 inches.

The north-sloping part of the roof at 1045 Budge Drive drains to the north of the house where there is no gutter, French drain, or any other type of drain to move the water away from the house. As a result, water tends to pond north of the house and especially north of the northeast part of the house. Here it permeates or flows under the foundation causing dampness observed in April, 2014 (Figure 19, lower left photograph). Then the water flows east and south past the east end of a pony wall, ponding just inside the southeast foundation of the home (Figure 19). At this point, there is only one way for the water to exit and that is downwards. Just north of the southeast foundation is precisely the headscarp of the Budge landslide (Figure 20), suggesting the possibility that this major leak could have been one of the factors causing the nucleation of the slide in 2011, the formation of the initial cracks that ultimately defined the northern physical extent of the slide.

Figure 19: Foundation of the home at 1045 Budge Drive plotted on a one-foot contour map showing where water flows around the pony wall to pond behind the southeast foundation. Picture lower left is looking north where moisture regularly comes through or under the concrete block foundation. Picture lower right is looking east.

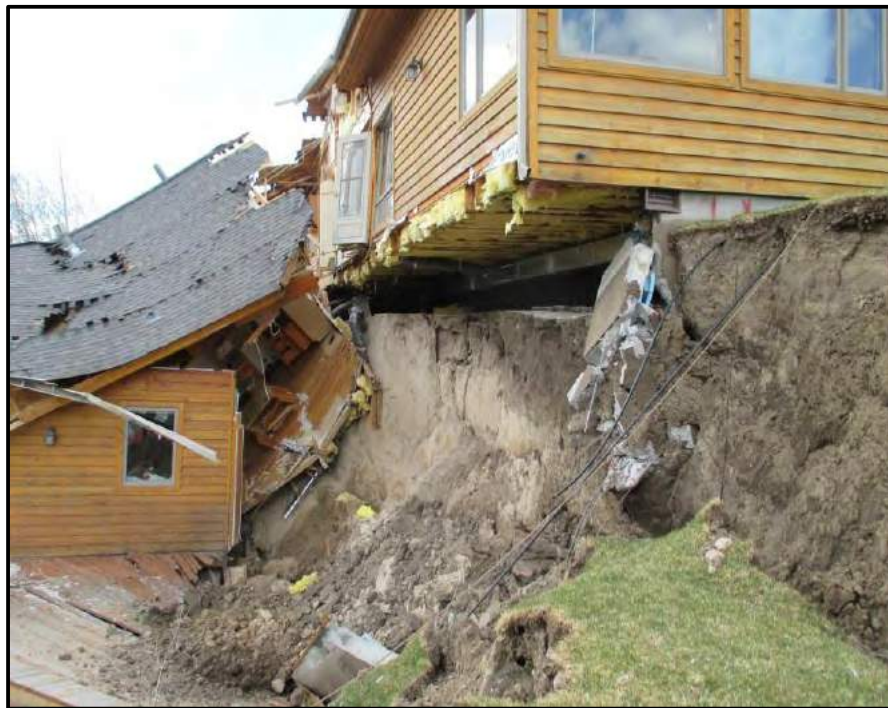
Figure 20: Headscarp of the landslide directly under the inside edge of the southeastern foundation of the house at 1045 Budge Drive

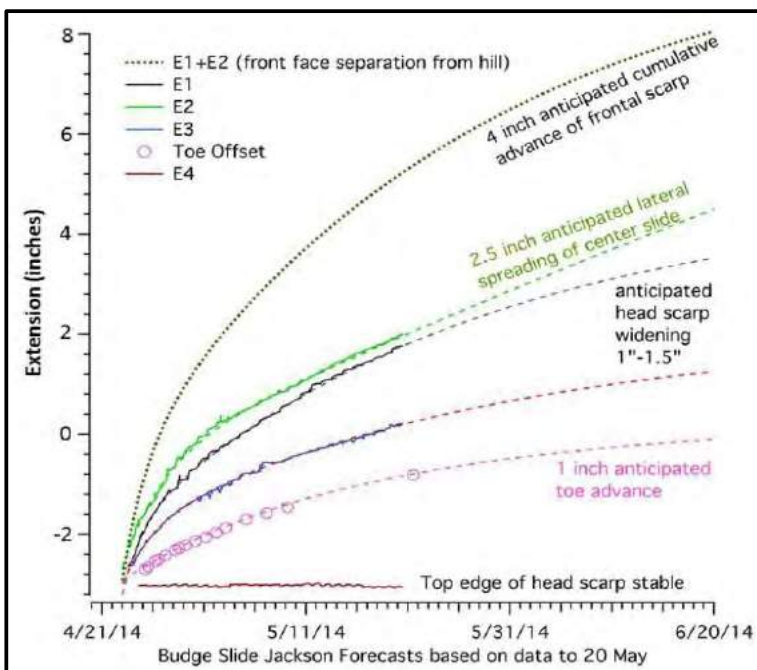
Figure 21, provided by Roger to the Town of Jackson, shows extension measured since installation through May 20, 2014, and the anticipated future extension based on similar observations elsewhere. The rate of motion of the slide has decreased steadily and Roger predicts up to 4 more inches of motion over the next month. We have been very fortunate to have access to such state-of-the-art instruments.

Figure 21: Extension measured by four instruments spanning the headscarp of the Budge Slide and modelled advance of the frontal scarp. Observations shown were from April 23 through May 20, 2014.
