# Description of the Five Cores Drilled in the Vicinity of Budge Drive, Jackson, Wyoming in April and May, 2014

An addendum to the  
**Geologic Report on the Slide near  
Budge Drive, Jackson, Wyoming**  
to the Jackson Town Council  
by the Geologists of Jackson Hole.

# Core Descriptions for LT-1 to LT-5 Cores cut at Budge Drive Landslide Site

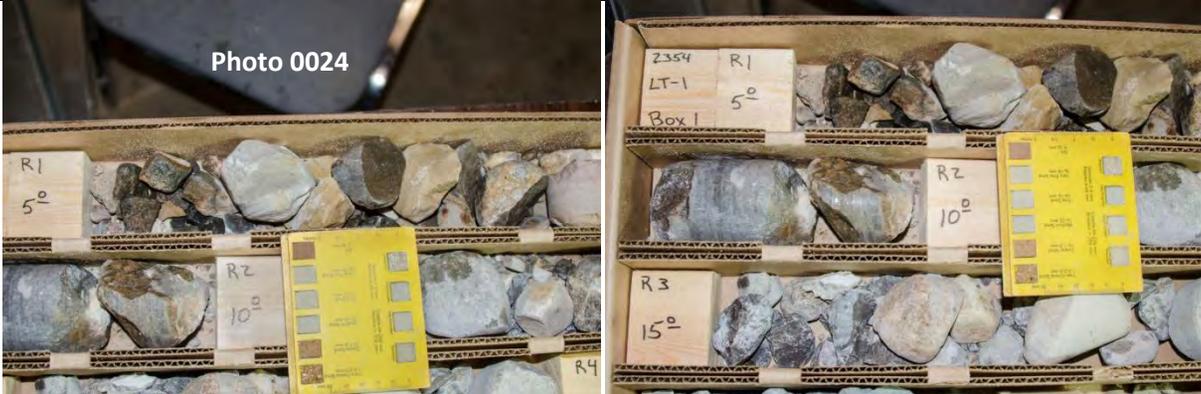
Interval (feet)	Description	Recovery %
0-5.0	NR	0
5-10.0	A mix of pebbles to large cobbles; dark andesite(?), quartzite, fine grained white sandstone. Photos 0024-25	40

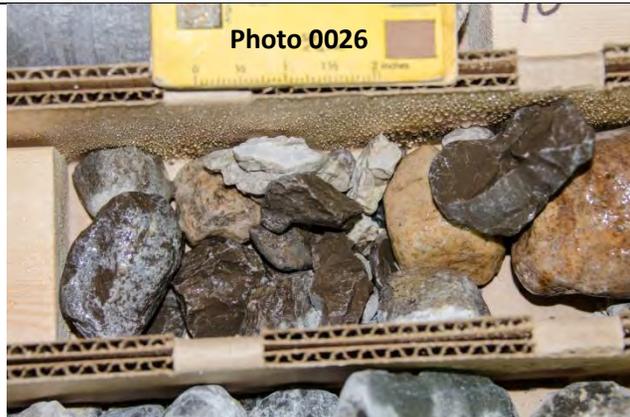
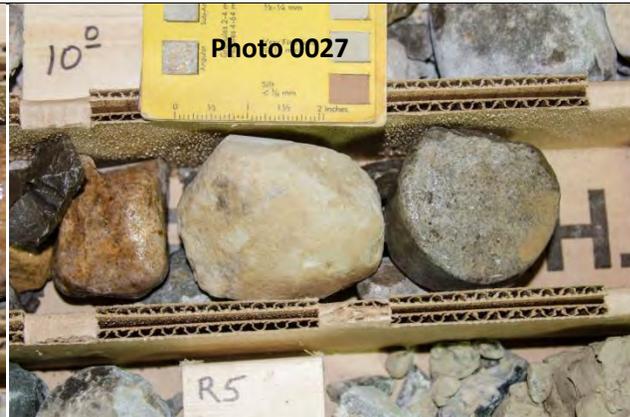
10-15.0	Mix of pebbles to cobbles as above.	20
15-17.5	Same as above	40
17.5-20	Same as above. Photos 0026-27.	35

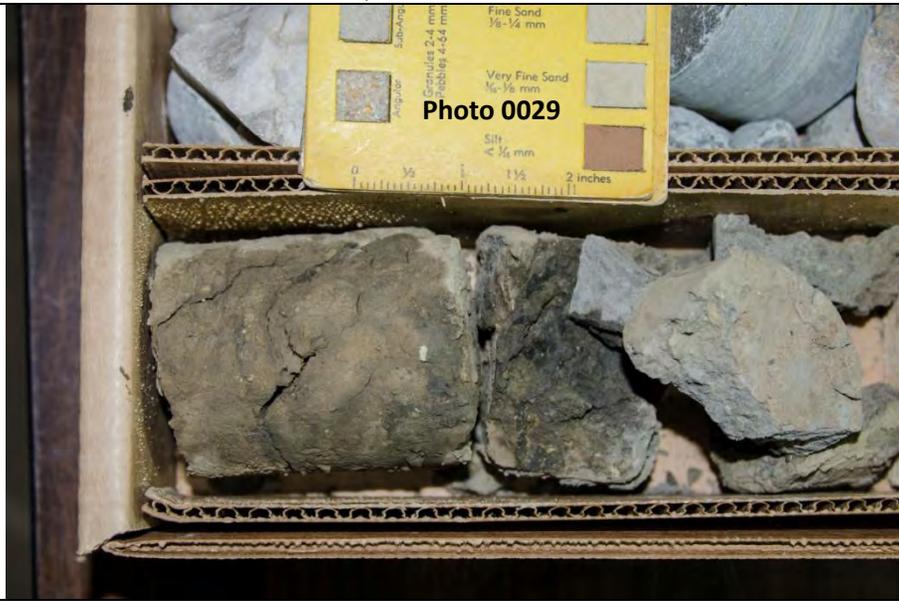
20-22.5 Upper few inches is pebbles to small cobble of rounded black andesite(?). Below this to base of interval is a brown clay-laden siltstone that has occasional rounded pebble sized clasts; Photo 0028. Bottom ~8" is more a dark gray, very silty-fine sand laden claystone, pretty well lithified, still has a few small pebbles in it. Photo 0029

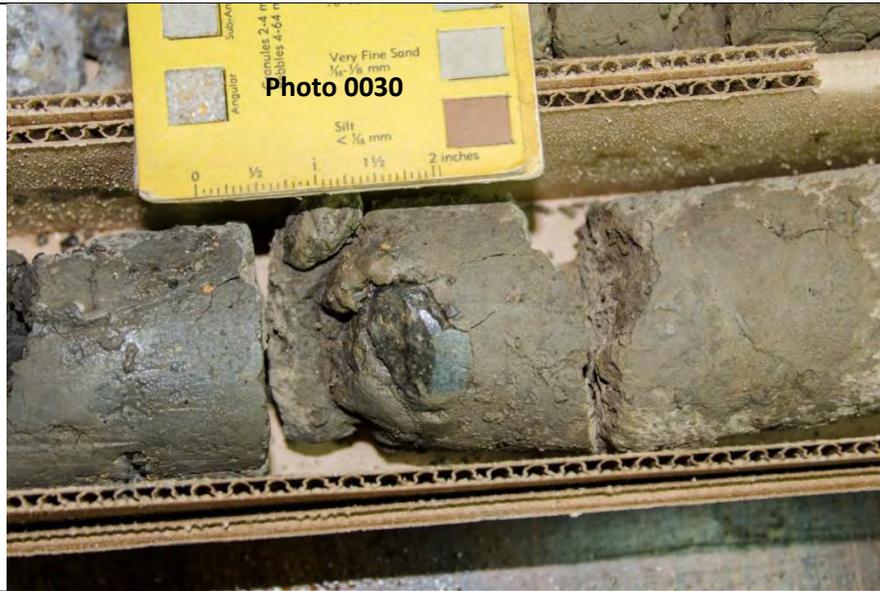
22.5-23.8 Same as base of above interval, though more of a clay-rich siltstone. Large sub-round andesite (dark volcanic) clasts. Photo 0030.

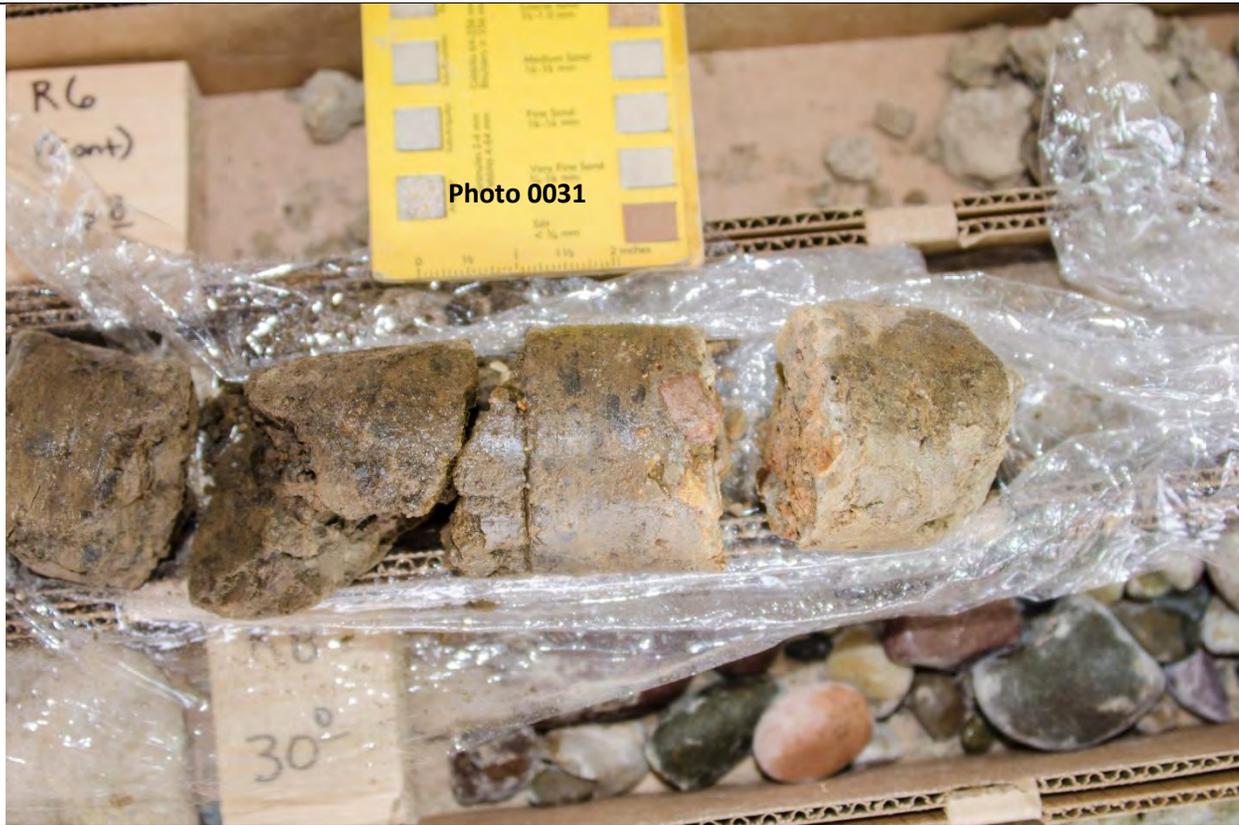
23.8-25 Tan-brown clay-rich conglomeratic siltstone; sub-angular to sub-rounded pebble sized clasts that appear to be mostly (?) andesite (? Dark volcanic at any rate), though also light sandstone. Photo 0031

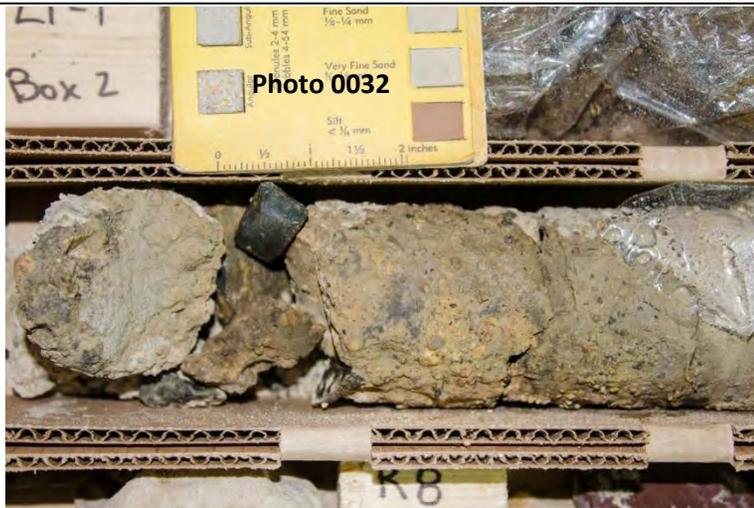
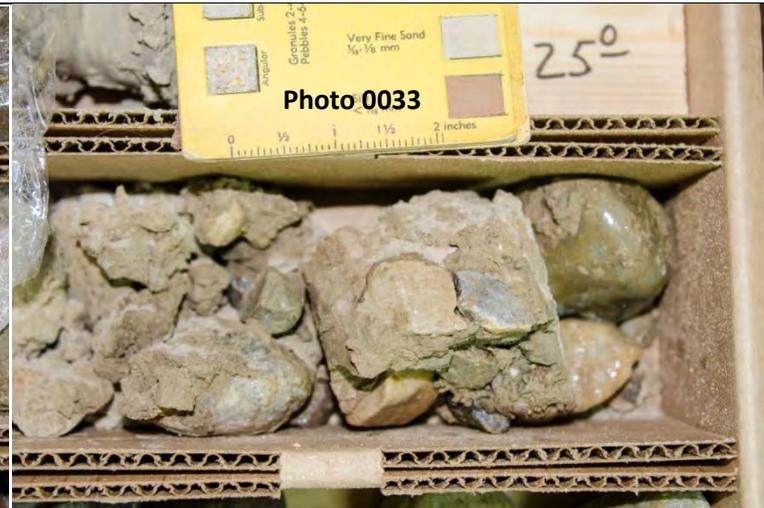
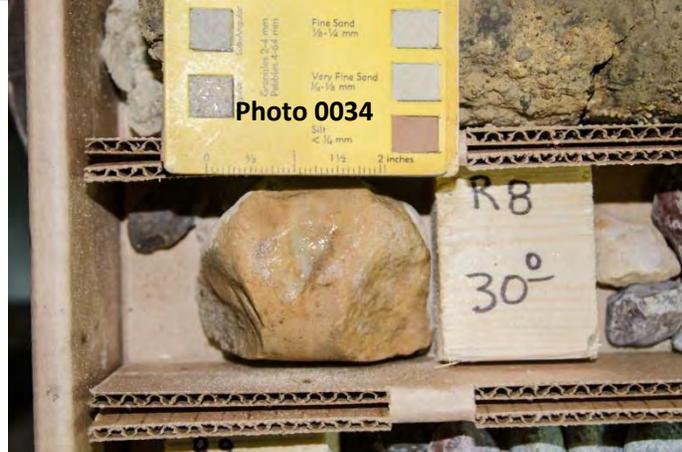
Tan-brown conglomeratic silty fine grained sandstone; clasts are pebble to perhaps small cobble size, some are rounded white sandstone (well lithified) to larger rounded to sub-rounded andesite (dark volcanic); Photos 0032-33. At base is a 3" core through what was perhaps a large cobble of white, well lithified sandstone, rounded to subrounded grains (Photo 0034).

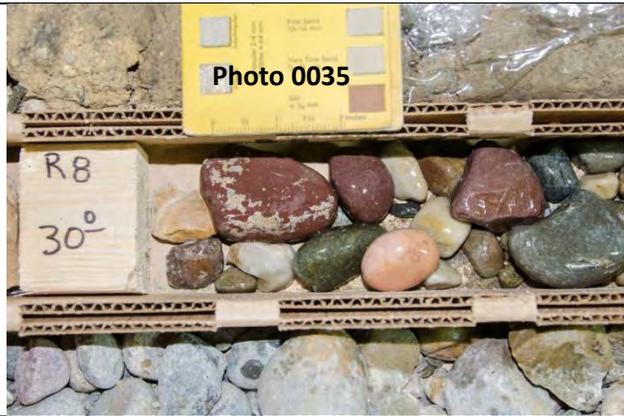
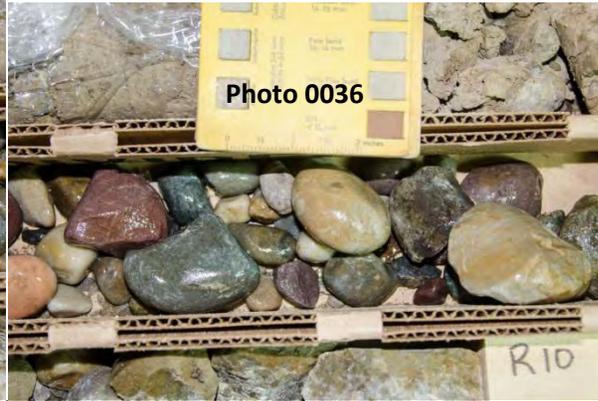
30-32.5 Well rounded fluvial pebbles to small cobbles that consist of: red fine grained moderately dirty sandstone that is well sorted, rounded to subrounded grains (mostly quartz, but significant admixture of dark to black, white grains; perhaps some mica); Light dense quartz sandstone or even quartzite; dark volcanic (andesite?). Photos 0035-36.

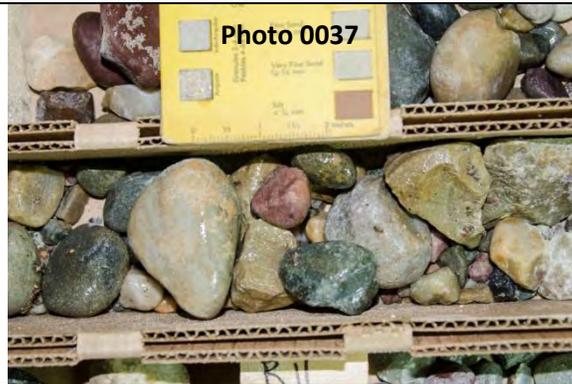
Very similar to immediately above. Photo 0037.

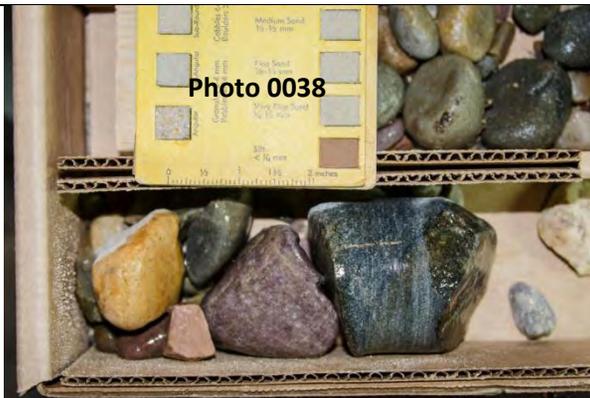
Very similar to immediately above. Photo 0038.

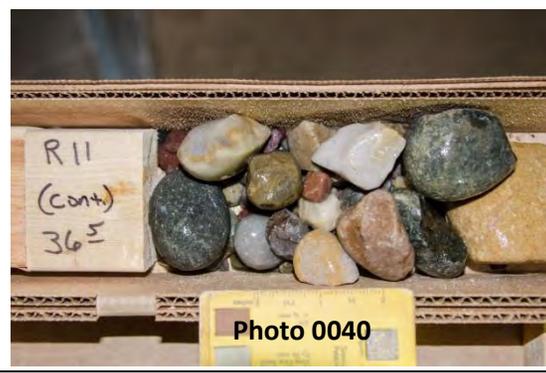
36.5-37.5	Very similar to immediately above Photo 0040	35
-----------	----------------------------------------------	----

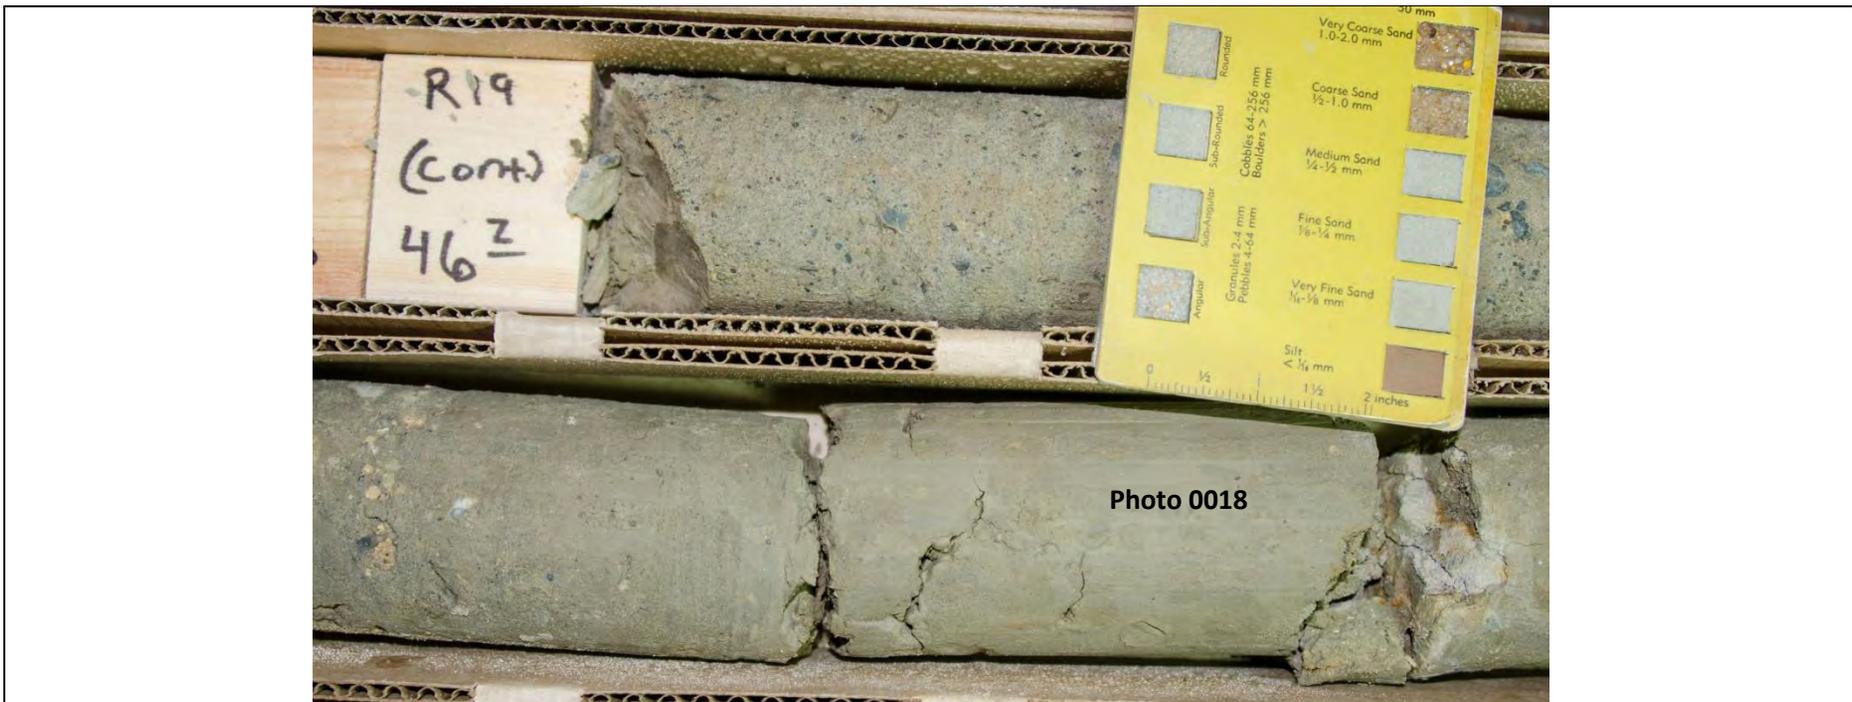
Photo 0018

46.2-49	<b>Conglomeratic brown siltstone</b> with coarse sand size to pebble sized sub-angular to sub-rounded clasts (predominantly dark andesite?), grades downward into same but coarser matrix ( <b>very fine to fine sand</b> ), predominantly quartz, though with a small admixture of dark (andesite?) and other color grains. Lower ~1' interval the conglomerate clasts disappear, apparently over 1-2" and the lower 1' is a pure very fine sub-angular quartz <b>sandstone</b> PHOTO 0018	100

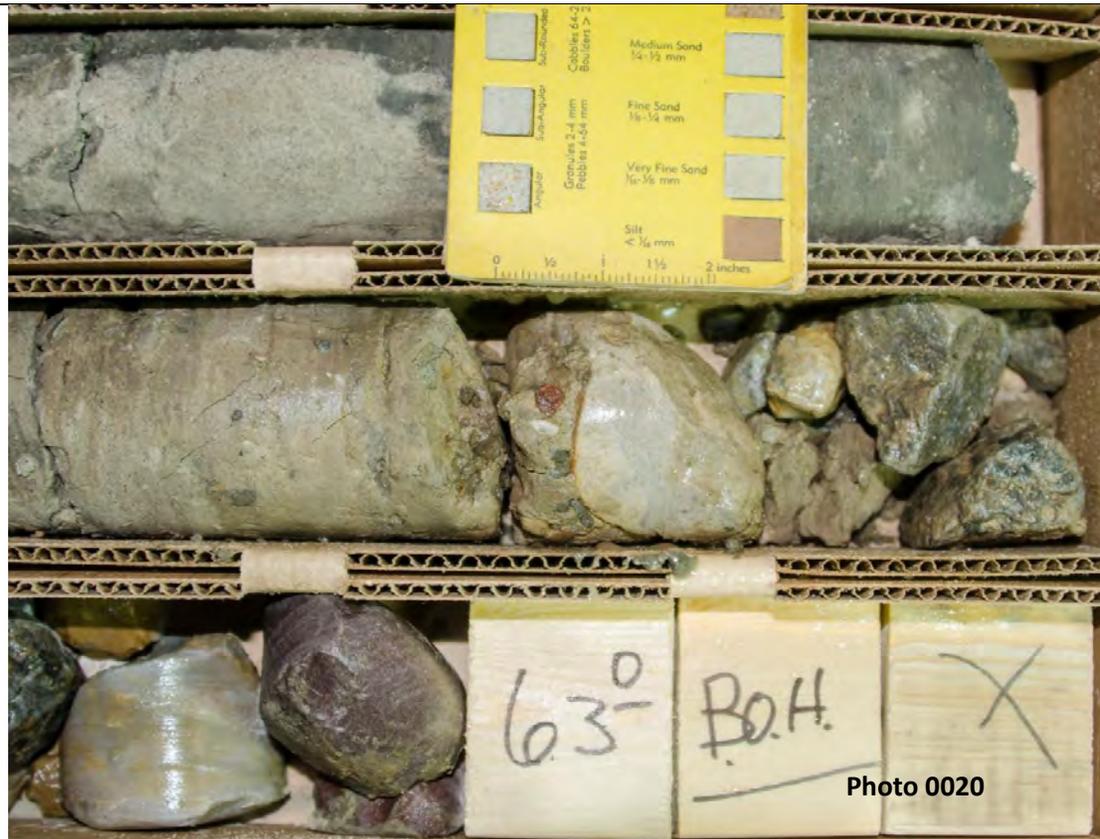
Photo 0020

53.8-56	Same as above.	100
56-61	Upper 18" of core is very similar fine to very fine dark sandstone as above, perhaps a few more andesite? clasts in lower portion. Below that the sandstone changes color abruptly and this lower ~2' is brown in color and more conglomeratic, especially the upper most 3", a 1" horizon in middle, and the lower 2"; this last 2" contains red, white, yellow sub-rounded clasts. The above sits direction on a 3" cobble (?) of a dense (well lithified) light colored poorly sorted fine sandstone with sub-angular clasts; apparently not quartz, knife scored grains and leaves no steel on them. PHOTOS 0020-21. The very bottom has broken andesite pieces, whether broken from small cobbles or a larger piece broken by coring is not evident.	60

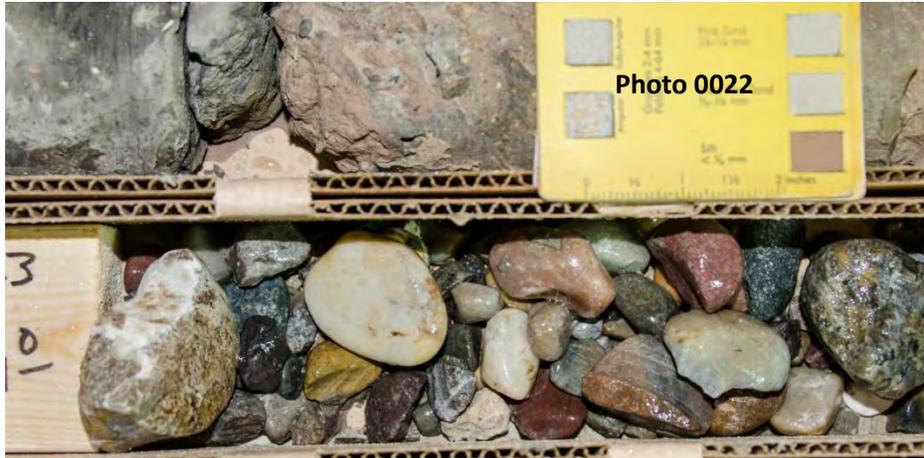
Photo 0022

Appears to be all well rounded pebbles to small cobbles and likely larger cobbles drilled by the core bit. Range from: dense red sandstone; light quartzite; dark volcanic rock with large white phenocrysts; dark dense fine grained volcanic (andesite?) PHOTOS 0022-23.

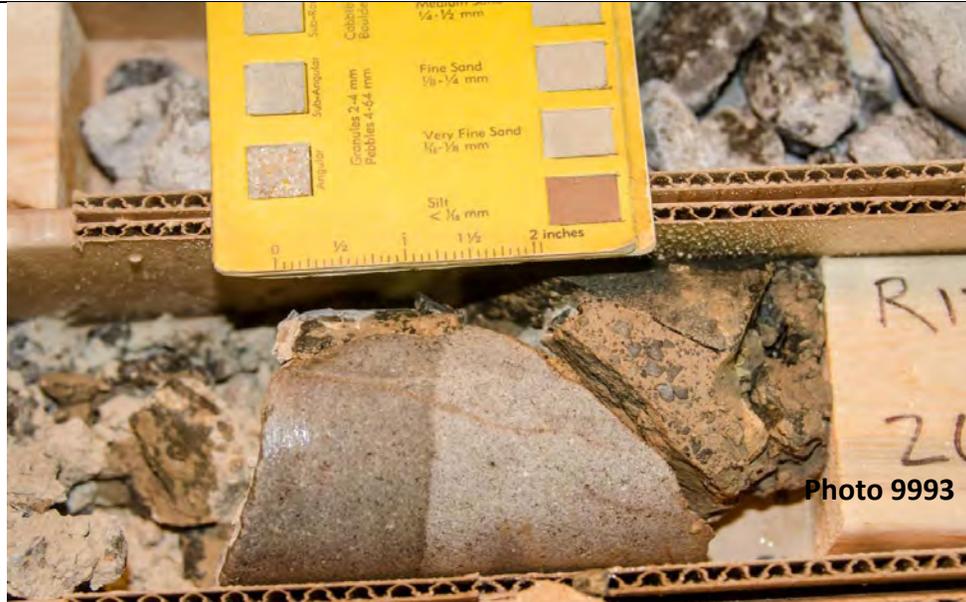
Photo 9993

19.5-21	Same as above with largest recovered piece ~2.5" in length.	30
21-24	Same as above with largest recovered piece ~4" in length. At base there is one 3" long conglomeration of rounded andesite pieces that is held together by a gray, silty clay matrix. Again not clear where clay might be derived from.	40
24-26.5	Andesite largely as above except that: the one largely coherent piece of core has a prominent ~horizontal contact in it where andesite abruptly goes from dark gray to light gray; there is a steeply dipping foliation plane (~450) that was apparently open about 3/4" and which is filled with brecciated, angular andesite clasts held together by a clay matrix (PHOTO_9993).	25

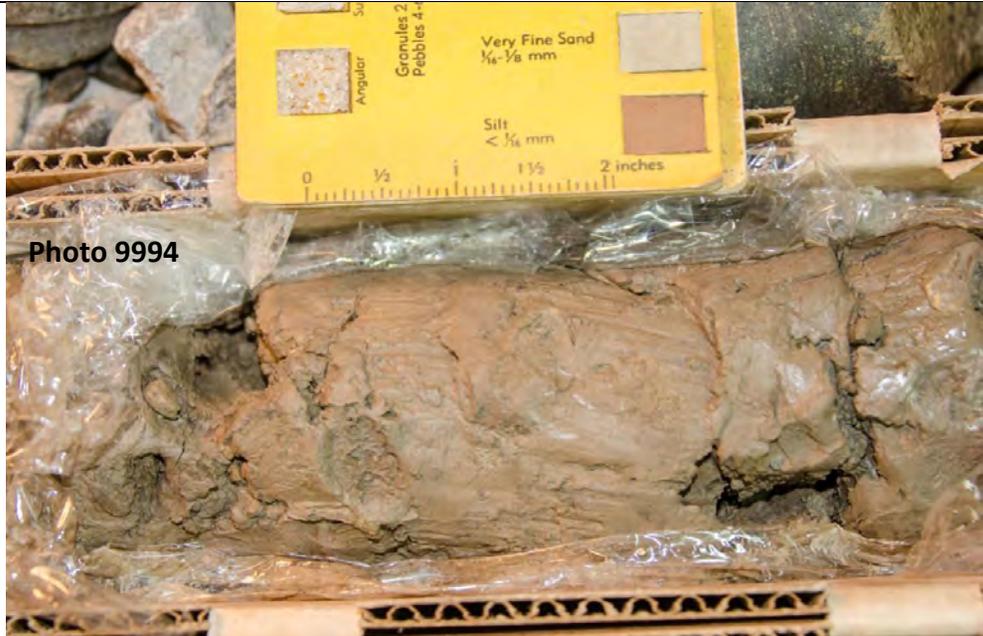
Photo 9994

Upper ~1' (??) is darker gray **andesite** as everywhere above except in the small piece described immediately above where there is the 3" thick layer of lighter andesite. All broken rubble except for piece at bottom which is ~3.5" in length. Immediately below this piece of andesite there is an abrupt (?) transition to a brown, slightly silty **clay-claystone** that is quite malleable between the fingers; it has some sub-angular clasts (andesite?) from large sand to pebble size. It is likely that nearly all the recovery is from this lower part of the core which extends to the interval's base. PHOTO 9994

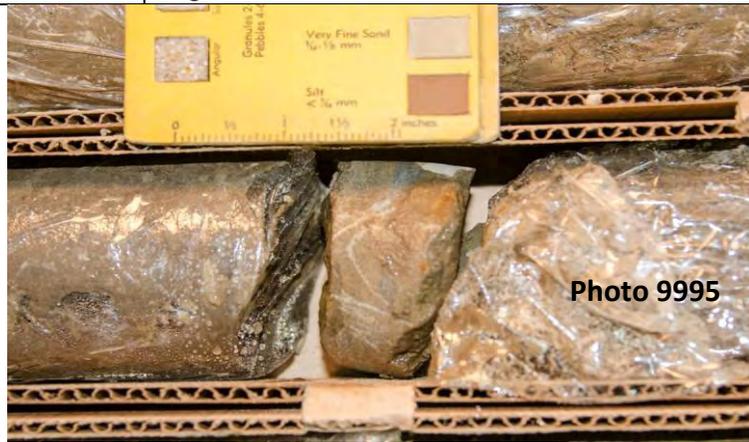
Photo 9995

Entire interval is **claystone** as above (brown, slightly silty) with what appear to all be andesite clasts ranging in size from large sand to one small cobble. PHOTOS 9995 shows drilled andesite cobble; 9996 shows unwrapped claystone with multiple sub-angular andesite clasts.

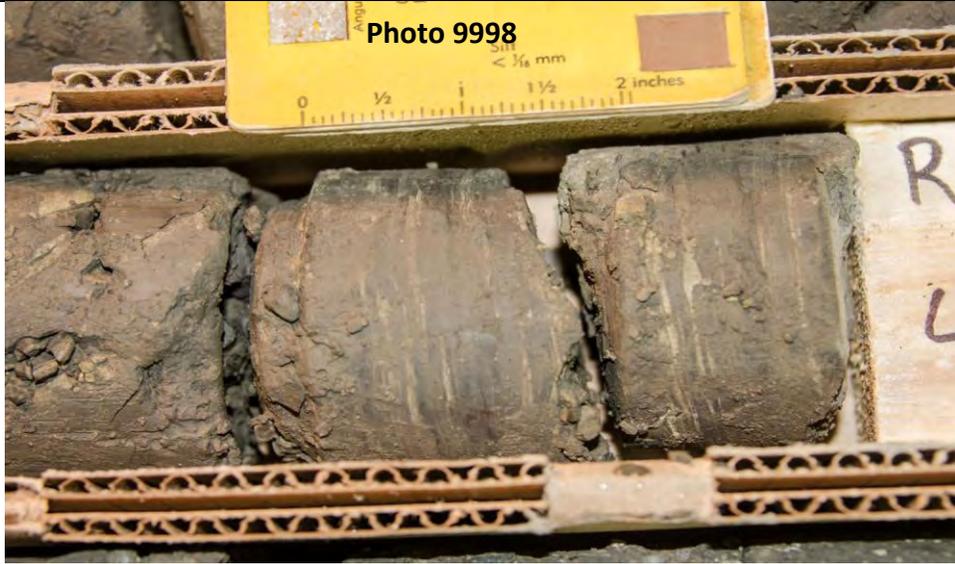
36.5-39	<p>Upper few inches is one 2" very light <b>andesite</b> piece with broken pieces below of a much darker <b>andesite</b>; all likely cobbles - pebbles beneath the conglomerate??. Below this is ~1.5" of a grayish-brown, silty <b>clay-claystone</b><sup>1</sup>. Below this is ~6" of dark gray slightly silty claystone with occasional clasts of sub-rounded to sub-angular andesite, mostly small pebble sized. The clasts are "floating" in the clay matrix.</p>	40
39-41.5	<p>Same slightly silty <b>clay-claystone</b><sup>1</sup> as above with same admixture of clasts, mostly andesite. There are some other unidentified and quite weathered coarse sand size clasts. Very bottom 4" has horizontal seemingly stretched out lenses of very fine sand-like nature? PHOTO 9998.</p>	100

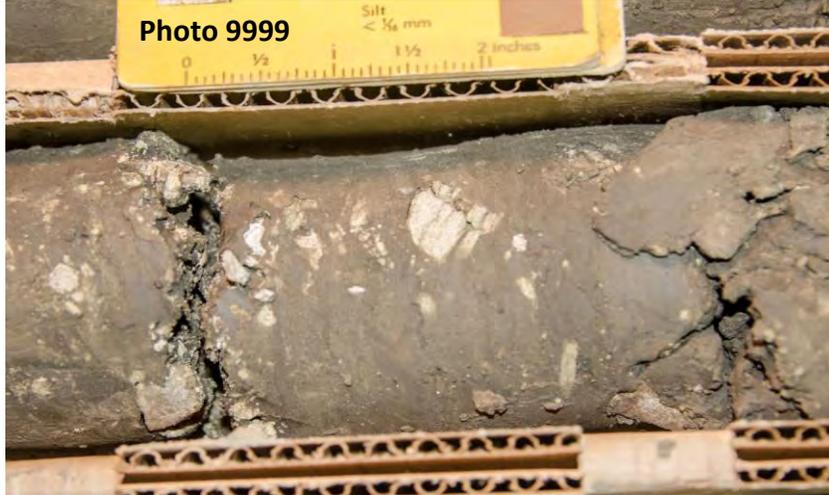
41.5-44 Same slightly silty grayish-brown **clay-claystone** as above. Abundant andesite clasts from coarse sand size up to small cobble size. All appear to be "floating" in the claystone matrix, are sub-rounded to angular (PHOTO 9999).

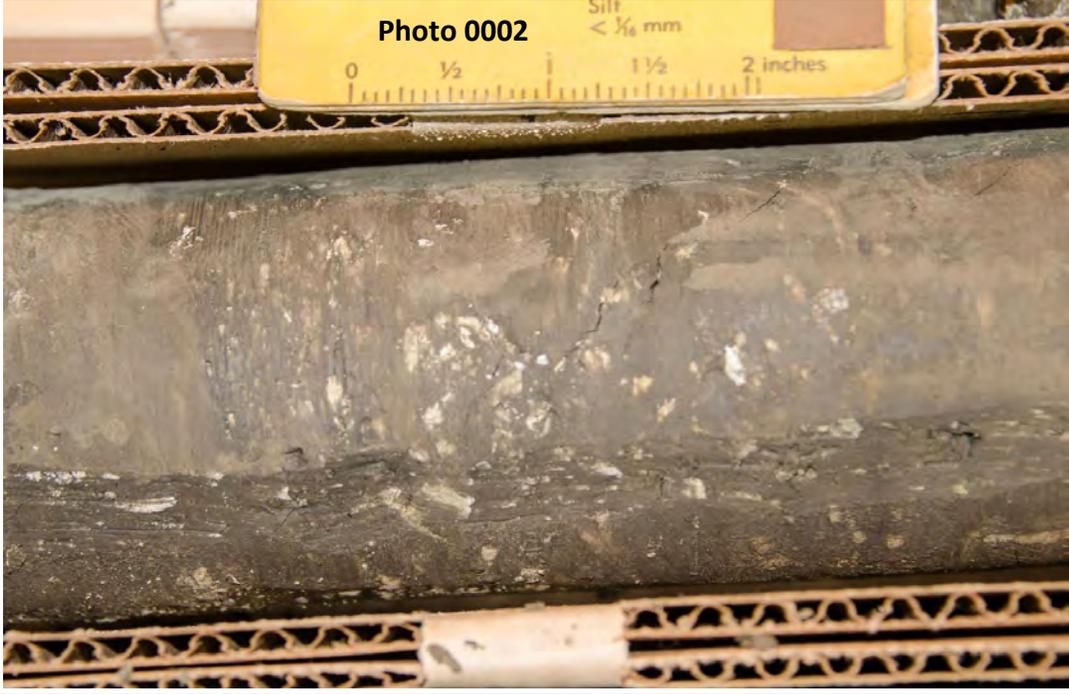
44.2-46.5	Same <b>clay-claystone</b> as above (PHOTO 0002). Same angular to sub-angular andesite clasts of large pebble to coarse sand size.	100

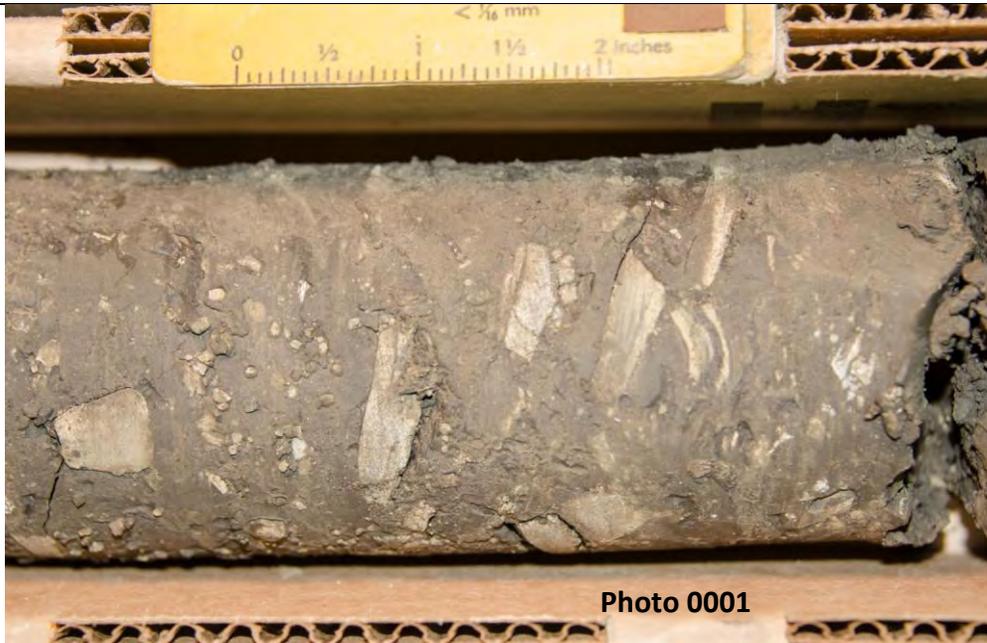
Photo 0001

46.5-51.5	<p>Same <b>clay - claystone</b> as above (PHOTO 0001). Same angular to sub-angular andesite clasts of large pebble to coarse sand size. Clasts which are elongate in shape do at least in some cases appear to demonstrate a roughly sub-horizontal orientation which if this is the interpreted debris flow might have had some laminar aspect to its flow. See PHOTO 0001.</p> <p><b>NOTE:</b> There is no apparent bedding in this clay-claystone, all clasts "float" in the clay matrix, and this is strongly indicative of a mass flow, a debris flow. The fact that clasts seem to be entirely angular to sub-angular andesite of sand size to cobble size suggests that they were likely introduced catastrophically into the clay matrix.</p>	100+

**NOTE:** There is no apparent bedding in this **clay-claystone**, all clasts "float" in the clay matrix, and this is strongly indicative of a mass flow, a debris flow. The fact that clasts seem to be entirely angular to sub-angular andesite of sand size to cobble size suggests that they were likely introduced catastrophically into the clay matrix.

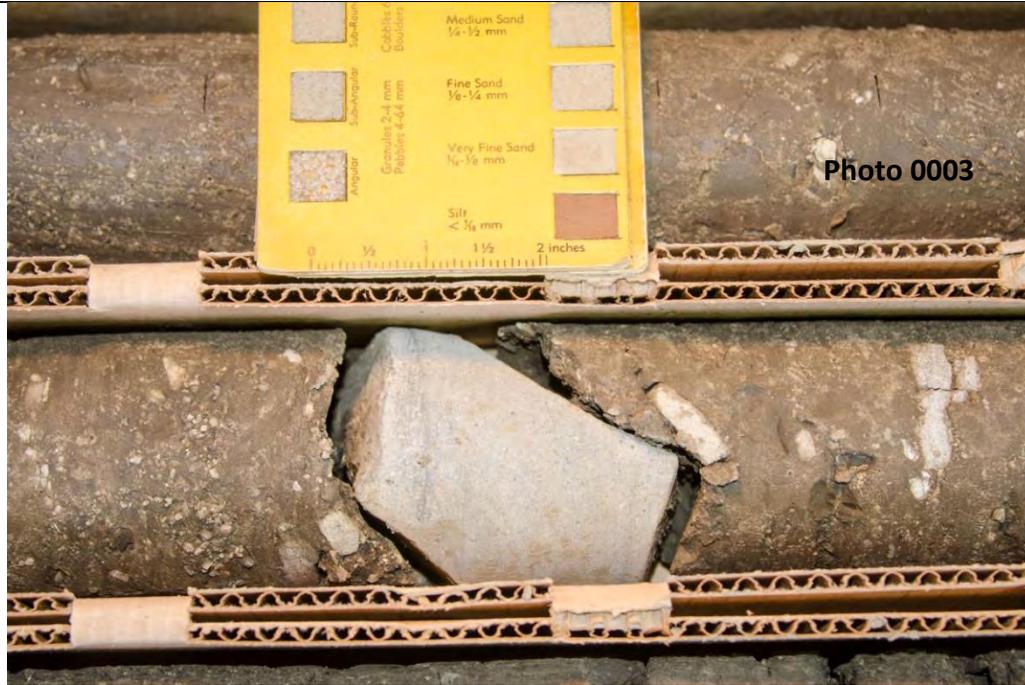
Photo 0003

More of same **clay-claystone** as above. Andesite clasts are mostly sand size, some pebble sized, one large cobble size (PHOTO 0003).

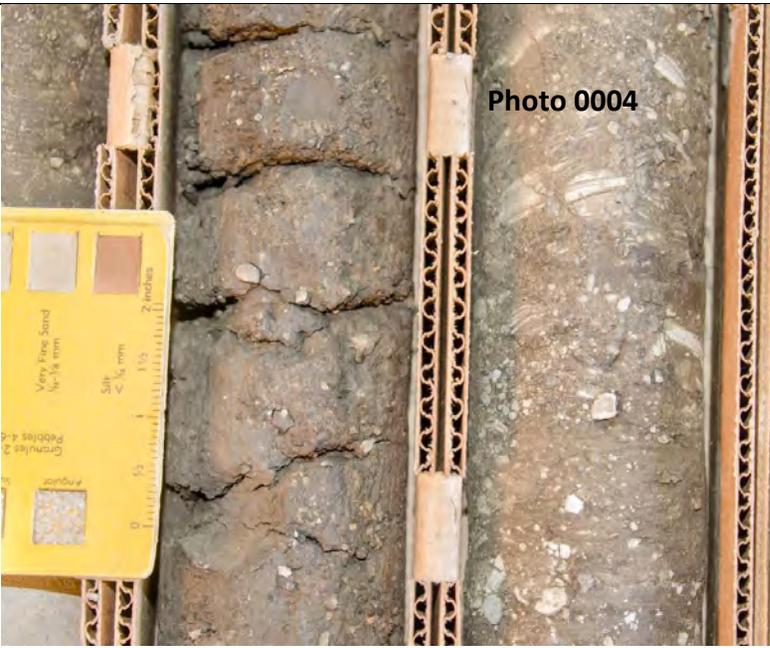
<p style="text-align: center;"><b>Photo 0004</b></p>

56.5-59.5	<p>More of <b>same clay-claystone</b> as above. Andesite clasts are mostly sand size, some pebble sized. Upper 2' of this interval is clearly clast poor as compared to the bottom 2'; see PHOTO 0004. But there is NO evidence of any bedding and in all cases the clasts are matrix supported. PHOTO 0006 is of the lower, clast "rich" zone just above 59.5'.</p>	100+
-----------	----------------------------------------------------------------------------------------------------------------------------------------------------------------------------------------------------------------------------------------------------------------------------------------------------------------------------------------------------------------------	------

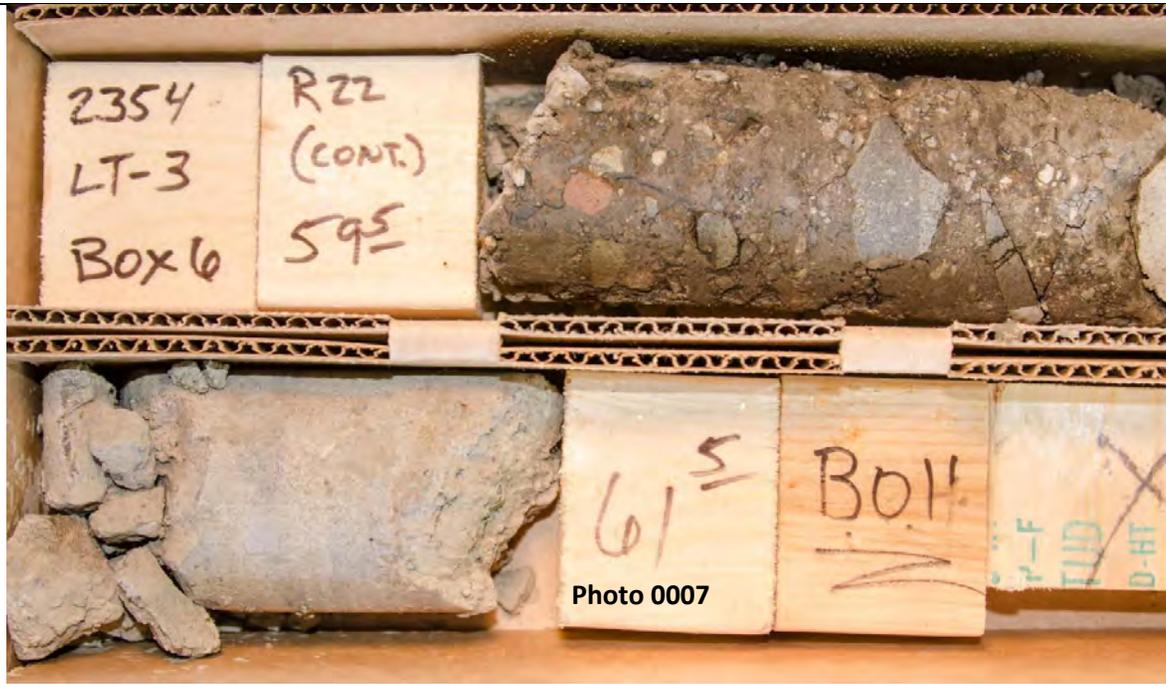
<p style="text-align: center;"><b>Photo 0006</b></p>	
59.5-61.5	<p>Same grayish-brown <b>clay-claystone</b> as in lower part of prior (above) interval (clast rich). Clasts from coarse sand size to large cobble size and with one exception all andesite; the exception is a pebble of red scoria (PHOTO 0007). TD of well is in large cobble?? of andesite (PHOTO 0007).</p>	100

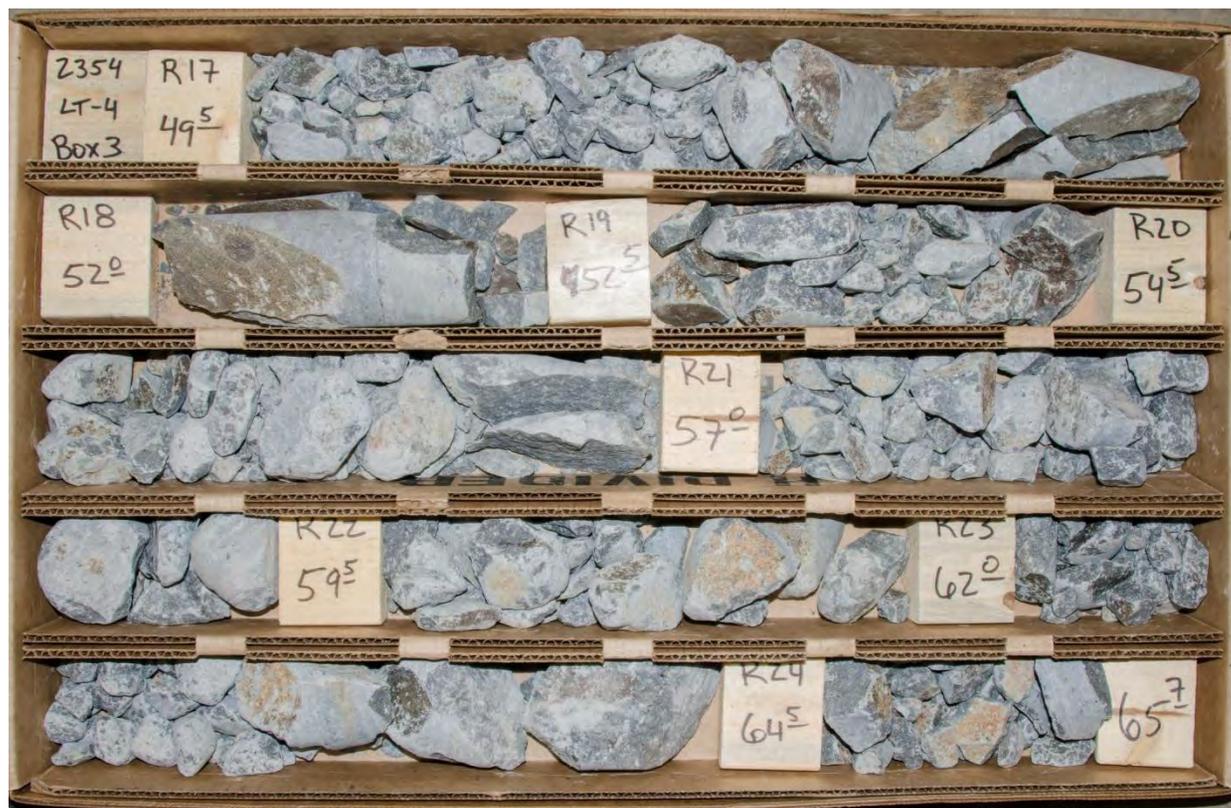
44.5'-47'	Andesite?; largest piece = 2" long	35
47'-49.5'	Andesite?; loose rubble, most pieces <1" long	35
49.5'-52'	Andesite?; Top is broken bits. Lower half is massive with subvertical shear or foliation planes; these are weathered so likely open before drilling, likely foliation planes (see PHOTO below)	80

52'-52.5'	Andesite?; Sub-vertical foliation planes with drk mineralization on planes (see PHOTO above)	~100
52.5'-54.5'	Andesite?; rounded rubble! (see PHOTO above)	30
54.5'-57'	Andesite?; rounded rubble except for bottom 4"	35
57'-59.5'	Andesite?; rounded rubble(see PHOTO above)	35
59.5'-62'	Andesite?; rounded rubble; red mineralization along foliation planes	30
62'-64.5'	Andesite?; rounded rubble at top, pieces 3"-4" long at bottom	45
64.5'-65.7'	Andesite?; just broken pieces	75
65.7'-67'	Andesite?; broken bits, quite rounded	70
67'-69.5'	Andesite?, fine grained with mostly equant crystal size, light gray in color. Broken, largest piece is 3.5", most are <1"	35
69.5'-72'	Andesite, same as above. Also mostly small pieces (<1"), but largest ~4"	45
72'-74.5'	Andesite, same as above; small broken & rounded rubble	35

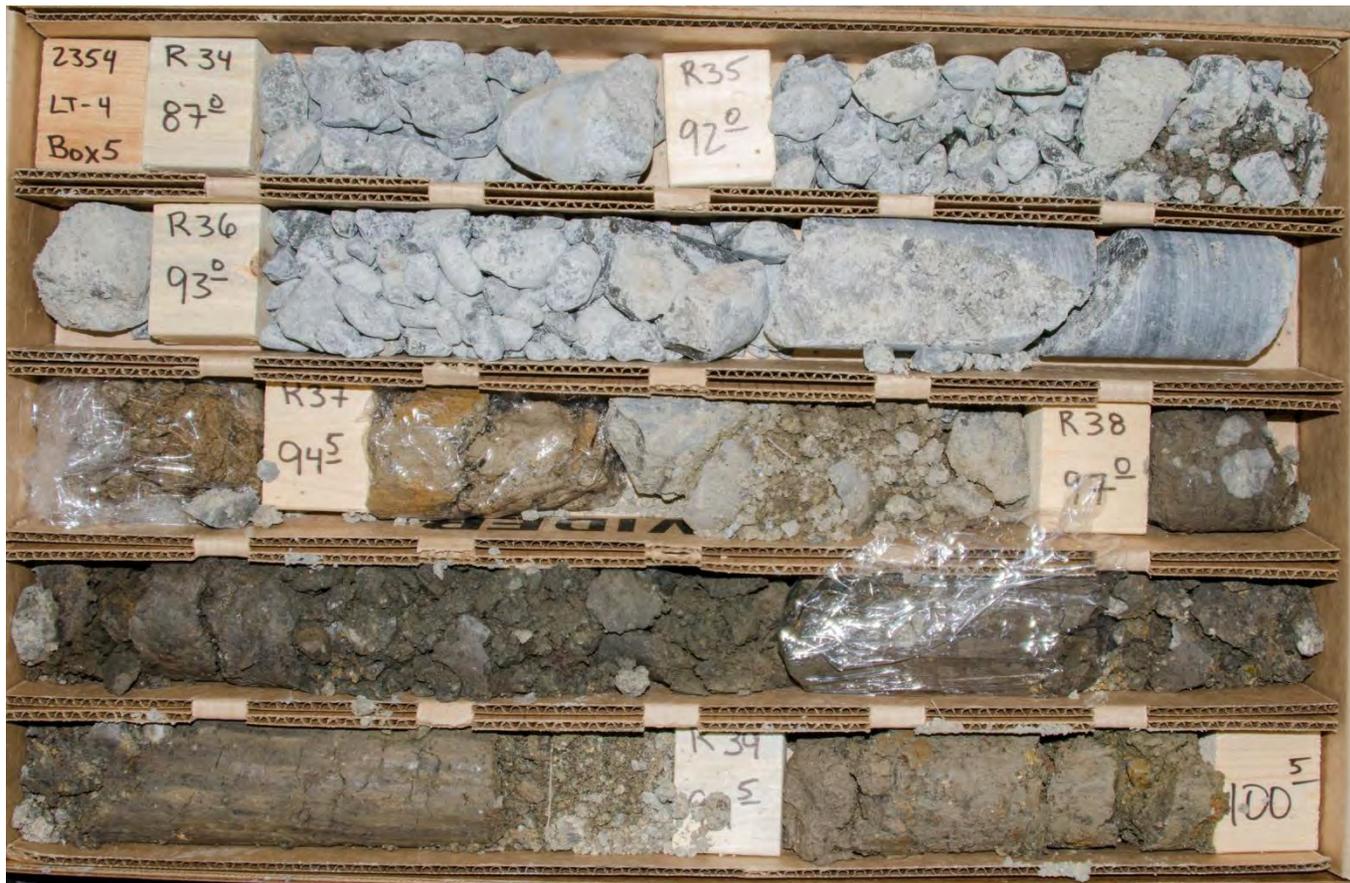
74.5'- 75.5'	NR	0
75.5'-77'	Andesite as above; Rubble to ground bits	30
77'-82'	Andesite, as above; rubble to ground bits, though 1 piece =3"	10
82'-83'	NR	0
83'-86'	NR	0
86'-87'	Andesite, as above; broken pieces <1" up to 2.5" in size	75
87'-92'	Andesite, as above; rounded bits & one piece 3" in length	10
92'-93'	Andesite, as above; Broken pieces, one bit is semi-together but almost clay-like in texture	75
93'-94.5'	Andesite as above; upper part is rubble, then nearly 1' massive, cohesive; bottom 6" is highly weathered(?), turning to clay (PHOTO below)	95

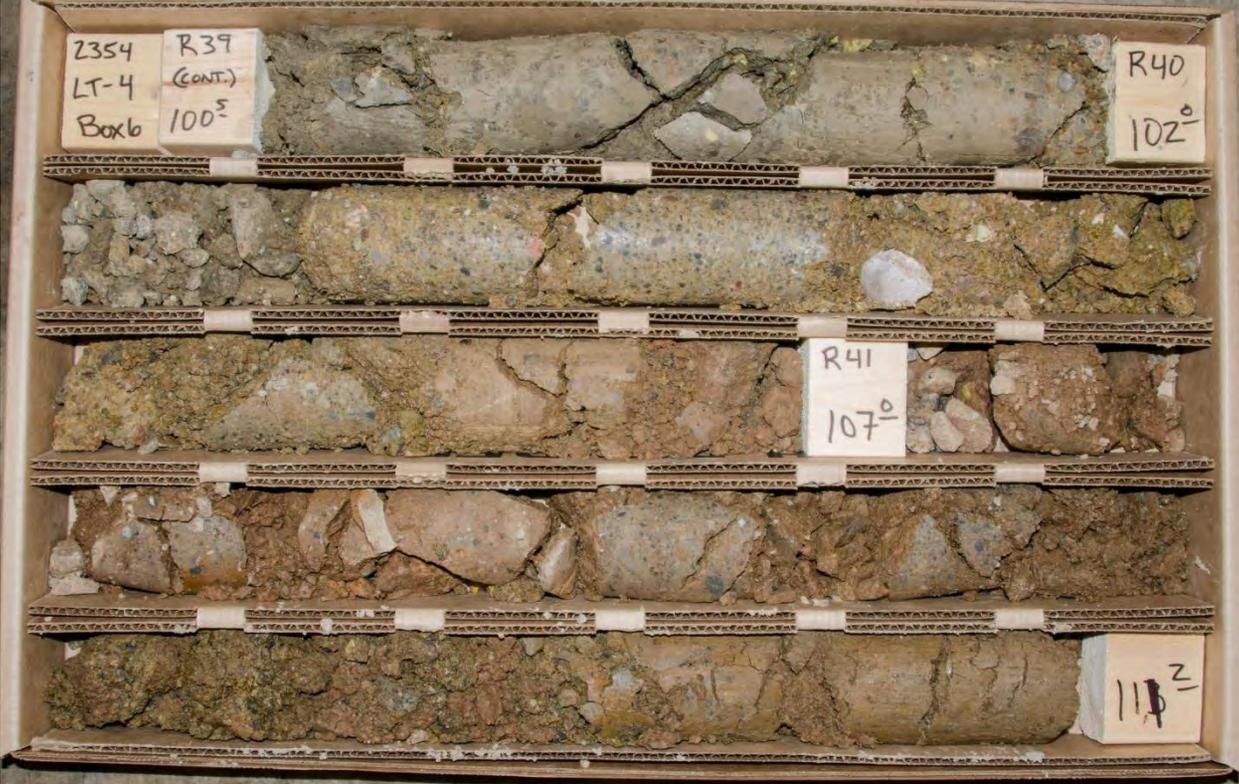
102'-107'	Dark brown conglomerate, highly weathered? Sandy-clay matrix, clasts up to small pebble size (very dark). Sub-rounded to sub-angular in shape (clasts; andesite??). Many very dark clasts (andesite?) and white clasts; occasional red clast. Bottom 1/2 this section badly broken up. (see PHOTO below)	70

107'-111.2'	Dark brown conglomerate, highly weathered? Sandy-clay matrix, clasts up to small pebble size (very dark). Sub-rounded to sub-angular in shape (clasts; andesite??). Many very dark clasts (andesite?) and white clasts; occasional red clast. Lower part of this section is mostly a dirty SS, there are no large clasts (PHOTO above)	100

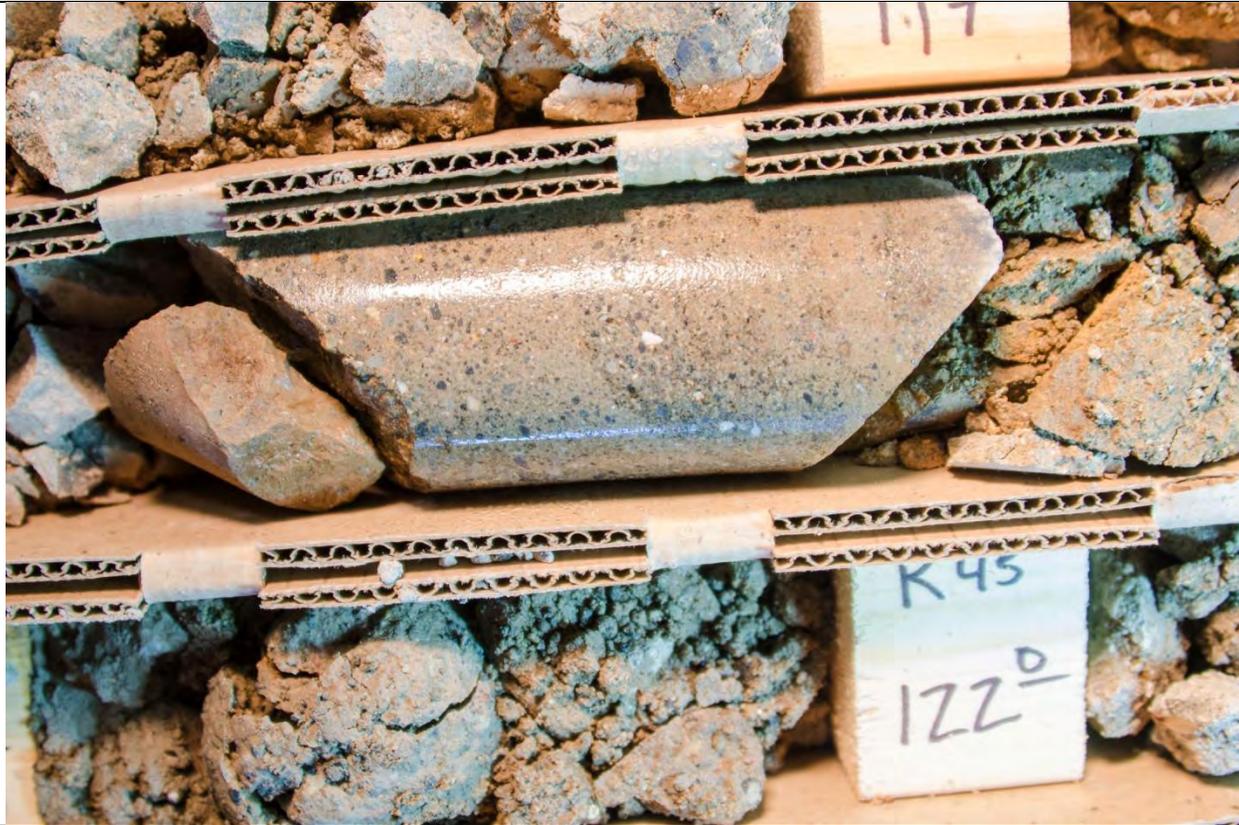
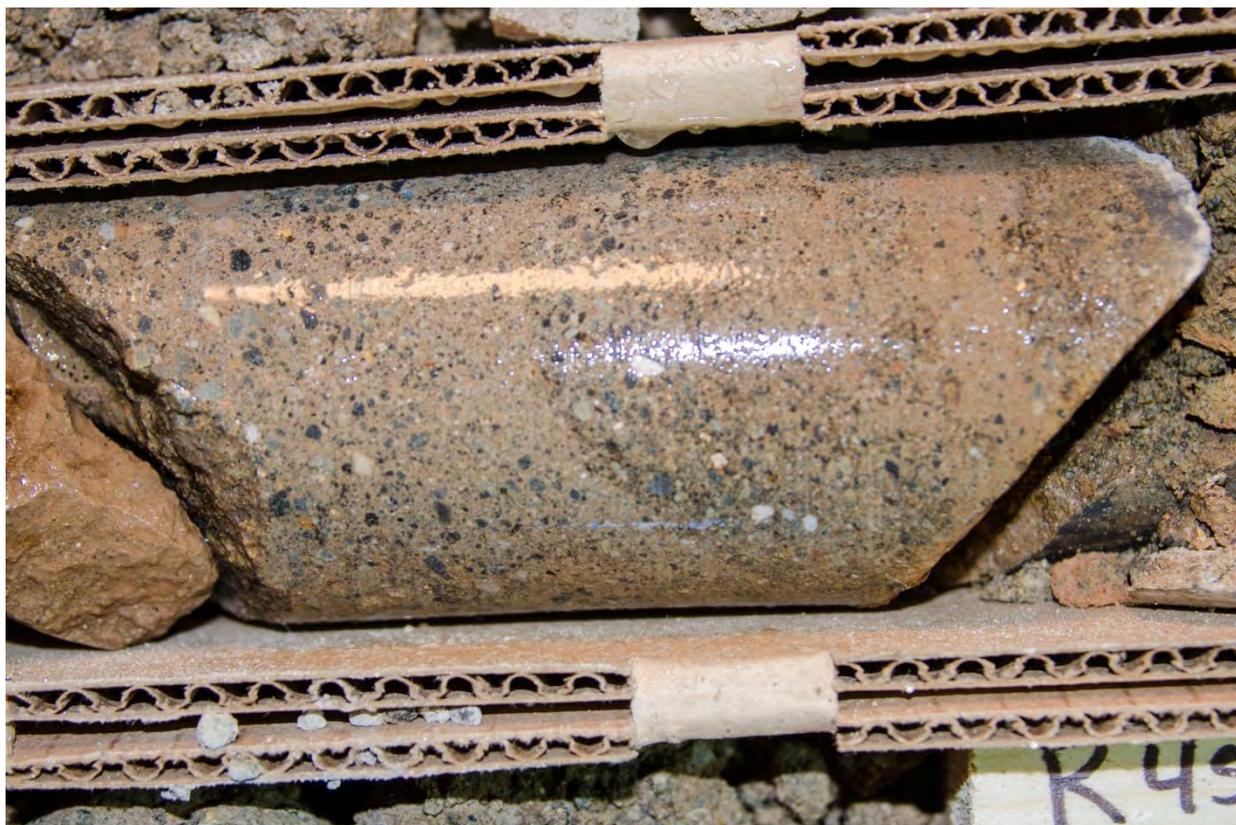
Conglomerate as above. Much of recovery rather broken. Appear to be 2"-3" zone of sandstone (no large clasts). 8"-10" piece in middle that is very lithified, in this piece see bedding, coarser & finer grained layers (see two PHOTO below). Then below this is back to broken & less lithified conglomerates in box.
