# Description of the Five Cores Drilled in the Vicinity of Budge Drive, Jackson, Wyoming in April and May, 2014

An addendum to the  
**Geologic Report on the Slide near  
Budge Drive, Jackson, Wyoming**  
to the Jackson Town Council  
by the Geologists of Jackson Hole.

# Core Descriptions for LT-1 to LT-5 Cores cut at Budge Drive Landslide Site

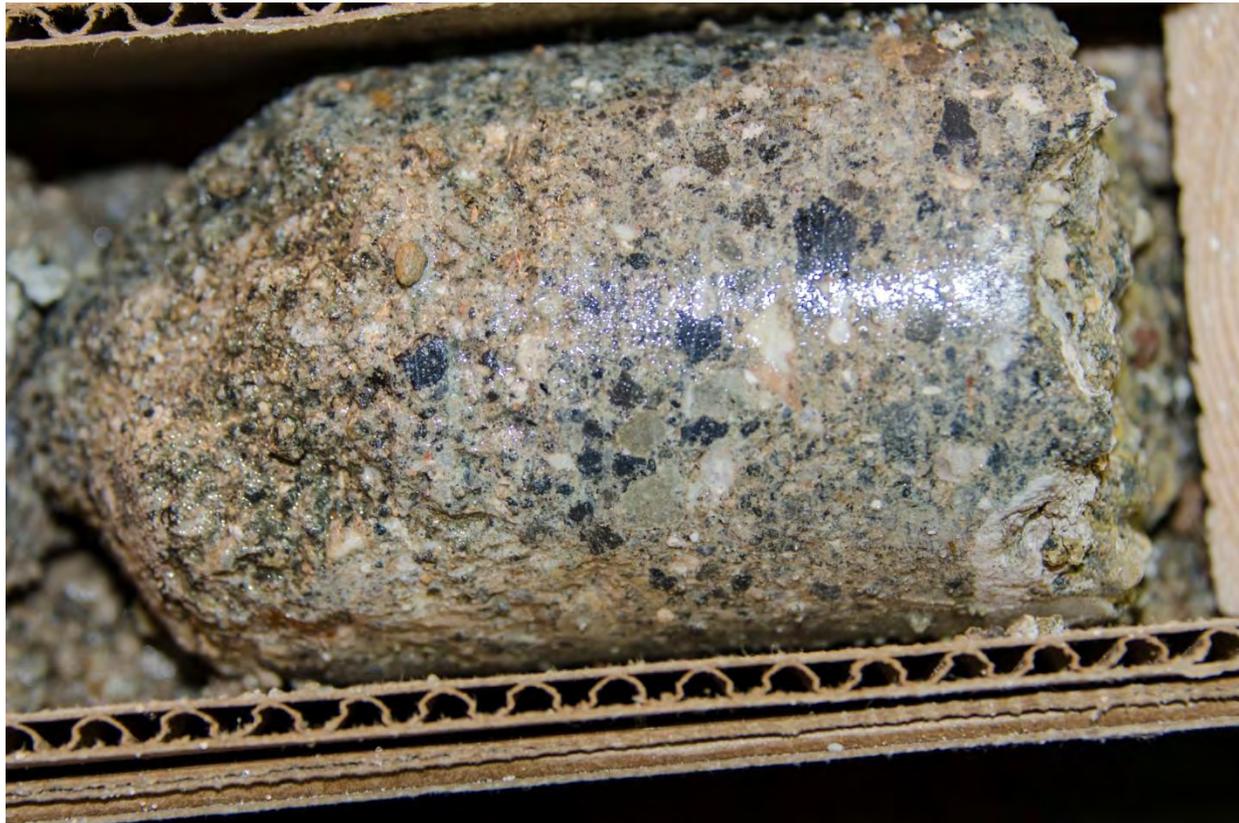
Conglomerate like above. Mostly broken pieces, but one 5" piece that is lithified, has black angular clasts (see PHOTO below).

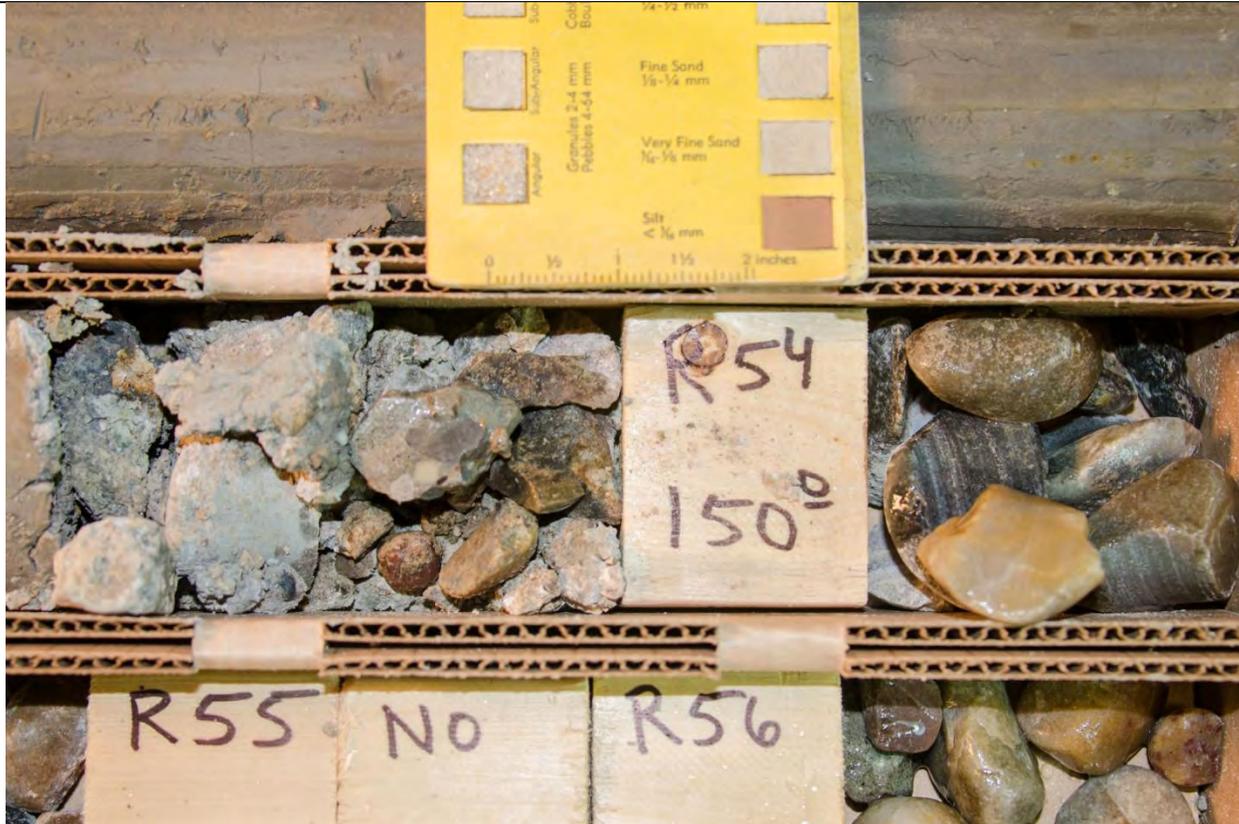
145'-145.9'	Clay-claystone (soft clay); dark gray. But has some clasts in it up to pebble size (andesite?; sub-angular)	100
145.9'-147'	Clay-claystone, gray-brown that grades downward into Fine Sandstone. SS is well sorted, sub-angular, and dirty (quite a few black, some red grains; 2-5%?)	100
147'-150'	All but bottom 4" is gray-brown silty clay-claystone (gritty in mouth). Bottom 4" is hard rubble, probably drilled cobbles; see piece of conglomerate & probably andesite? (see PHOTO below)	100

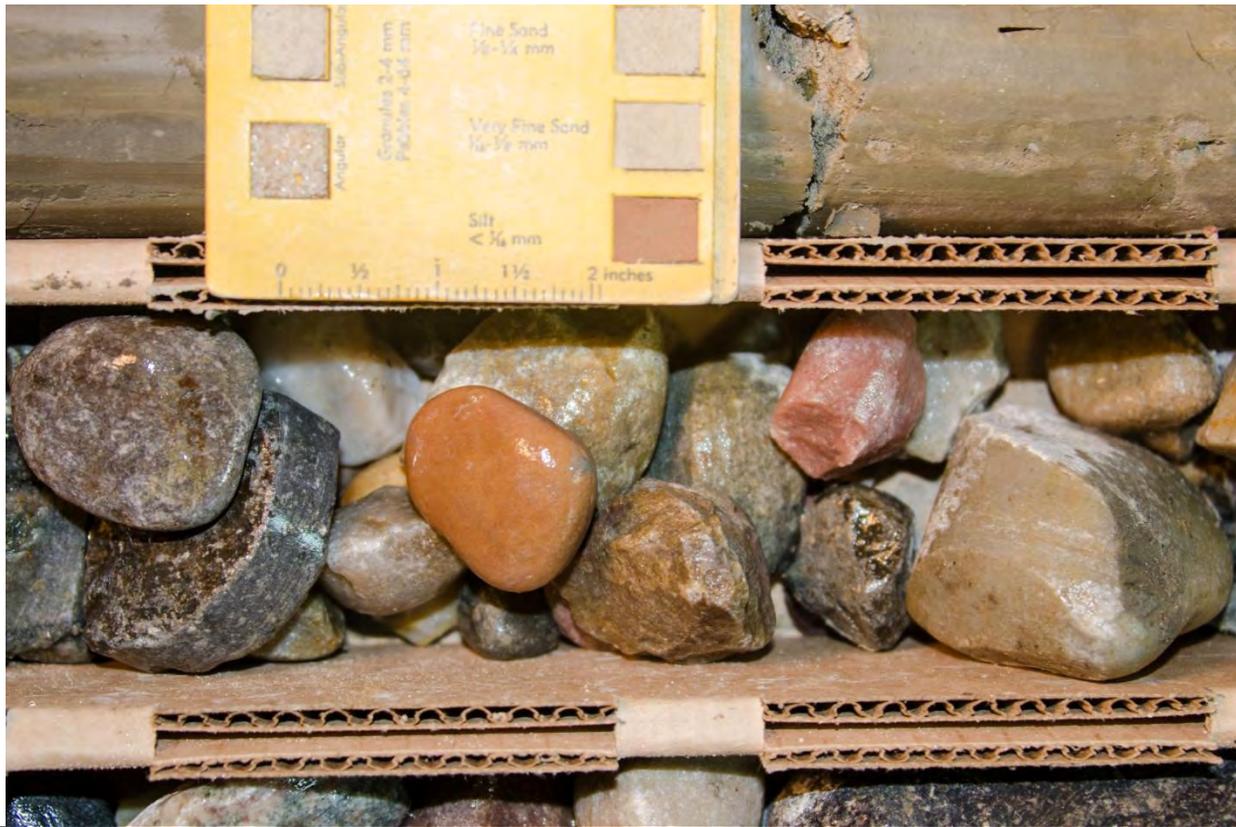
150'-154'	Drilled & broken up cobbles of multiple types: volcanic (andesite?); reddish quartzite or re-crystallized quartz ss with red grains in it. Dense greenish quartzite. All well rounded cobbles & large pebbles. (see PHOTOS above & below)	30
-----------	-------------------------------------------------------------------------------------------------------------------------------------------------------------------------------------------------------------------------------------------	----

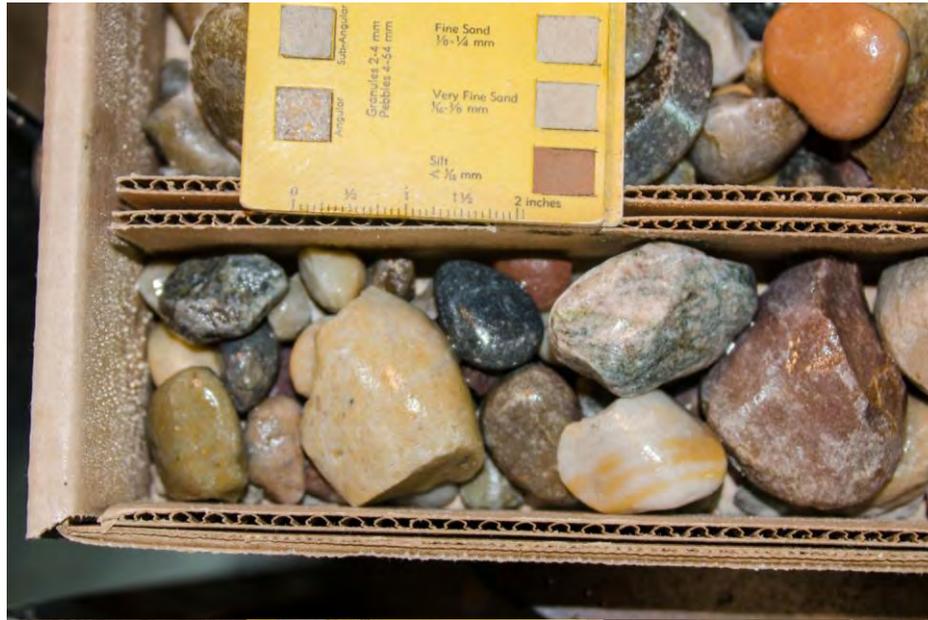
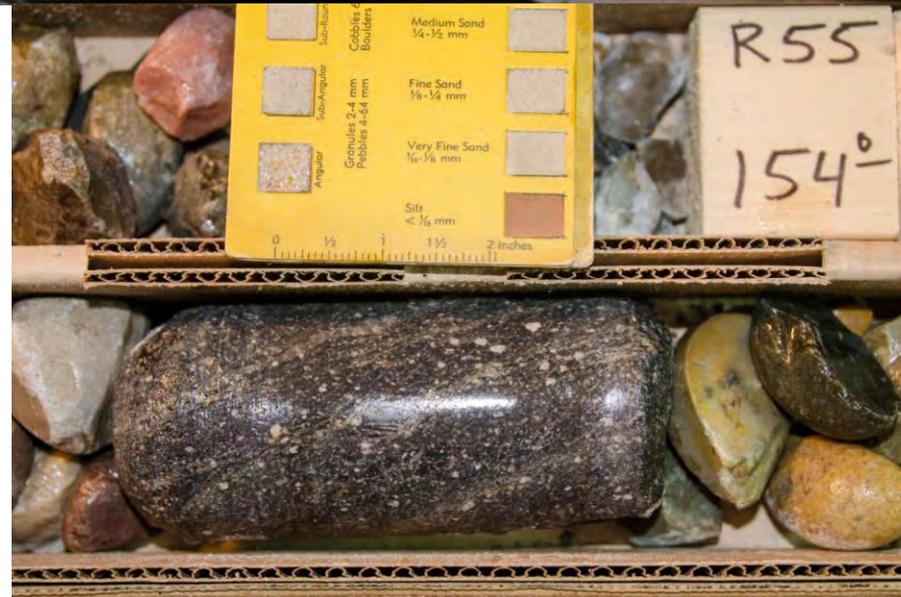
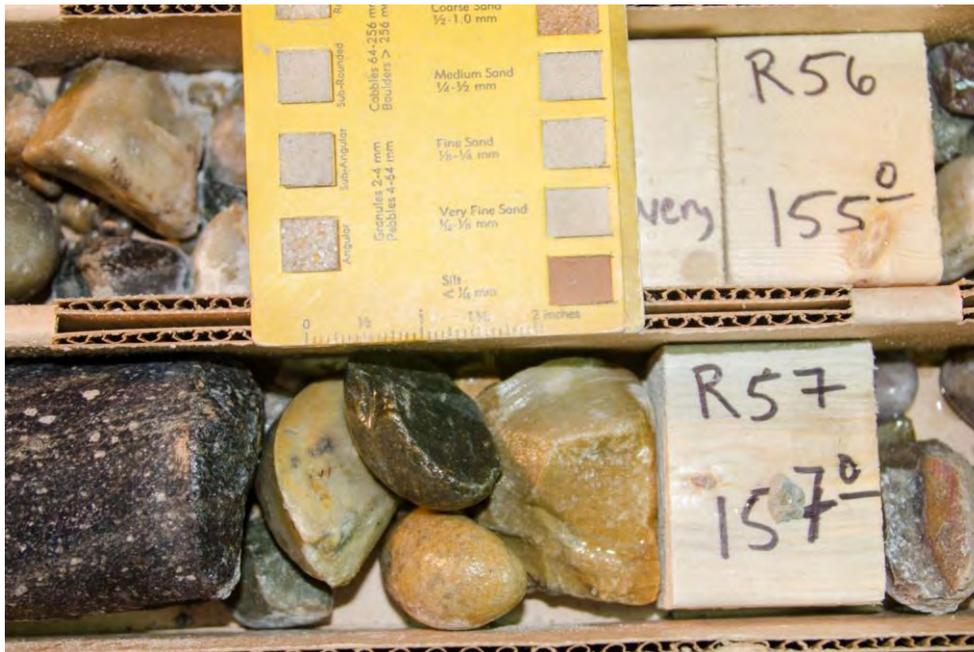
154'-155'	NR	0
155'-157'	Diverse, well rounded pebbles to large cobble (black dacite from north end of N Gros Ventre Butte? Per Dave Adams). Quartzite, Gneiss? Or granite piece (see 3 PHOTOS below)	70

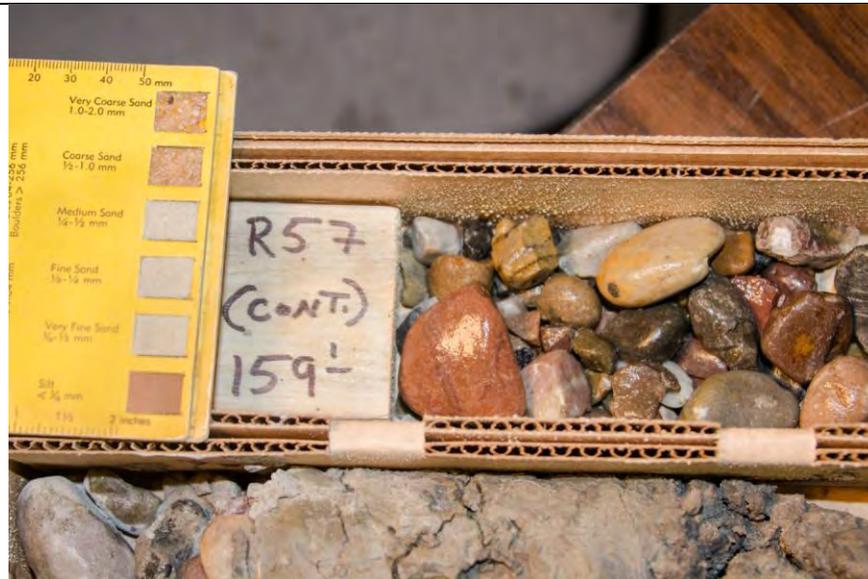
157'-159'	Pieces of large pebbles - small cobbles.	5
159'-160'	Pieces of large pebbles; white & red quartzite; dark volcanics (see PHOTO below)	45

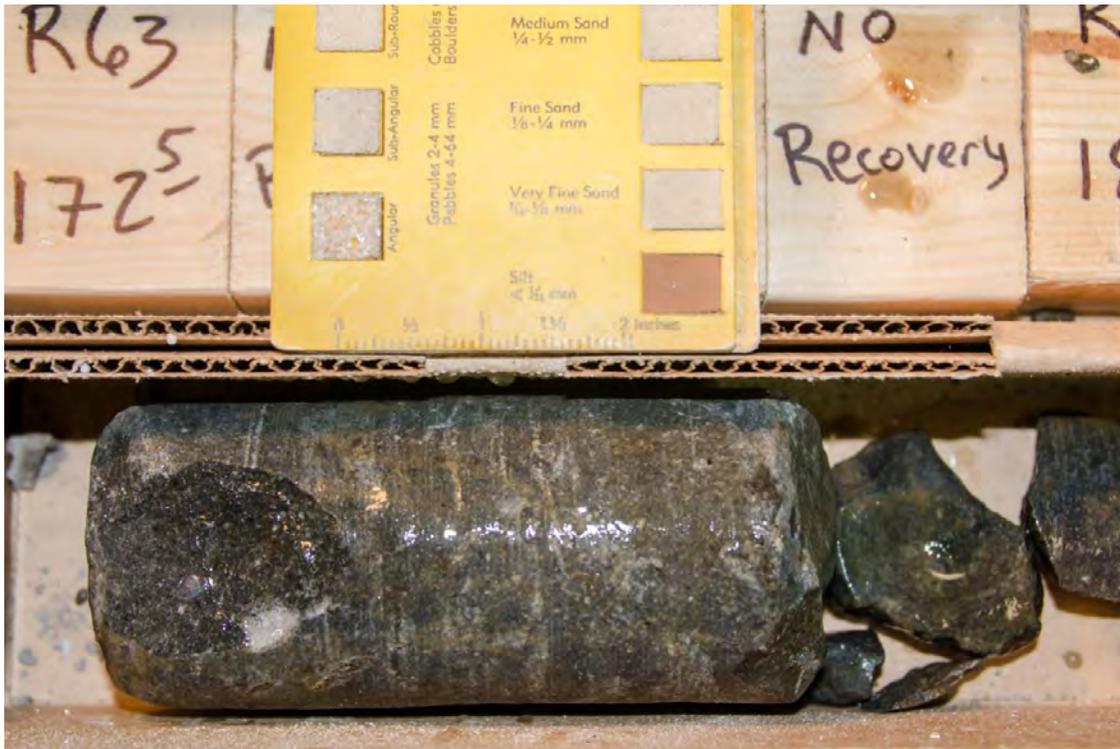
160-167'	NR	0
167'- 169.5'	Pebbles to small cobbles at top of or possibly IN silty, dark gray clay (see PHOTO below)	45
169.5'- 182'	NR	0
182'-187'	Large pebbles (volcanics?) held together by silty dark gray clay	1
187'-192'	One 3.5" piece of andesite	5
192'-197'	One 6"-8" piece of andesite??; perhaps from a boulder? Don't see rounded edge, just cylinder cut of core (see 1 PHOTO below)	15

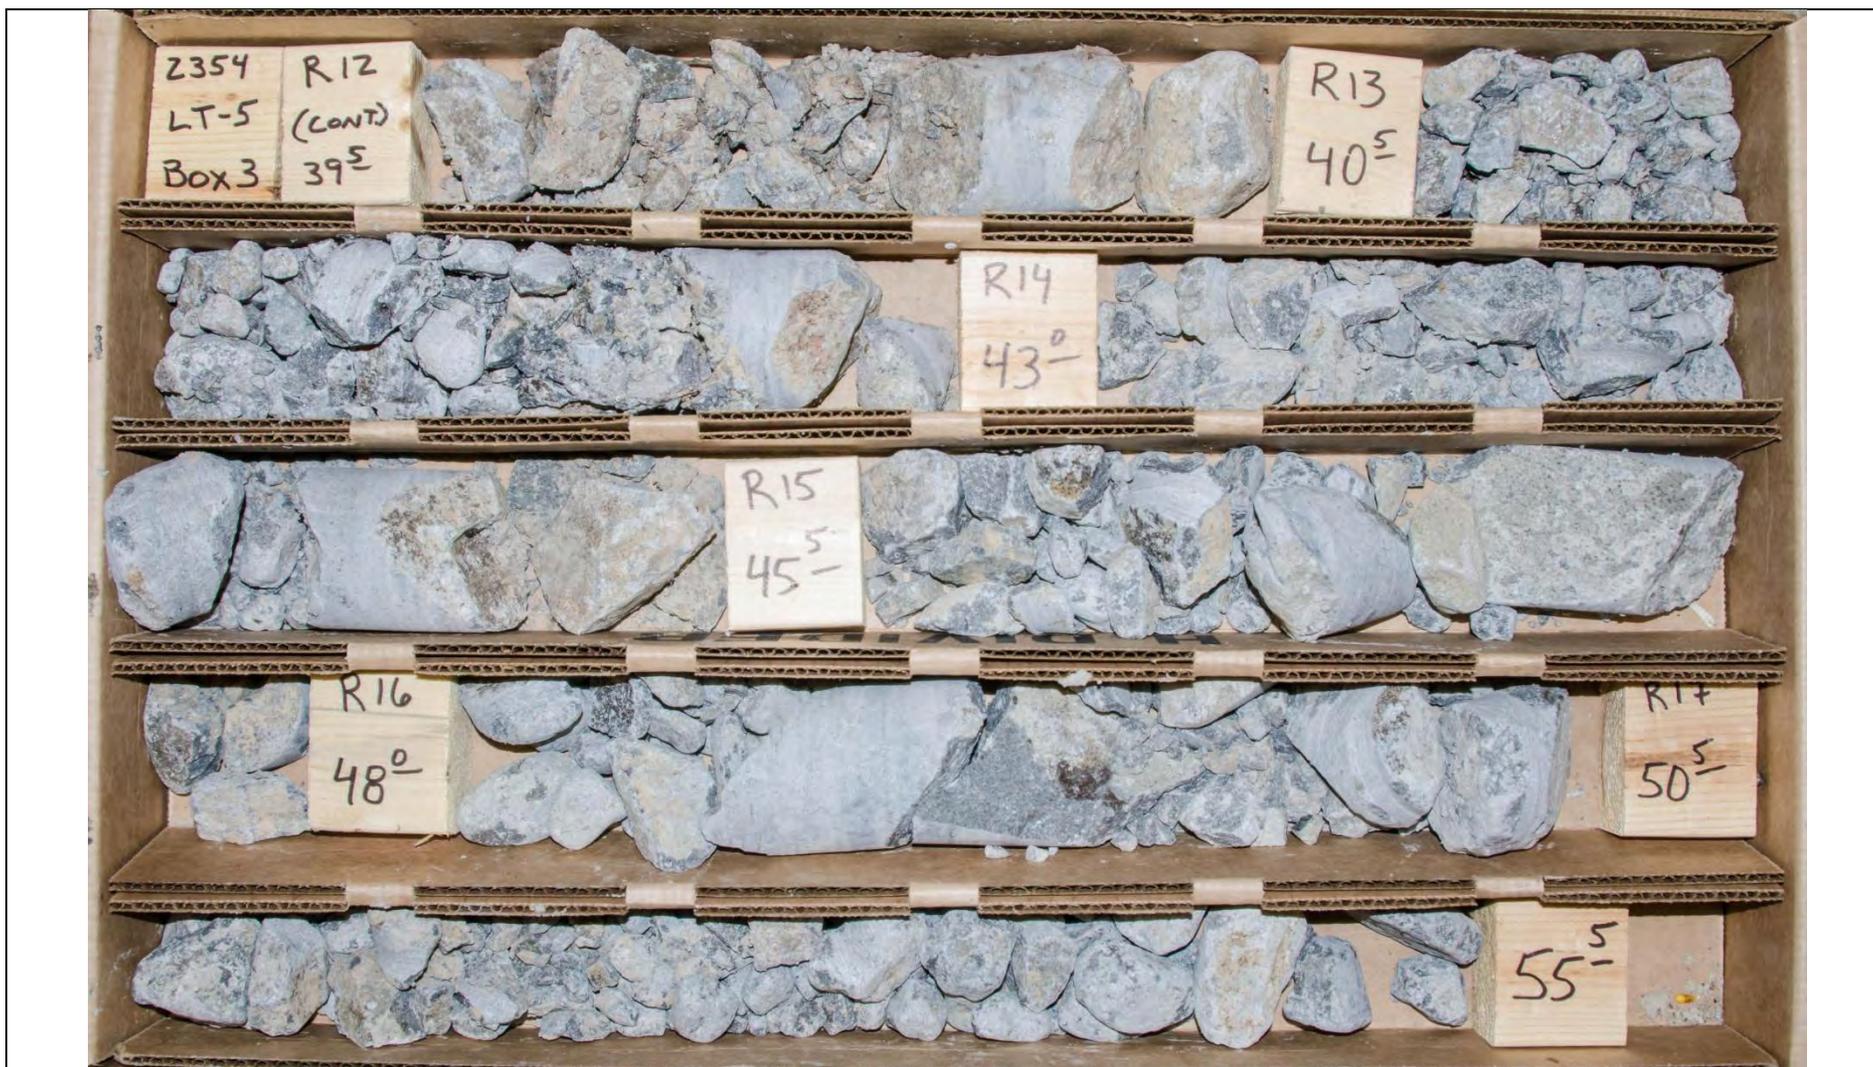
35.5-39.5	<b>Andesite</b> as above but very poor recovery, very much broken into mostly pebble sized and rounded pieces (see PHOTO below)	8

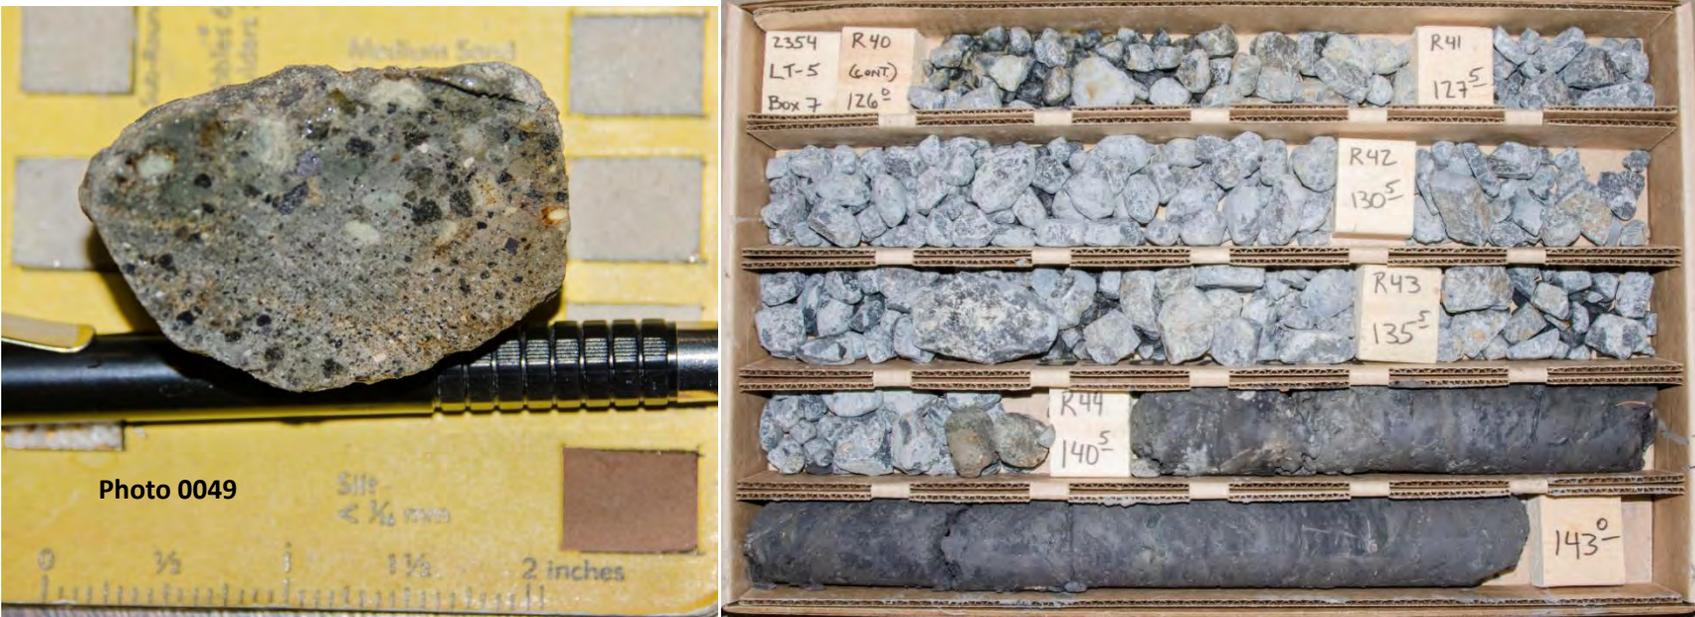
130.5-135.5	<b>Andesite</b> as above, broken into rounded pieces	30
135.5-140.5	<b>Andesite</b> as above, broken into rounded pieces. There is a single large rounded pebble (1.5") of very well lithified <b>conglomerate</b> sitting at the base of this interval (though everything is loose, so isn't necessarily from the base of the interval); <b>Photo 0049</b> . Dave Adams considers this evidence that the conglomerate is present here beyond just as a loose clast - I think this is unlikely but can not rule out the possibility. Dave cut the sample and it is seen in the photo below, and in the core box photo, also below, immediately above the 140.5' marker, immediately above the beginning of the clay-claystone section.	20

140.5-143	<b>Clay-claystone</b> , dark gray, some is a bit silty (gritty texture in mouth). Very homogenous in appearance; no obvious bedding surfaces. 3" above base there a 3-4" section has small fossils (small shells?) in the clay. The bottom 3" section is a bit lighter in color and has a lot of sand grains: clear quartz (?) & dark andesite?? grains? Still mostly a clay matrix. (see PHOTO above of core box, and larger PHOTO of core box below))	100

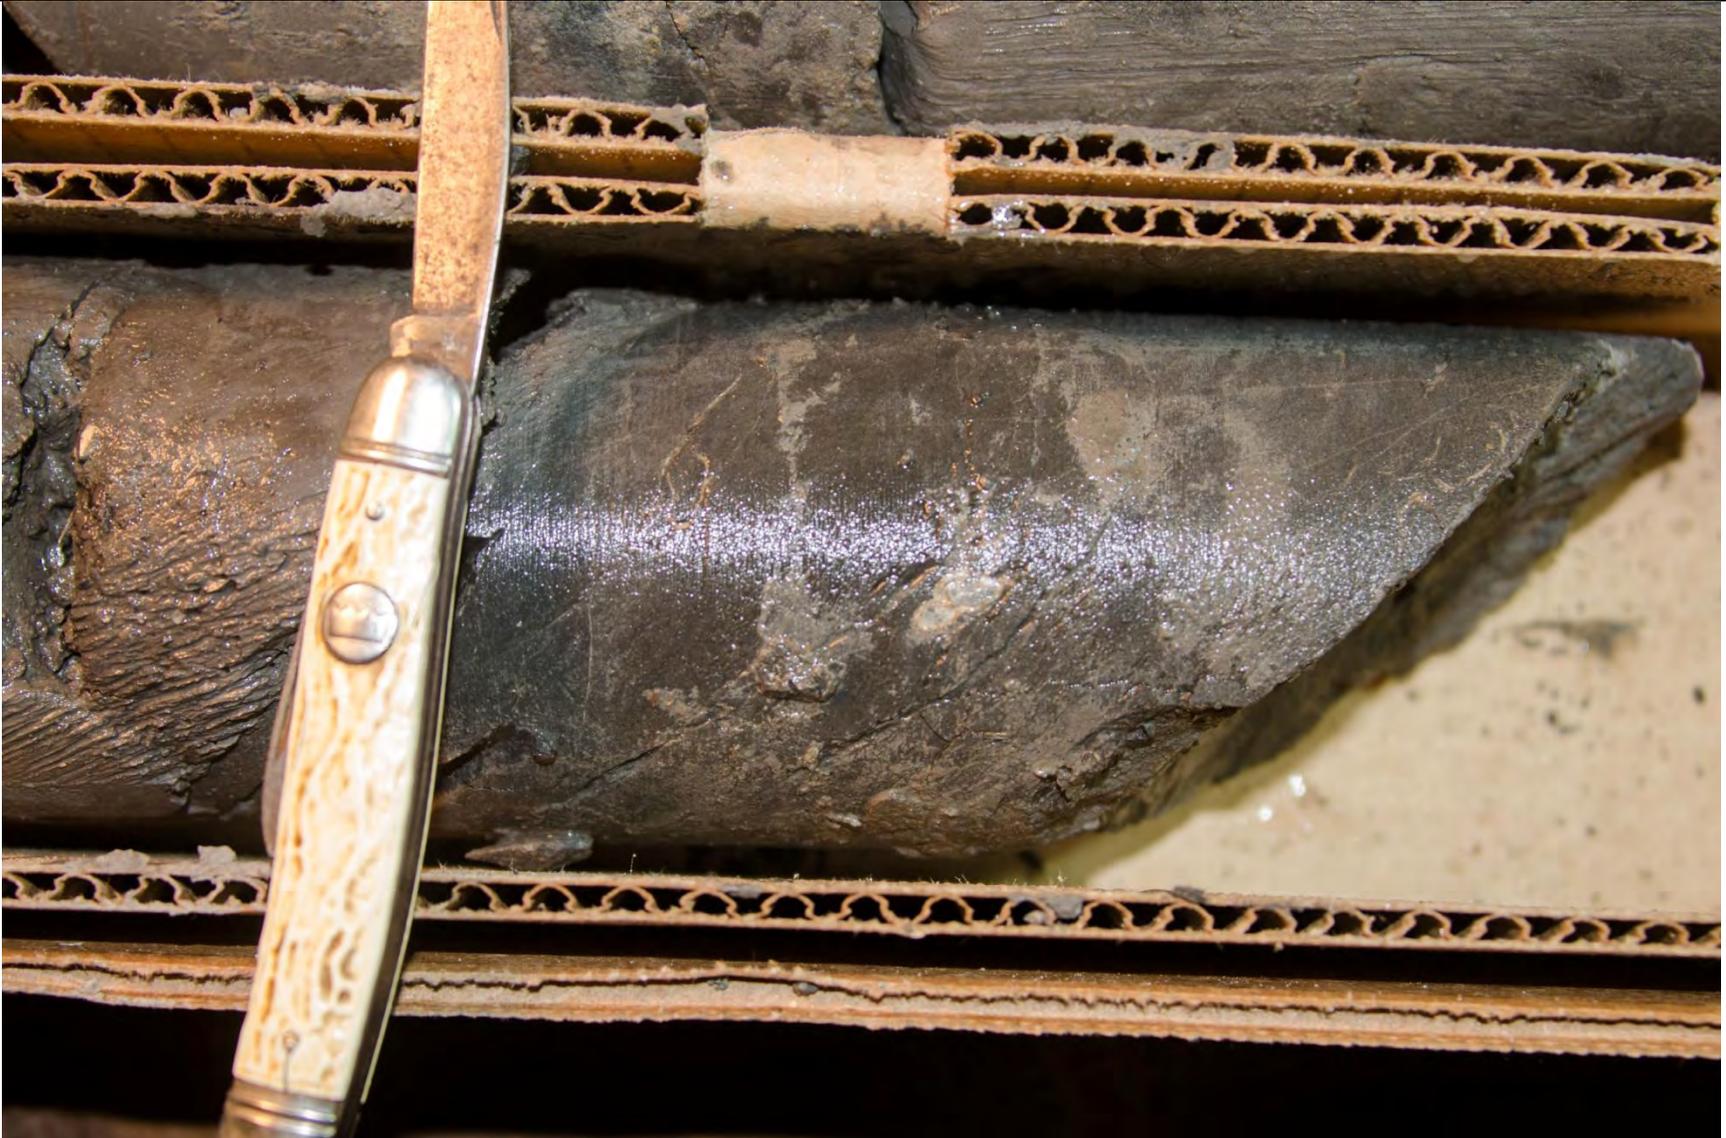
145.5-150.5	Poorly consolidated gray <b>Siltstone</b> , some clay; grains are sub-angular to sub-rounded, predominatly quartz but 2-4% black (andesite?) grains. Easily gouged with finger nail, grains wash loose with squirt bottle. Appears to have subtle texture, possible bedding. <b>Grades downward</b> into ever more clay rich silty gray <b>clay</b> that constitutes bottom 2.5' of this interval.	100
150.5-151	More than the 6" stated for interval of same silty gray <b>clay-claystone</b> . Appear to be small white fossil shells(?) in cross section on core face (curved, thin, fragments, perhaps one gastropod cross section?) (see PHOTO below)	150!!!

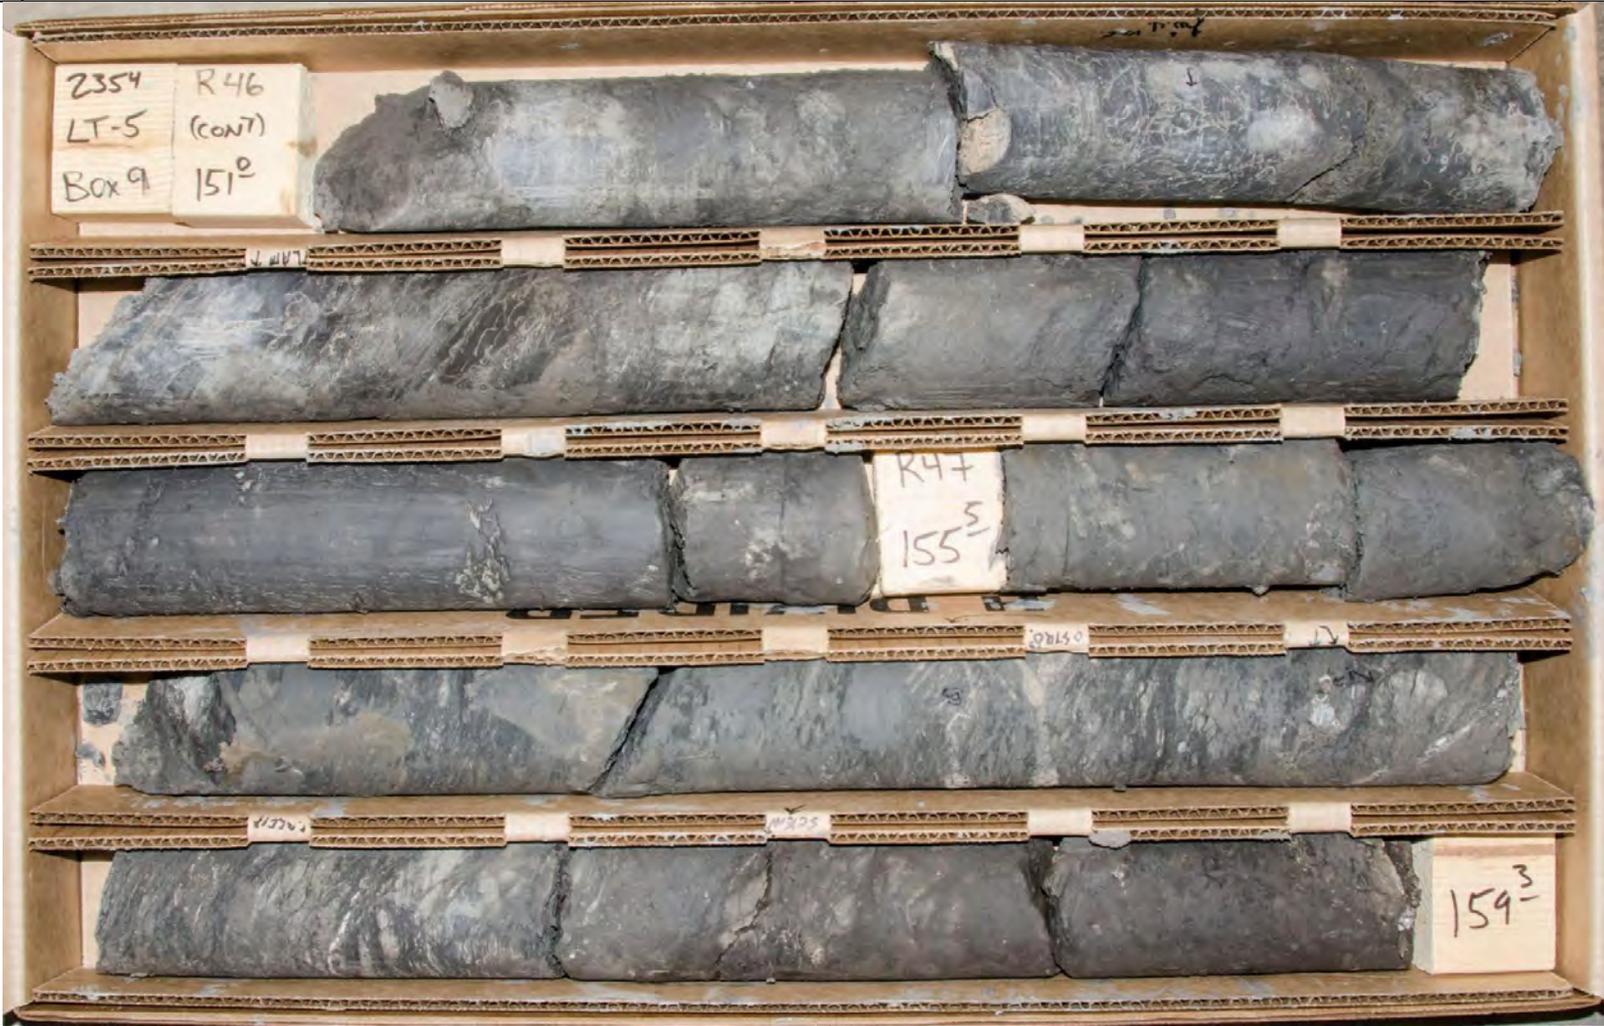
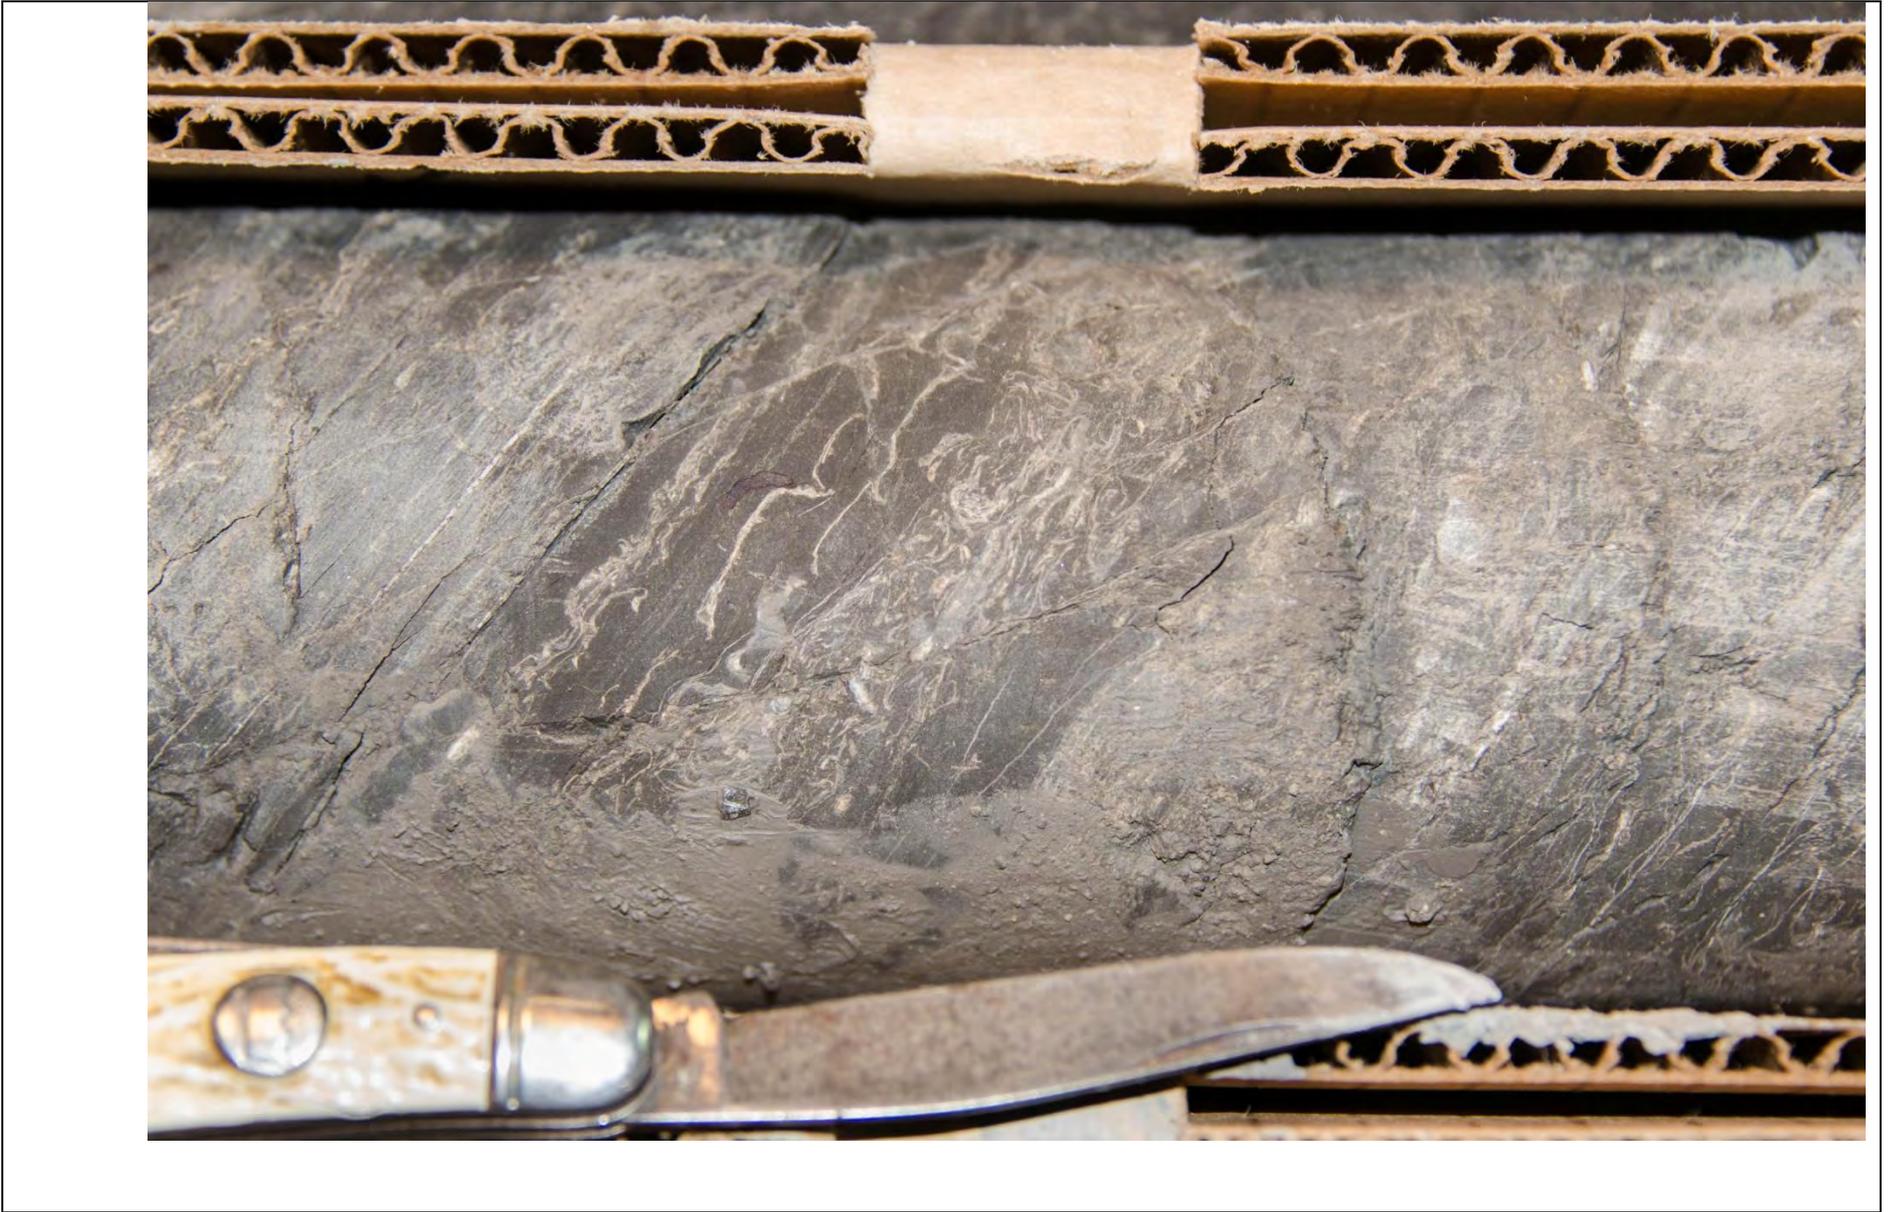
Gray, silty **clay-claystone**, can be scratched by finger nail though it is very coherent. Quite fossil rich, white curvi-linear shape of shells, possible ostracods(?) (see PHOTO of core box below). ~1.5' down there is very evident bedding that has a dip of ~30° relative to the core axis; discrete layer of white curvi-linear feature appears to be fossil lag? associated with thin (<1/4") **siltstone** zones that appear to fine upward. (see 2nd PHOTO below). Below to base of this section bedding not readily apparent, much less silt, purer clay that also has no apparent fossils in it.

Gray silty **clay-claystone** readily scratched by finger nail (see core box PHOTO above). Bedding not apparent but occasional fossil fragments, one large one nearly 1" in length (1st PHOTO below). Just below large fossil is pebble of sub-angular light SS ? (see 2nd PHOTO below). Same gray silty **clay-claystone** for next almost 2' then zone with abundant small fossils (see 3rd PHOTO below), and just below that a steeply dipping zone of white angular debris that are soft enough to scratch with knife blade (calcareous?) They form a very apparent surface at about 35° to the core axis (see 4th PHOTO below). Just above ~158' is zone with apparent bedding dipping perhaps 20°-30° , abundant small white fossils and a cross section of one large thin shell??. Below that similar core, occasional fossil to base.
