# Description of the Five Cores Drilled in the Vicinity of Budge Drive, Jackson, Wyoming in April and May, 2014

An addendum to the  
**Geologic Report on the Slide near  
Budge Drive, Jackson, Wyoming**  
to the Jackson Town Council  
by the Geologists of Jackson Hole.

# Core Descriptions for LT-1 to LT-5 Cores cut at Budge Drive Landslide Site

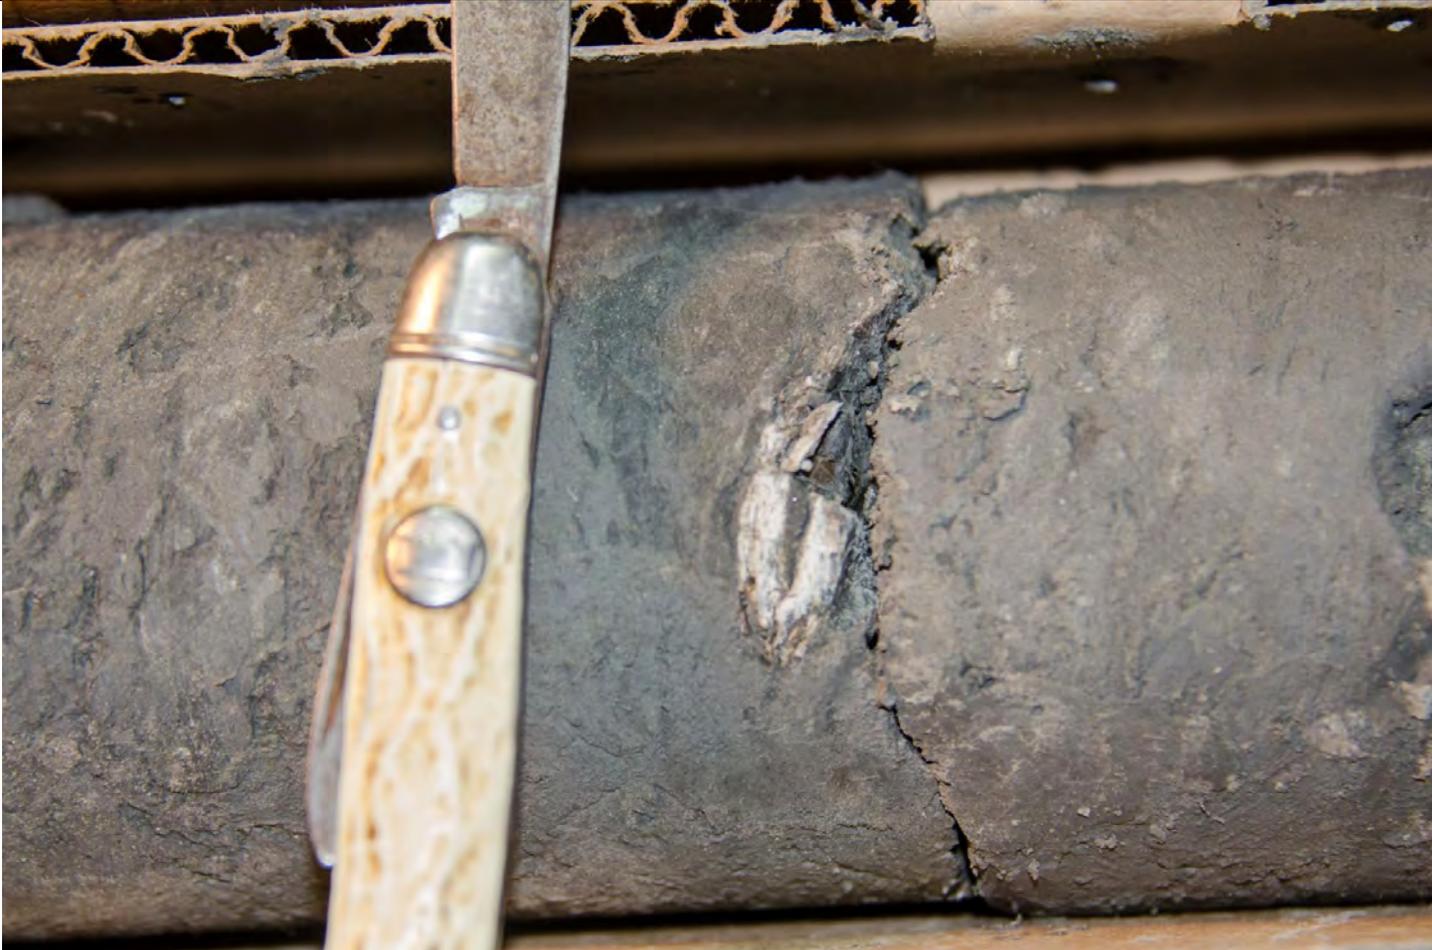
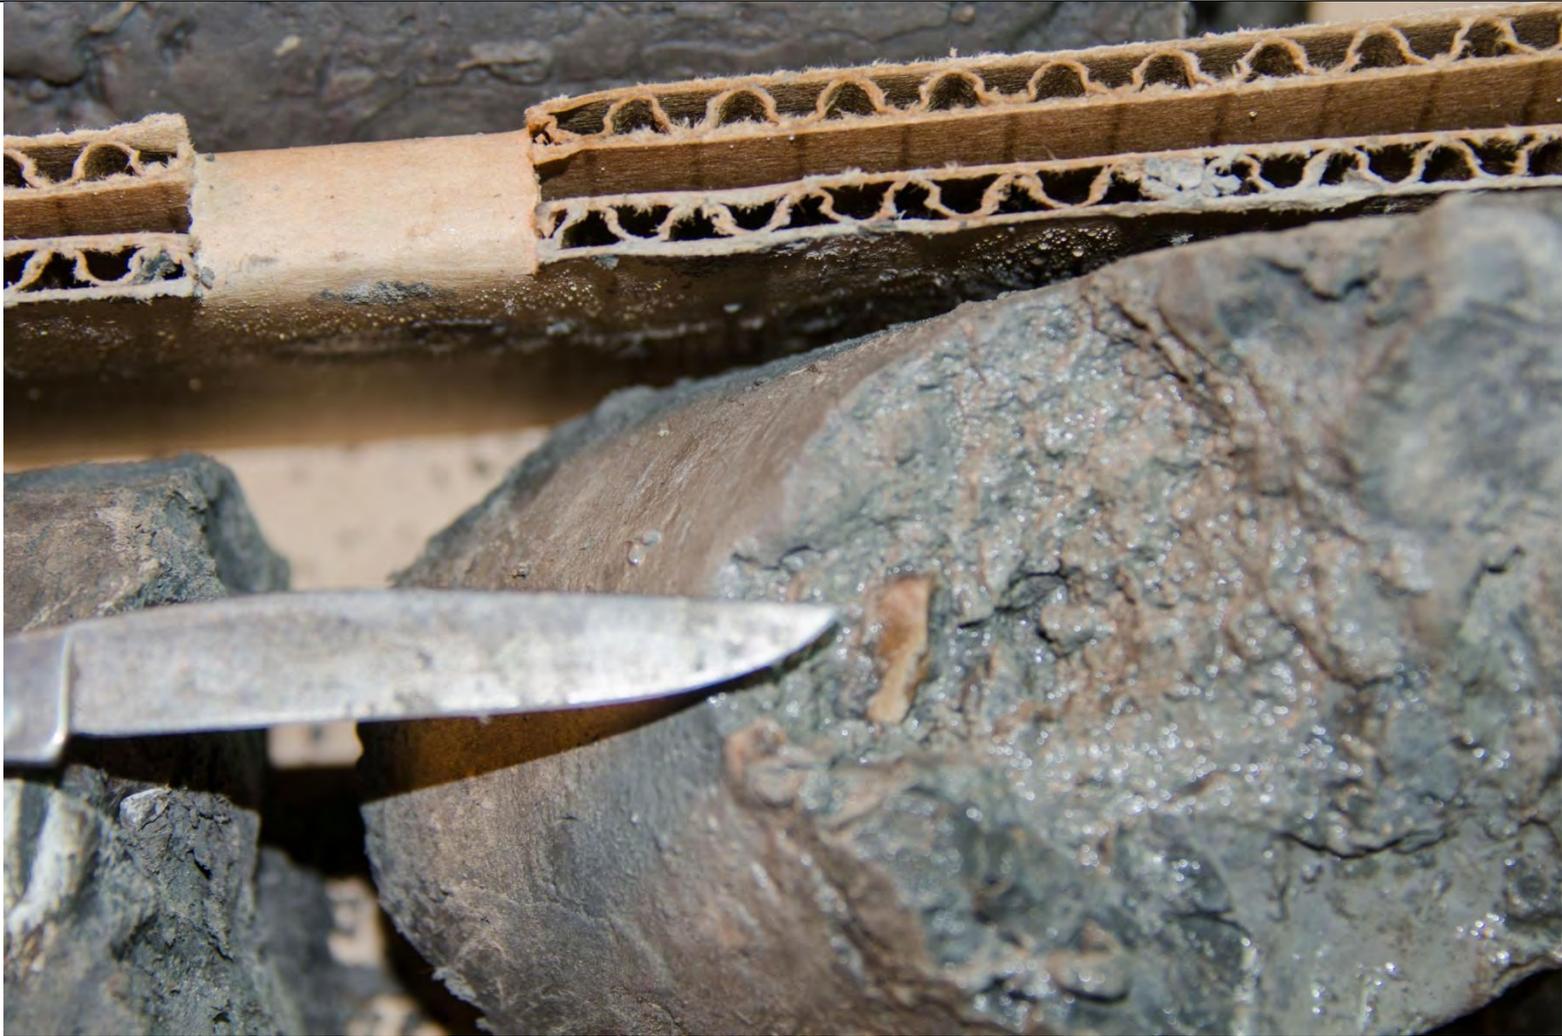
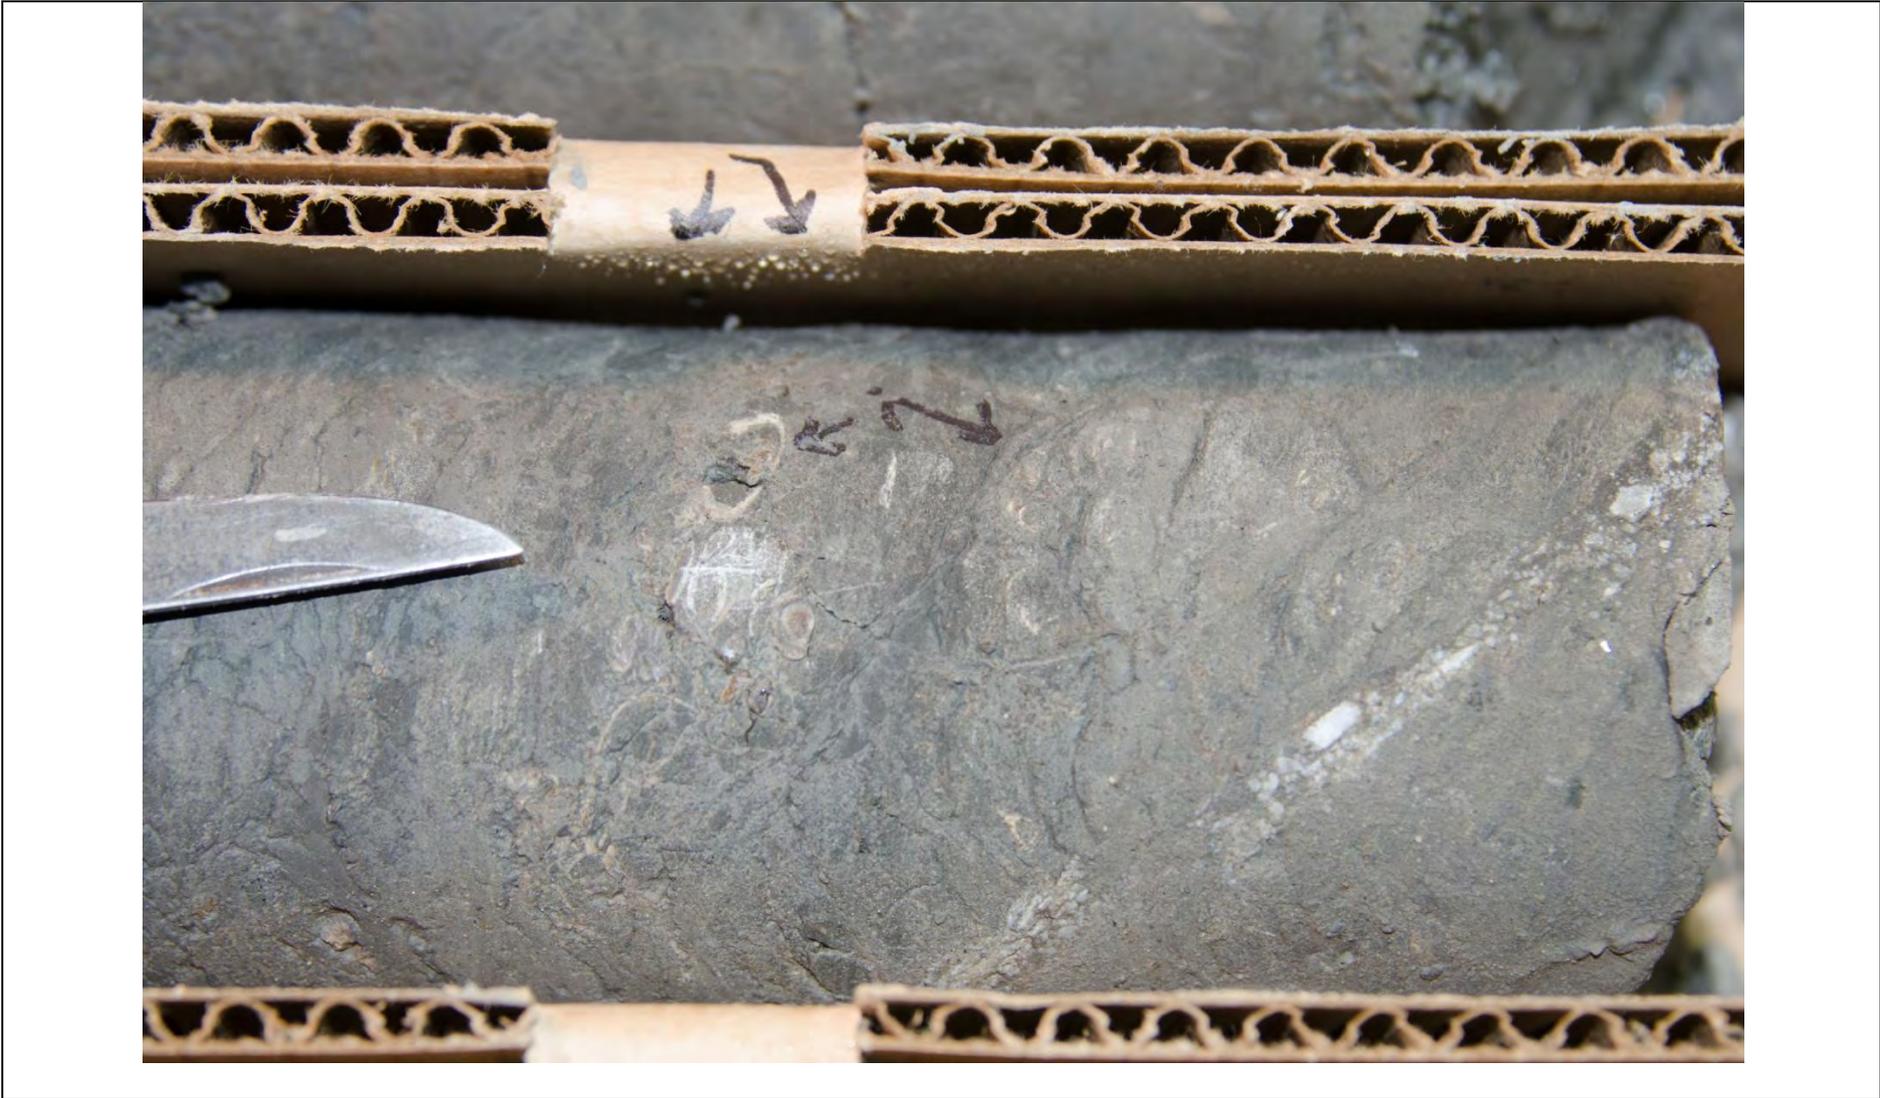
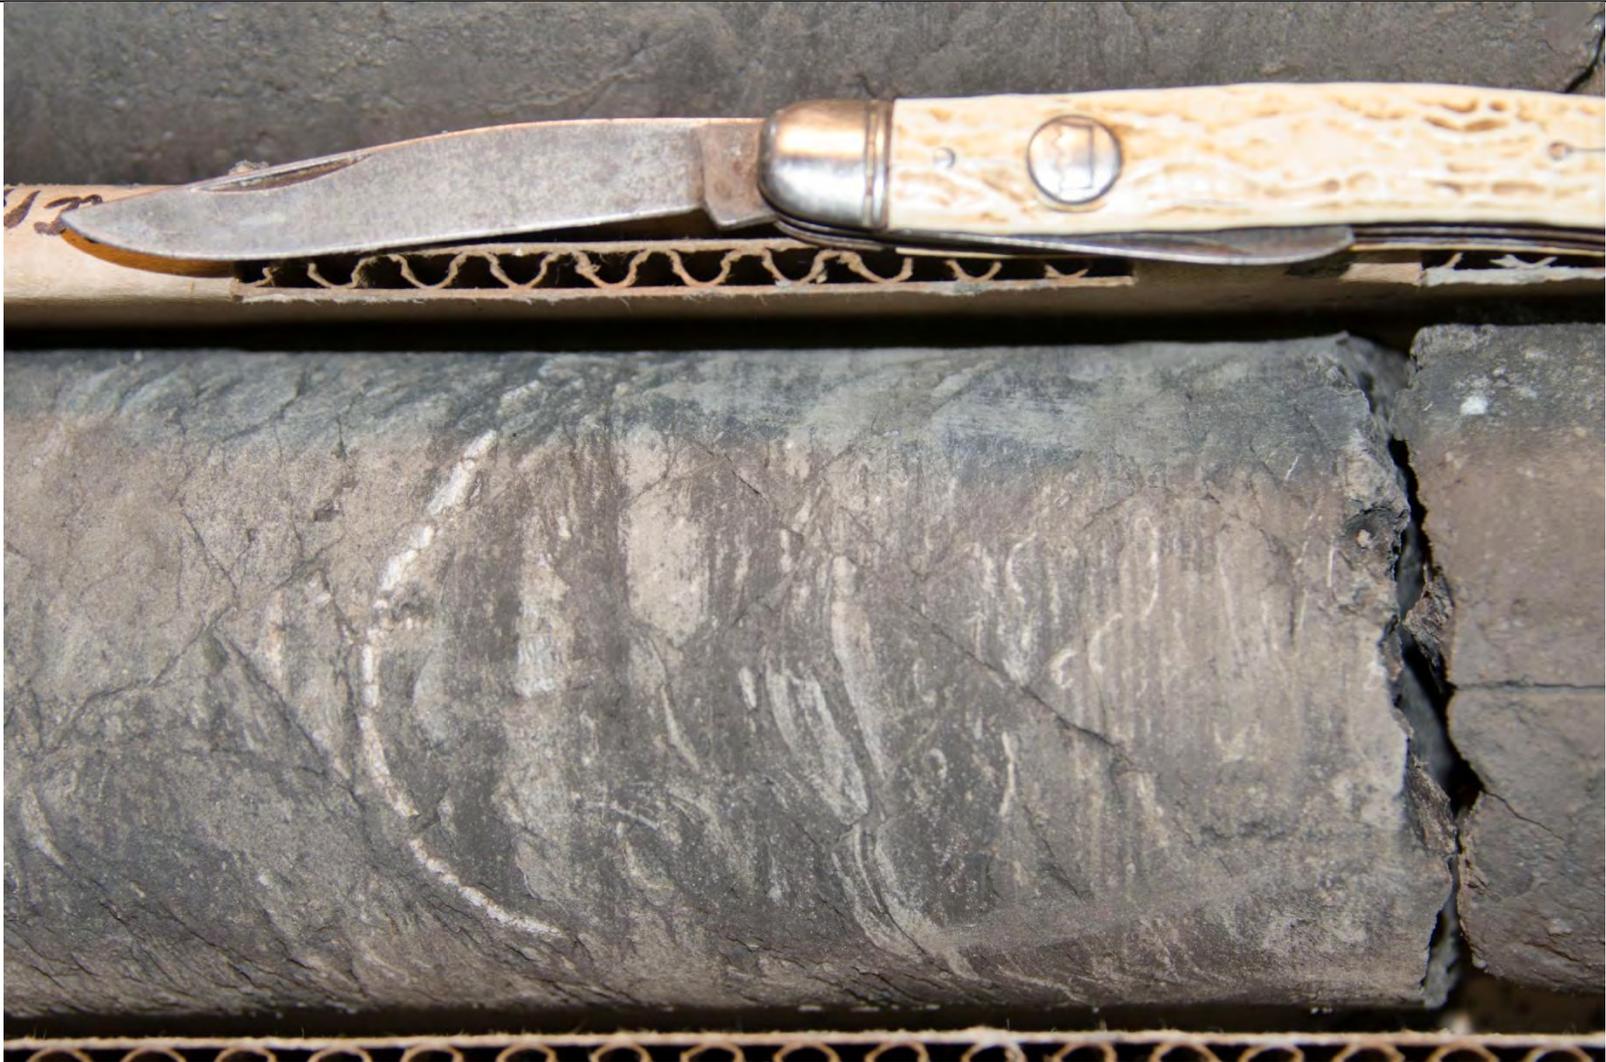
Gray silty **clay-claystone** readily scratched by finger nail (see core box PHOTO above). Bedding not apparent but occasional fossil fragments, one large one nearly 1" in length (1st PHOTO below). Just below large fossil is pebble of sub-angular light SS ? (see 2nd PHOTO below). Same gray silty **clay-claystone** for next almost 2' then zone with abundant small fossils (see 3rd PHOTO below), and just below that a steeply dipping zone of white angular debris that are soft enough to scratch with knife blade (calcareous?) They form a very apparent surface at about 35° to the core axis (see 4th PHOTO below). Just above ~158' is zone with apparent bedding dipping perhaps 20°-30° , abundant small white fossils and a cross section of one large thin shell??. Below that similar core, occasional fossil to base.

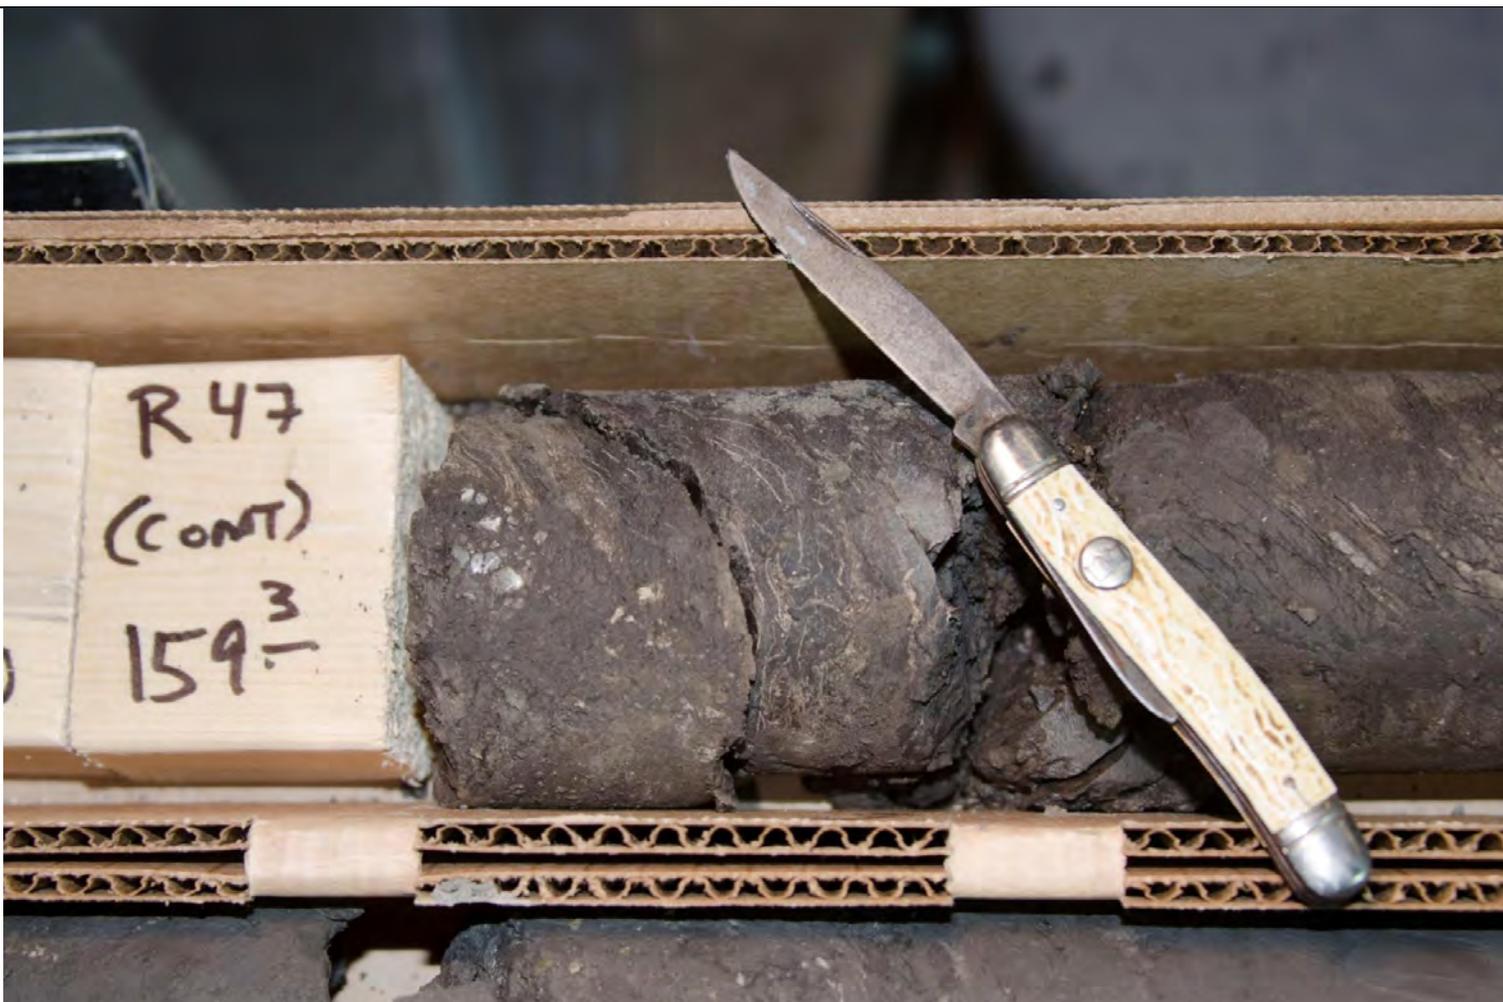
Dark gray **silty clay-claystone**; bedding dipping at  $\sim 25^\circ$ . Appears to have very fine white (calcareous?) veins shot through the upper 3"-4", with small pebble sized angular white calcareous? Clasts at very top (can be scratched by knife blade) (see PHOTO below). Lower part similar but no large clasts and calcareous veins not evident.

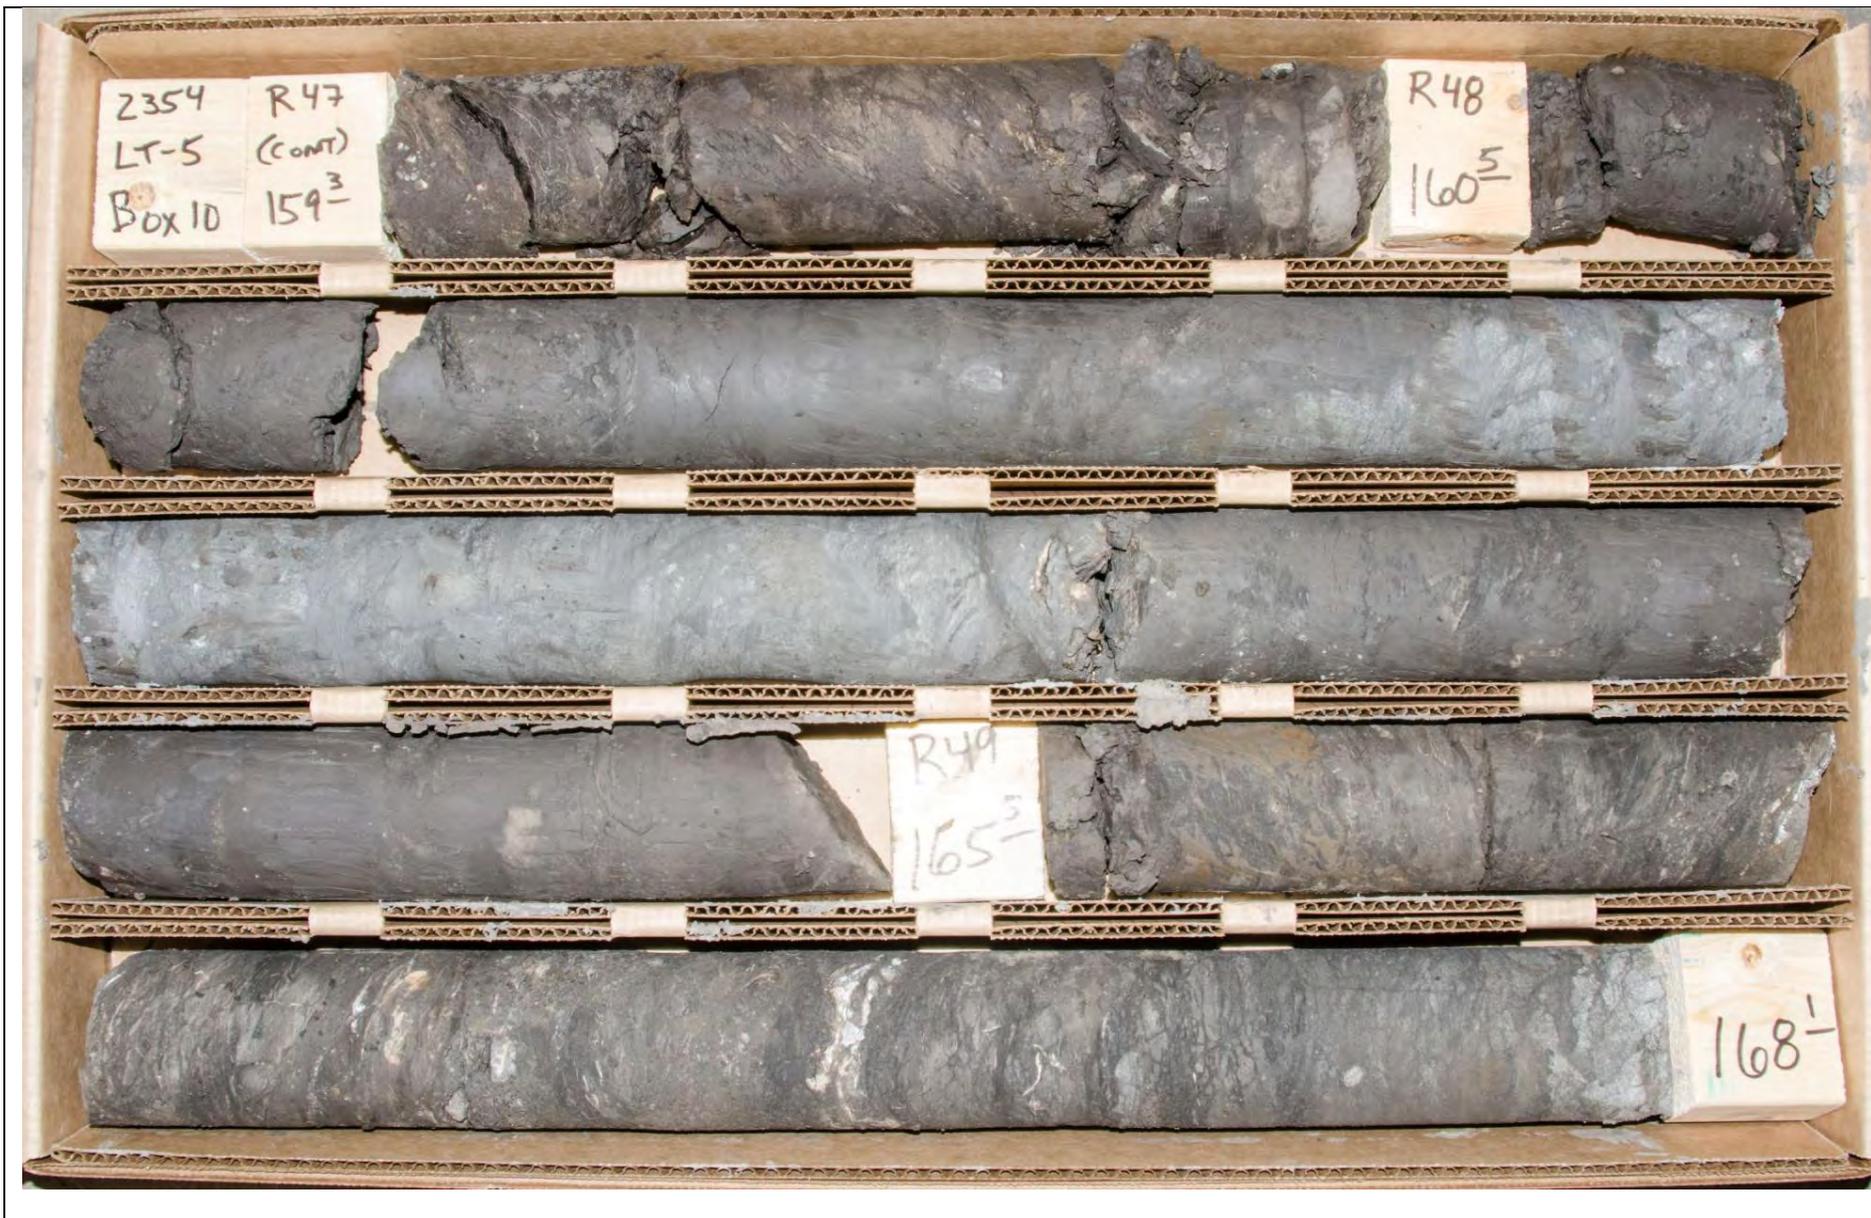
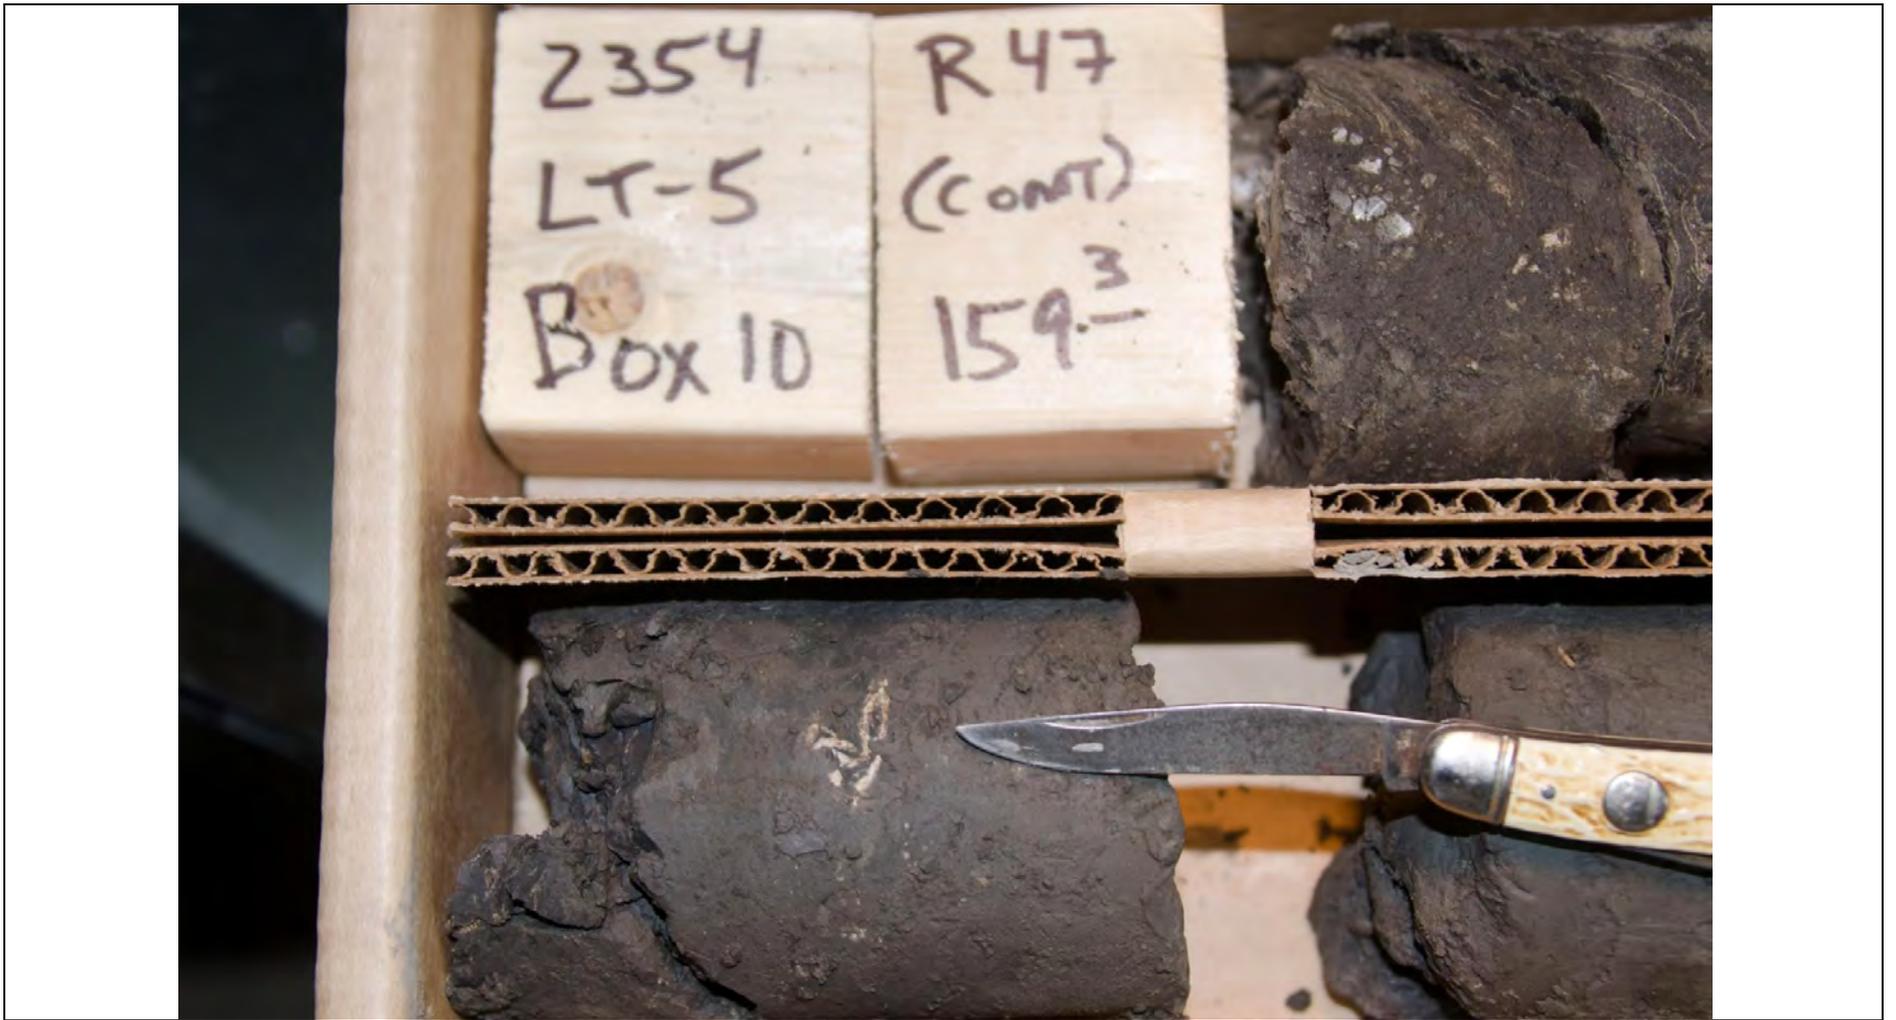
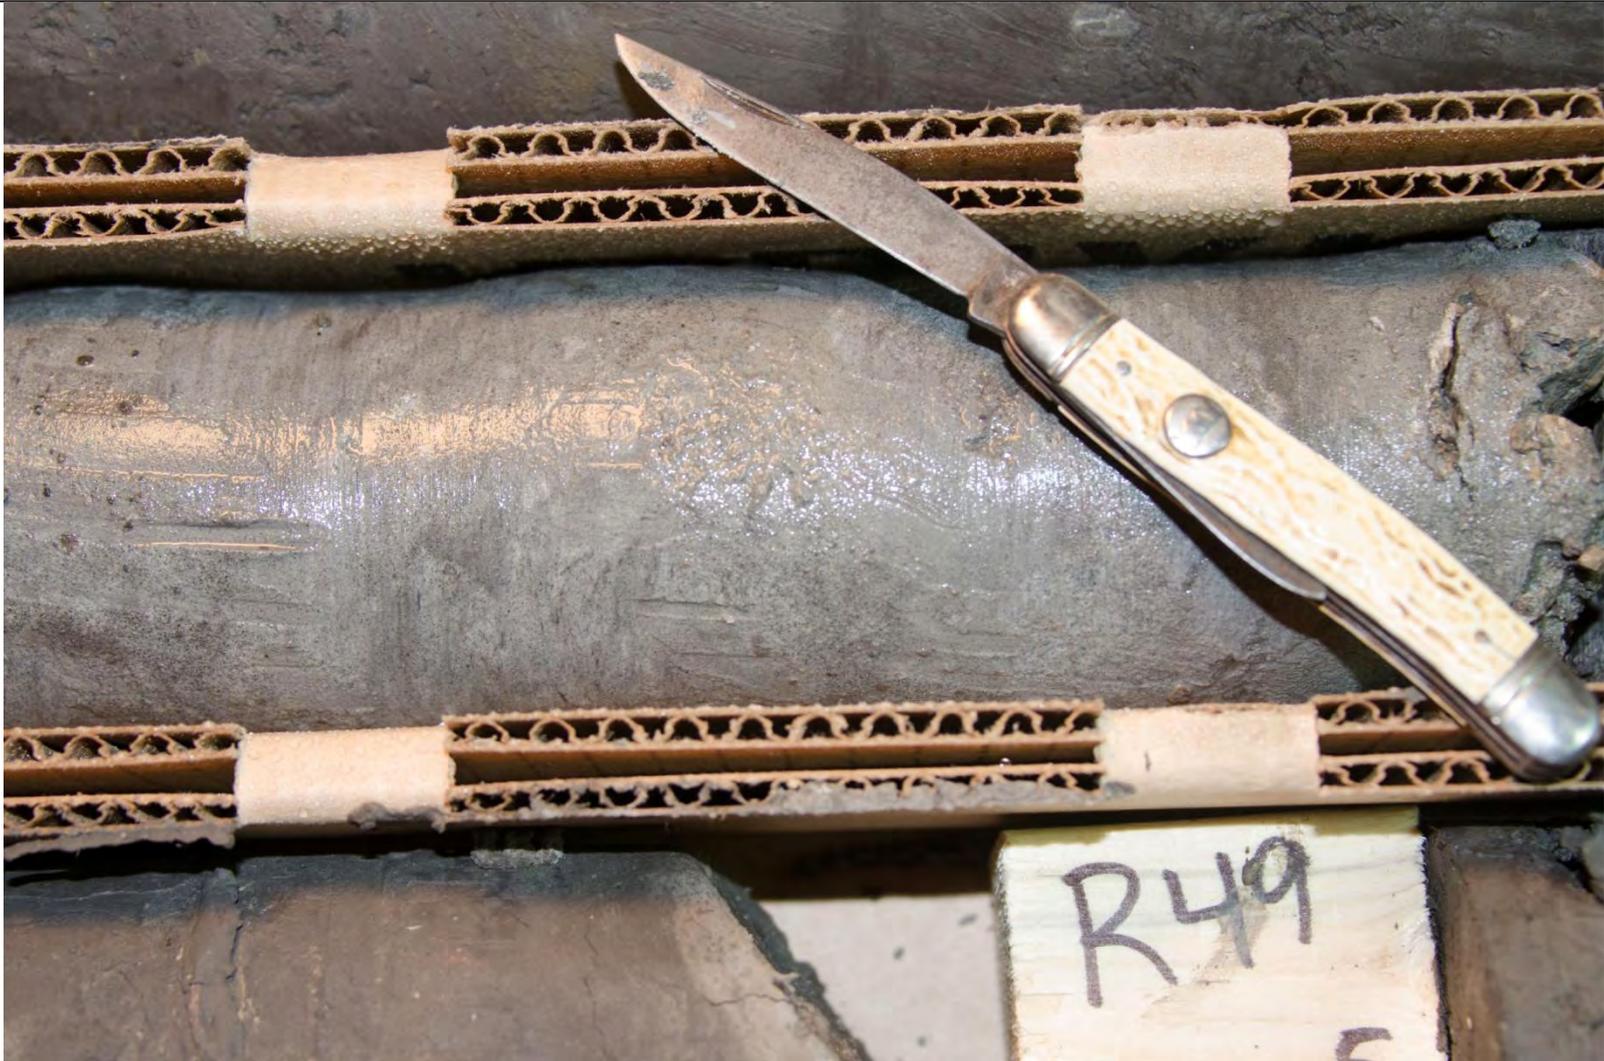
(see PHOTO of core box, below) Upper 15" is dark gray, **silty clay-claystone** with occasional white fossil fragment and small SS size to small pebble sized clasts that I can't identify but which can be scratched with knife blade (see 2nd PHOTO below). Below ~161.7' core grades into slightly **clayey siltstone to very fine grained sandstone**; well sorted, sub-angular-sub-rounded grains, predominantly quartz but a few % very black grains; moderately consolidated, can be scratched with fingernail, bedding not readily apparent (see 3rd PHOTO below). Below about 163.5' core grades back into silty gray **clay-claystone** to base of interval.

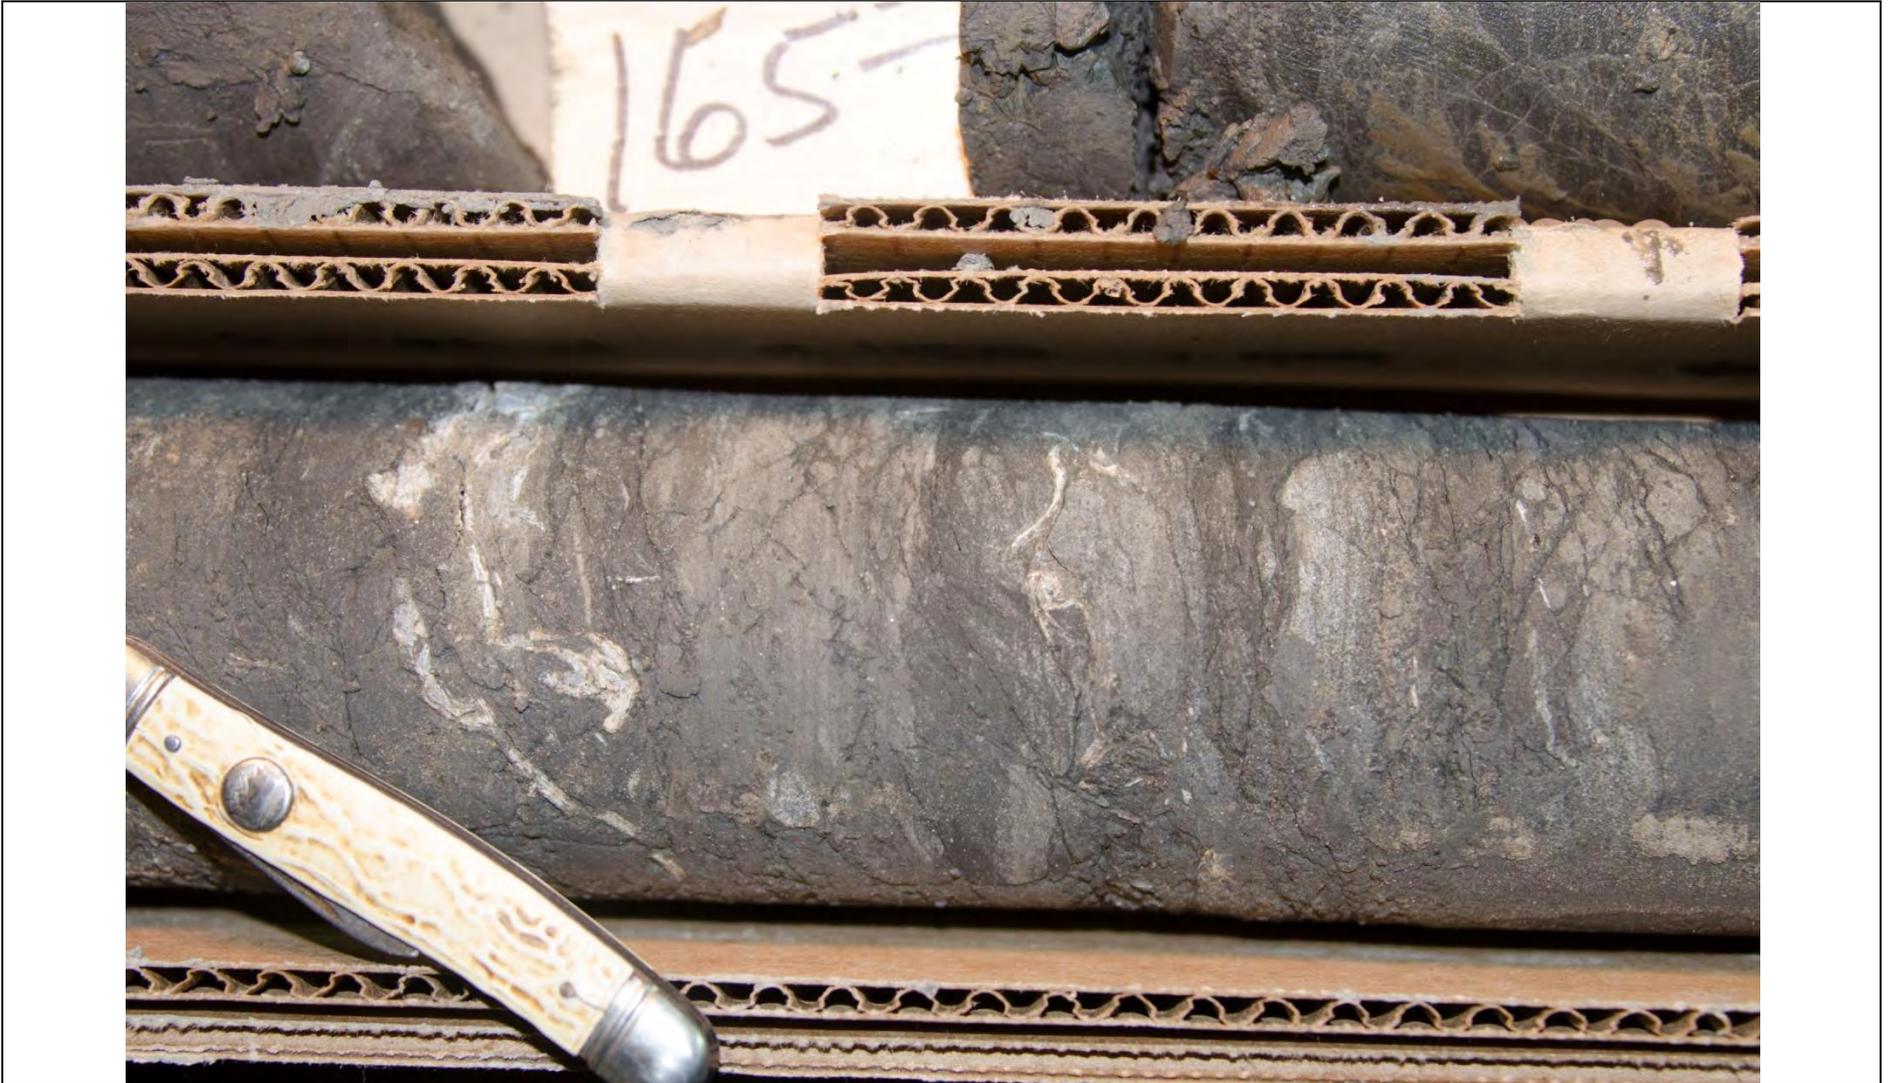
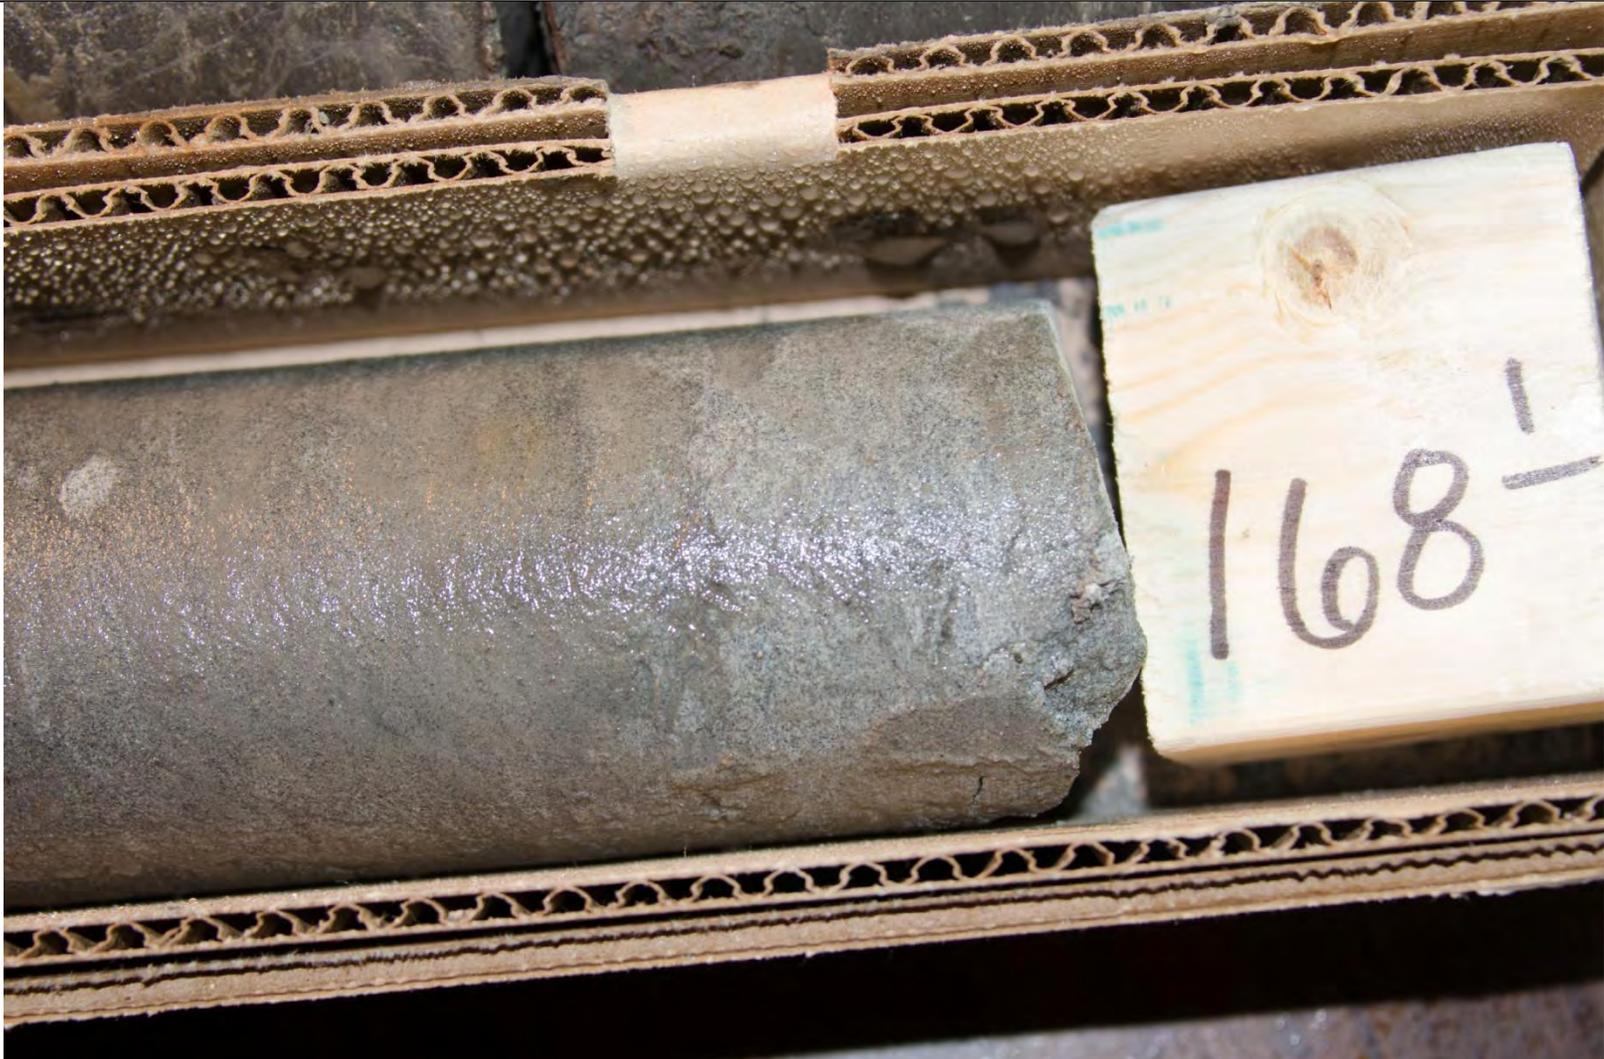
Upper 8" is dark gray silty **clay-claystone** that has  $\sim 10-15^\circ$  dip and has fossils; next 2'+ has slightly higher dip bedding and what appear to be small to large fossil cross sections (PHOTOS). Some beds are quite silty, back to clay, back to silty clay. Same **very fine grained sandstone to siltstone** at base; same sub-round to sub-angular quartz with 2-3% very black grains. (see 2 PHOTOS below)
