# Description of the Five Cores Drilled in the Vicinity of Budge Drive, Jackson, Wyoming in April and May, 2014

An addendum to the  
**Geologic Report on the Slide near  
Budge Drive, Jackson, Wyoming**  
to the Jackson Town Council  
by the Geologists of Jackson Hole.

# Core Descriptions for LT-1 to LT-5 Cores cut at Budge Drive Landslide Site

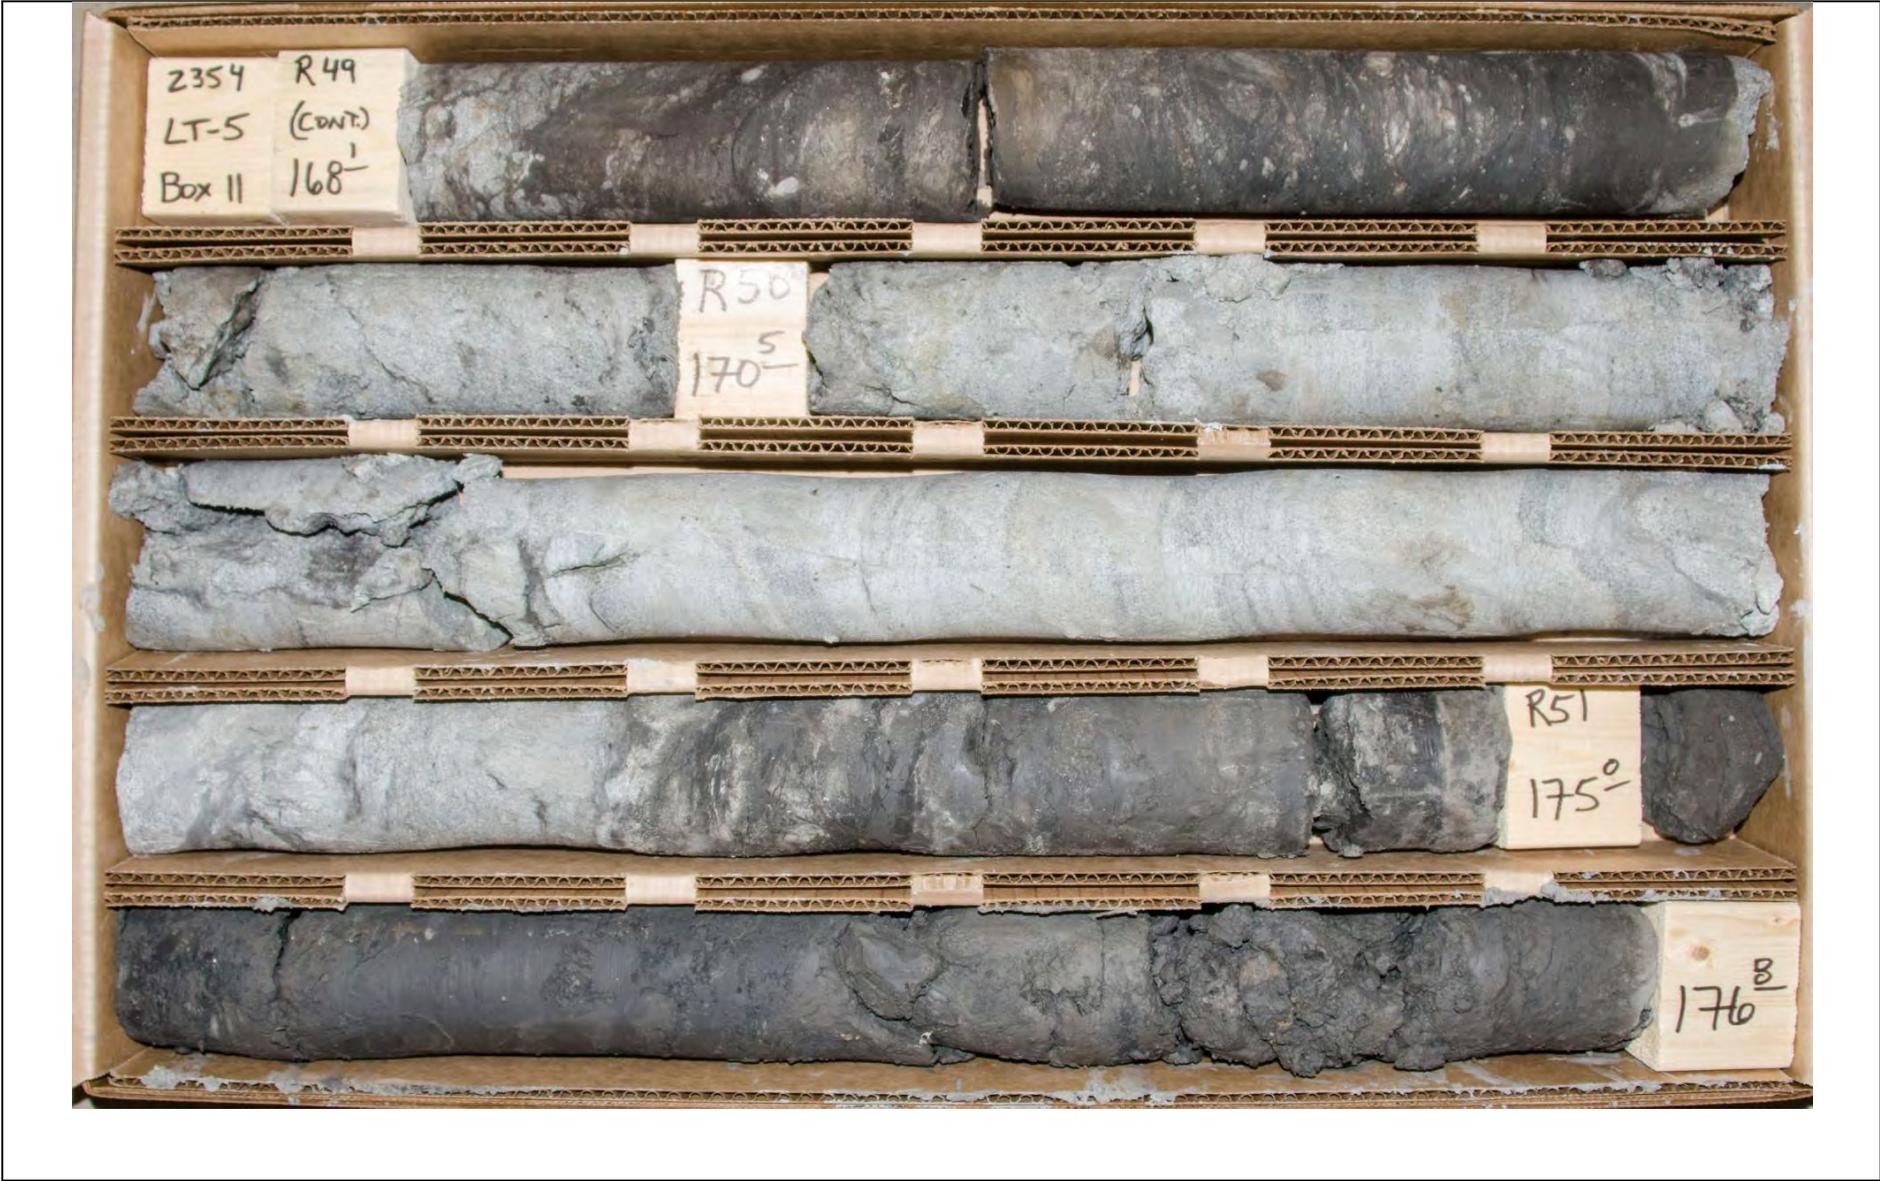
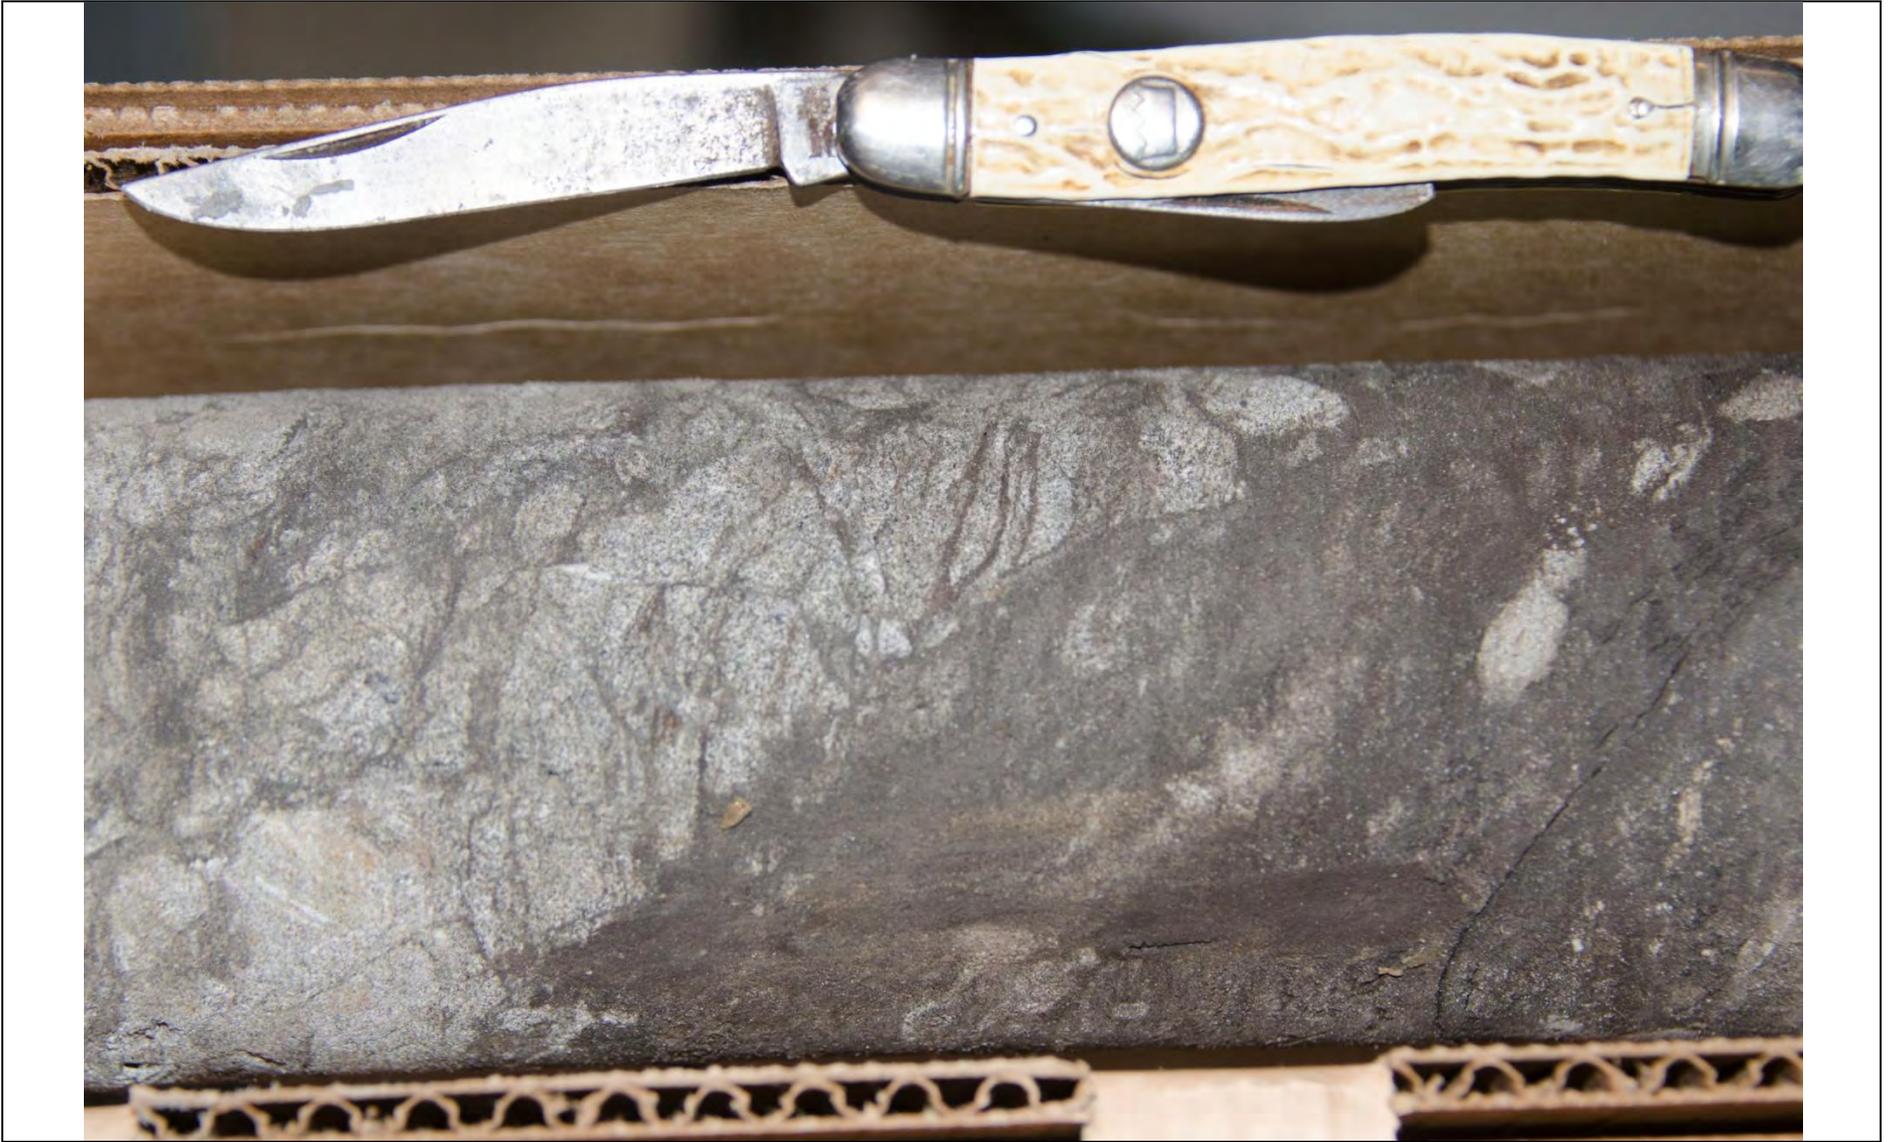
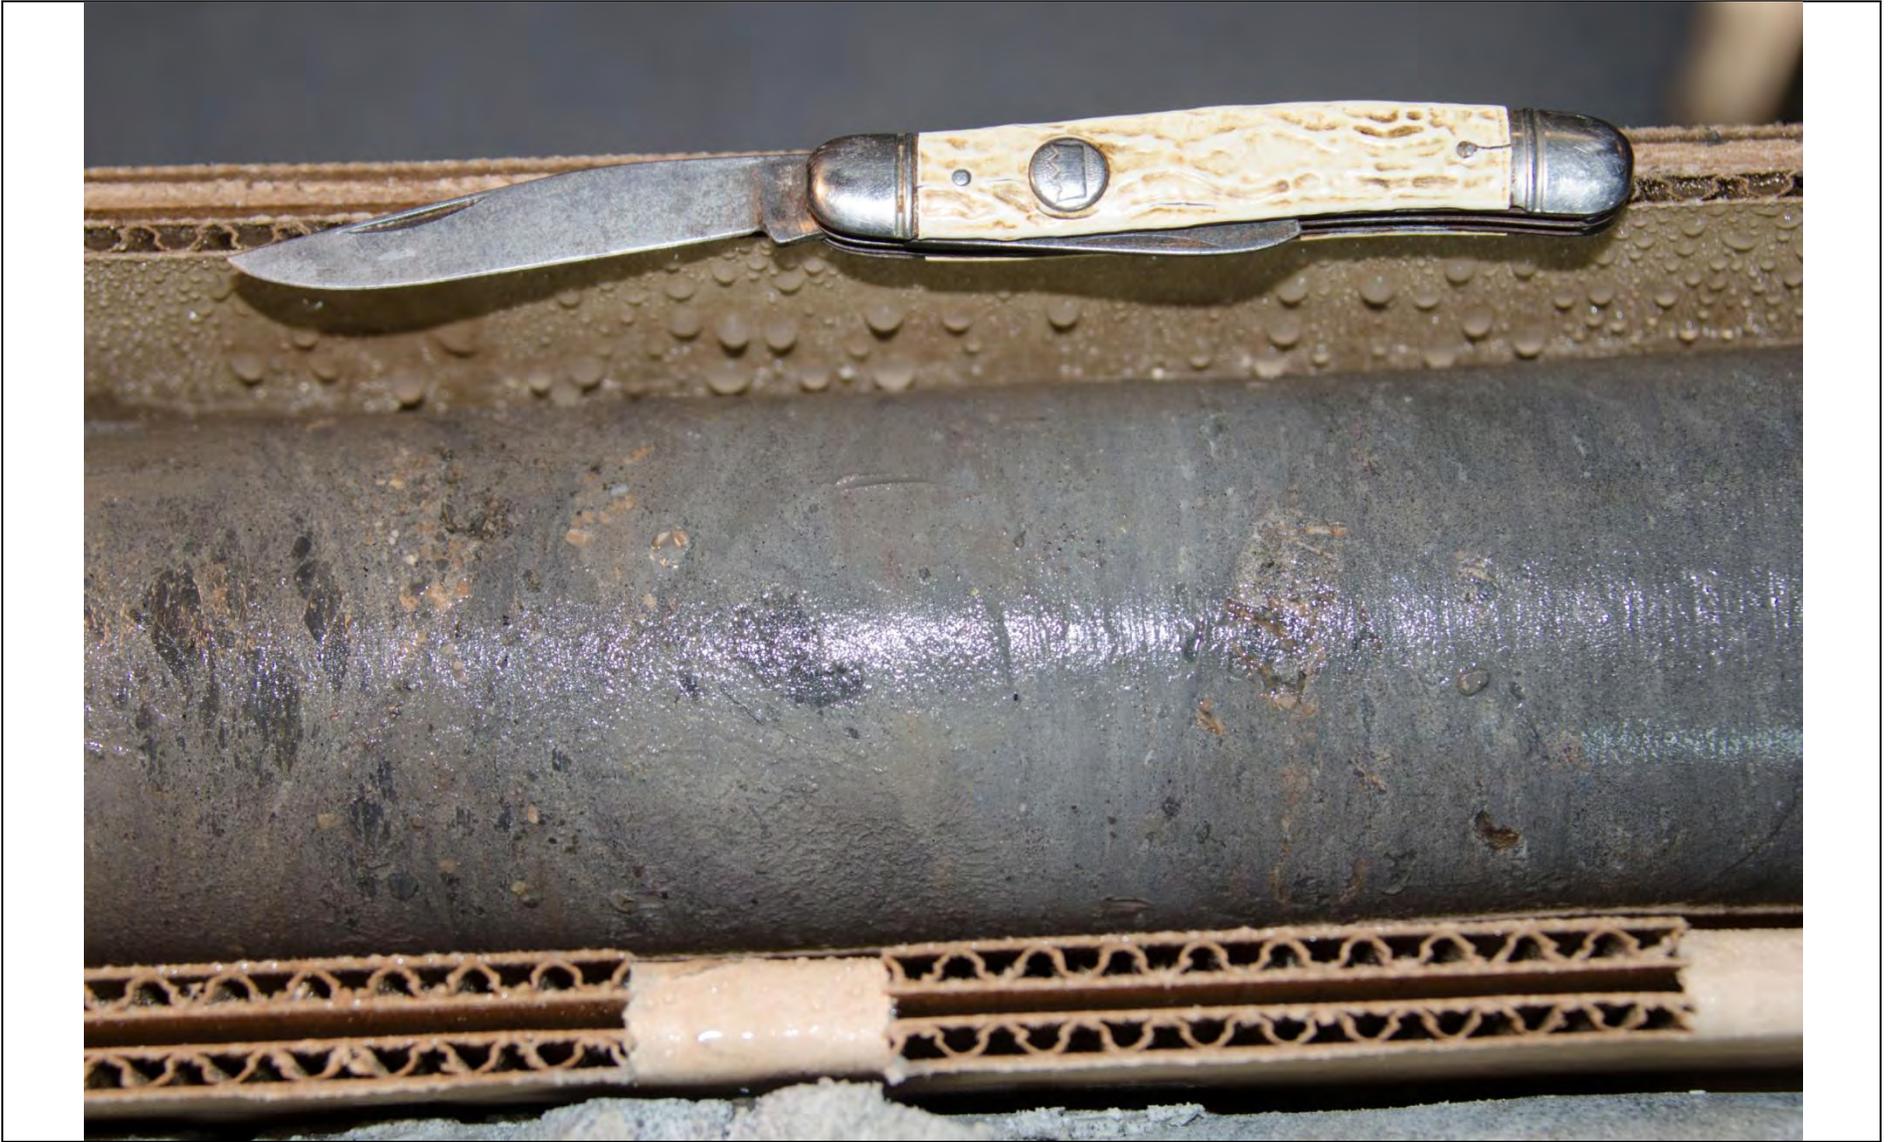
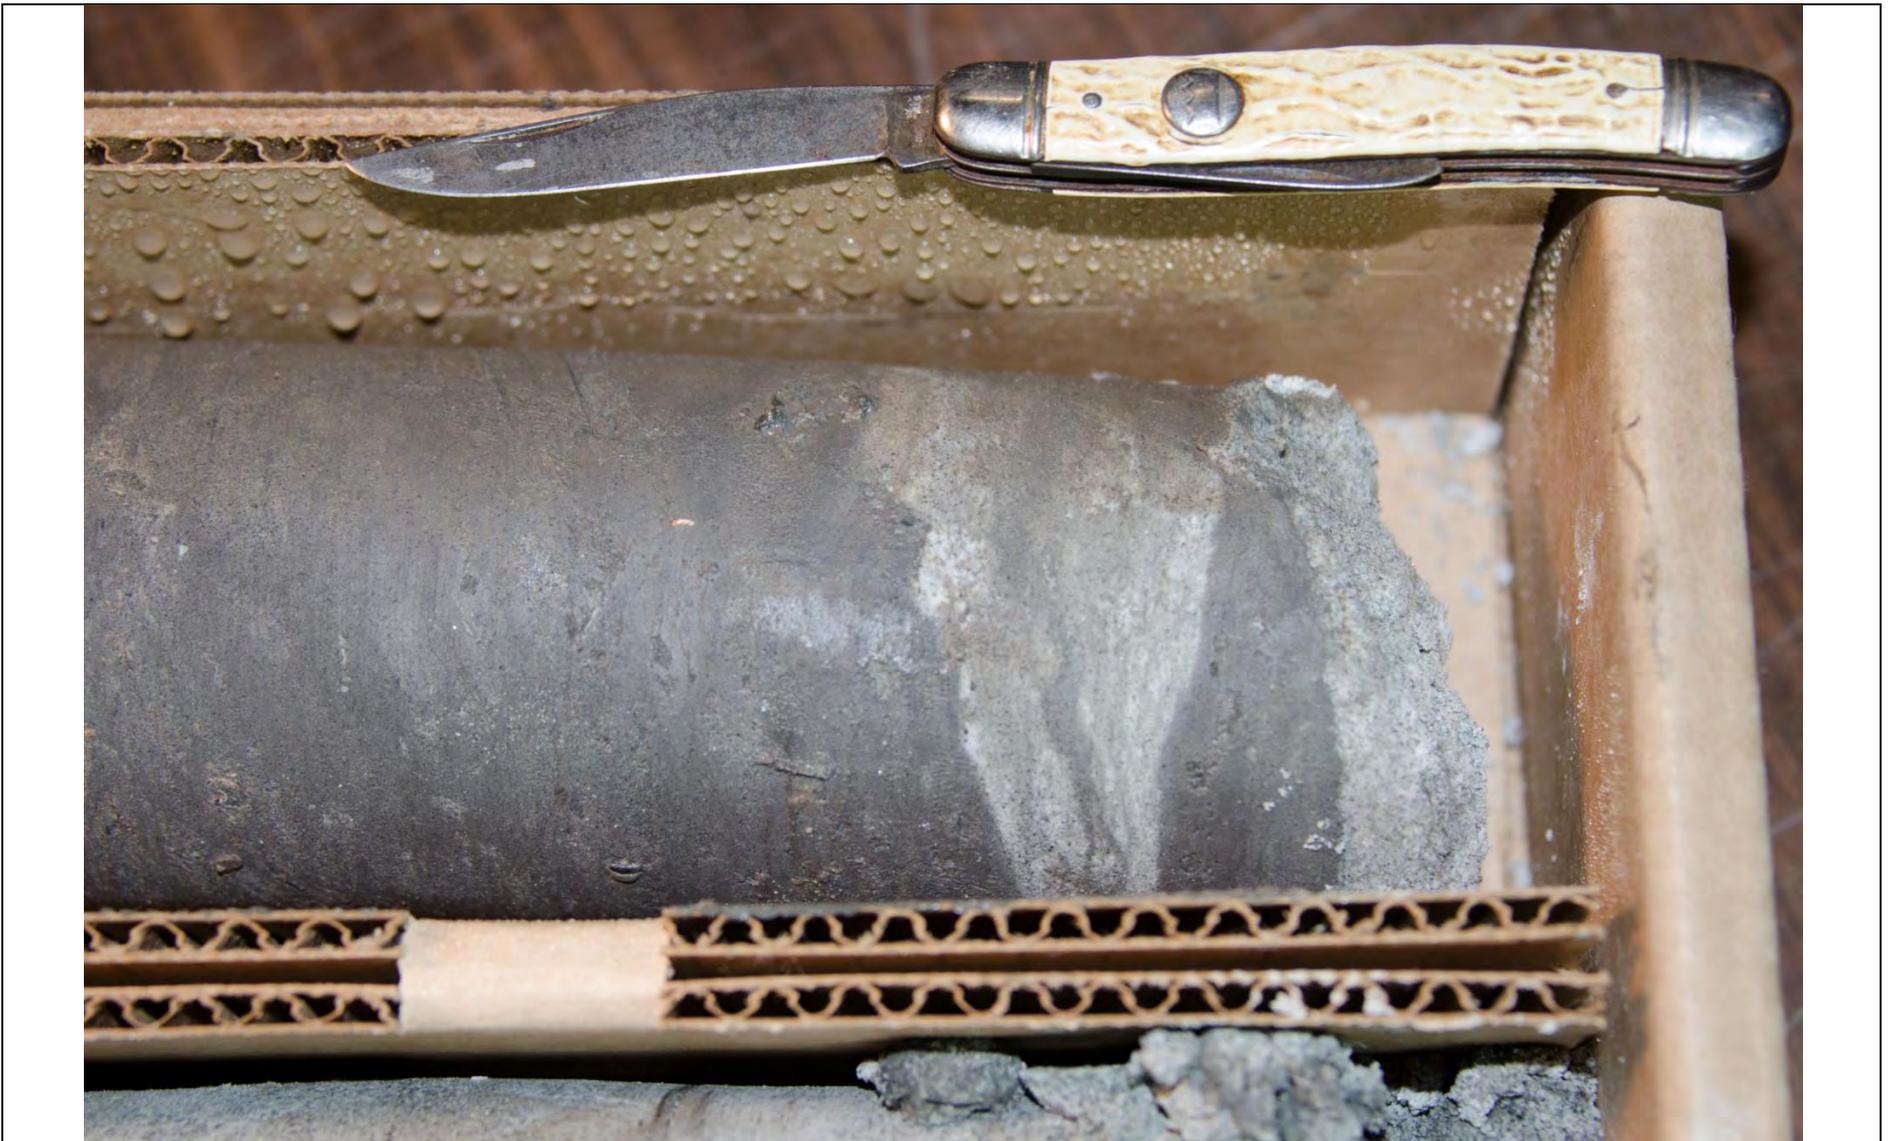
168-170.5	<p>(see core box PHOTO below) Upper 3" is <b>very fine grained quartz Sandstone</b> of quartz with ~4-5% black grains; very well sorted, moderate lithification - requires knife blade to make significant scratch. But this appears to have been disturbed and mixed up with mudstone, as though injected with the clay; soft-sediment deformation? There is a steeply dipping surface, perhaps 60° above what then is a dark gray silty mudstone below; this surface is undular, suggests perhaps this might be <u>some kind of slump deposit?</u> (see 2nd PHOTO below). Silty dark <b>clay-claystone</b> below has small to large (pebble sized) clasts of the SS &amp; other angular lithic fragments (see 3rd PHOTO below). At about 170' a rapid transition to the very fine grained <b>SS - Siltstone</b> (same description as above) (see 4th PHOTO below). Then same to base of interval.</p>	100
-----------	---------------------------------------------------------------------------------------------------------------------------------------------------------------------------------------------------------------------------------------------------------------------------------------------------------------------------------------------------------------------------------------------------------------------------------------------------------------------------------------------------------------------------------------------------------------------------------------------------------------------------------------------------------------------------------------------------------------------------------------------------------------------------------------------------------------------------------------------------------------------------------------------------------	-----

170.5-175	<p>(see core box PHOTO above) Light gray, very fine grained, well sorted <b>sandstone</b>; predominantly quartz, 3-5% black grains, sub-rounded all the way down to 174'; able to be scratched with finger nail, so moderately lithified. Appears to be alternating beds that change by percent of black grains (more, less; so cleaner / dirtier) that dip at <math>\sim 10-15^\circ</math> to core axis; thickness of beds from 1"-2" to less than 1/4" (see PHOTO below). At <math>\sim 174'</math> a rather quick transition back into silty, dark gray <b>clay-claystone</b>.</p>	100
-----------	----------------------------------------------------------------------------------------------------------------------------------------------------------------------------------------------------------------------------------------------------------------------------------------------------------------------------------------------------------------------------------------------------------------------------------------------------------------------------------------------------------------------------------------------------------------------------------------	-----

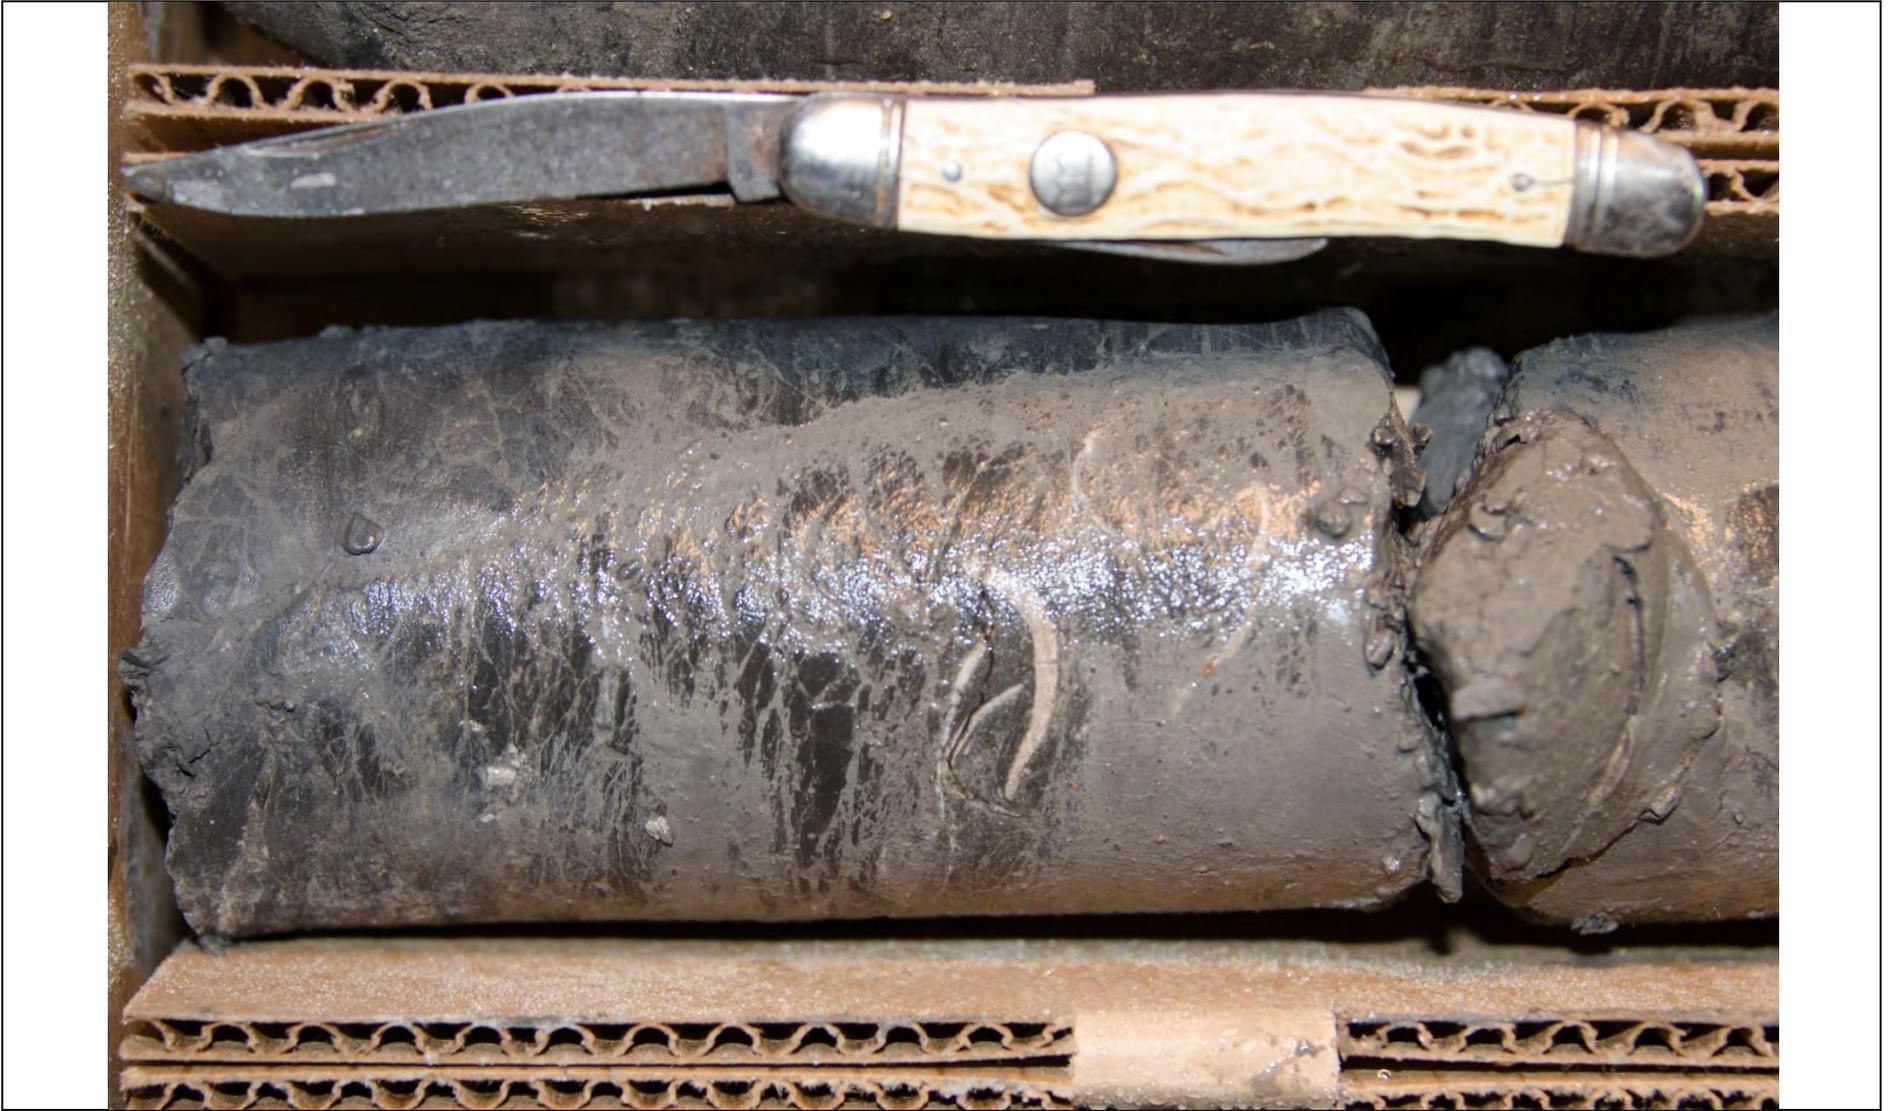
175-176.8	Same dark gray <b>silty clay-claystone</b> ; massive, no obvious bedding or clasts of any kind.	100
176.8-180	Dark gray <b>silty clay-claystone</b> with weak evidence of gently dipping bedding. Appear to be several large, white, curvi-linear fossil fragments (see PHOTO below)	100

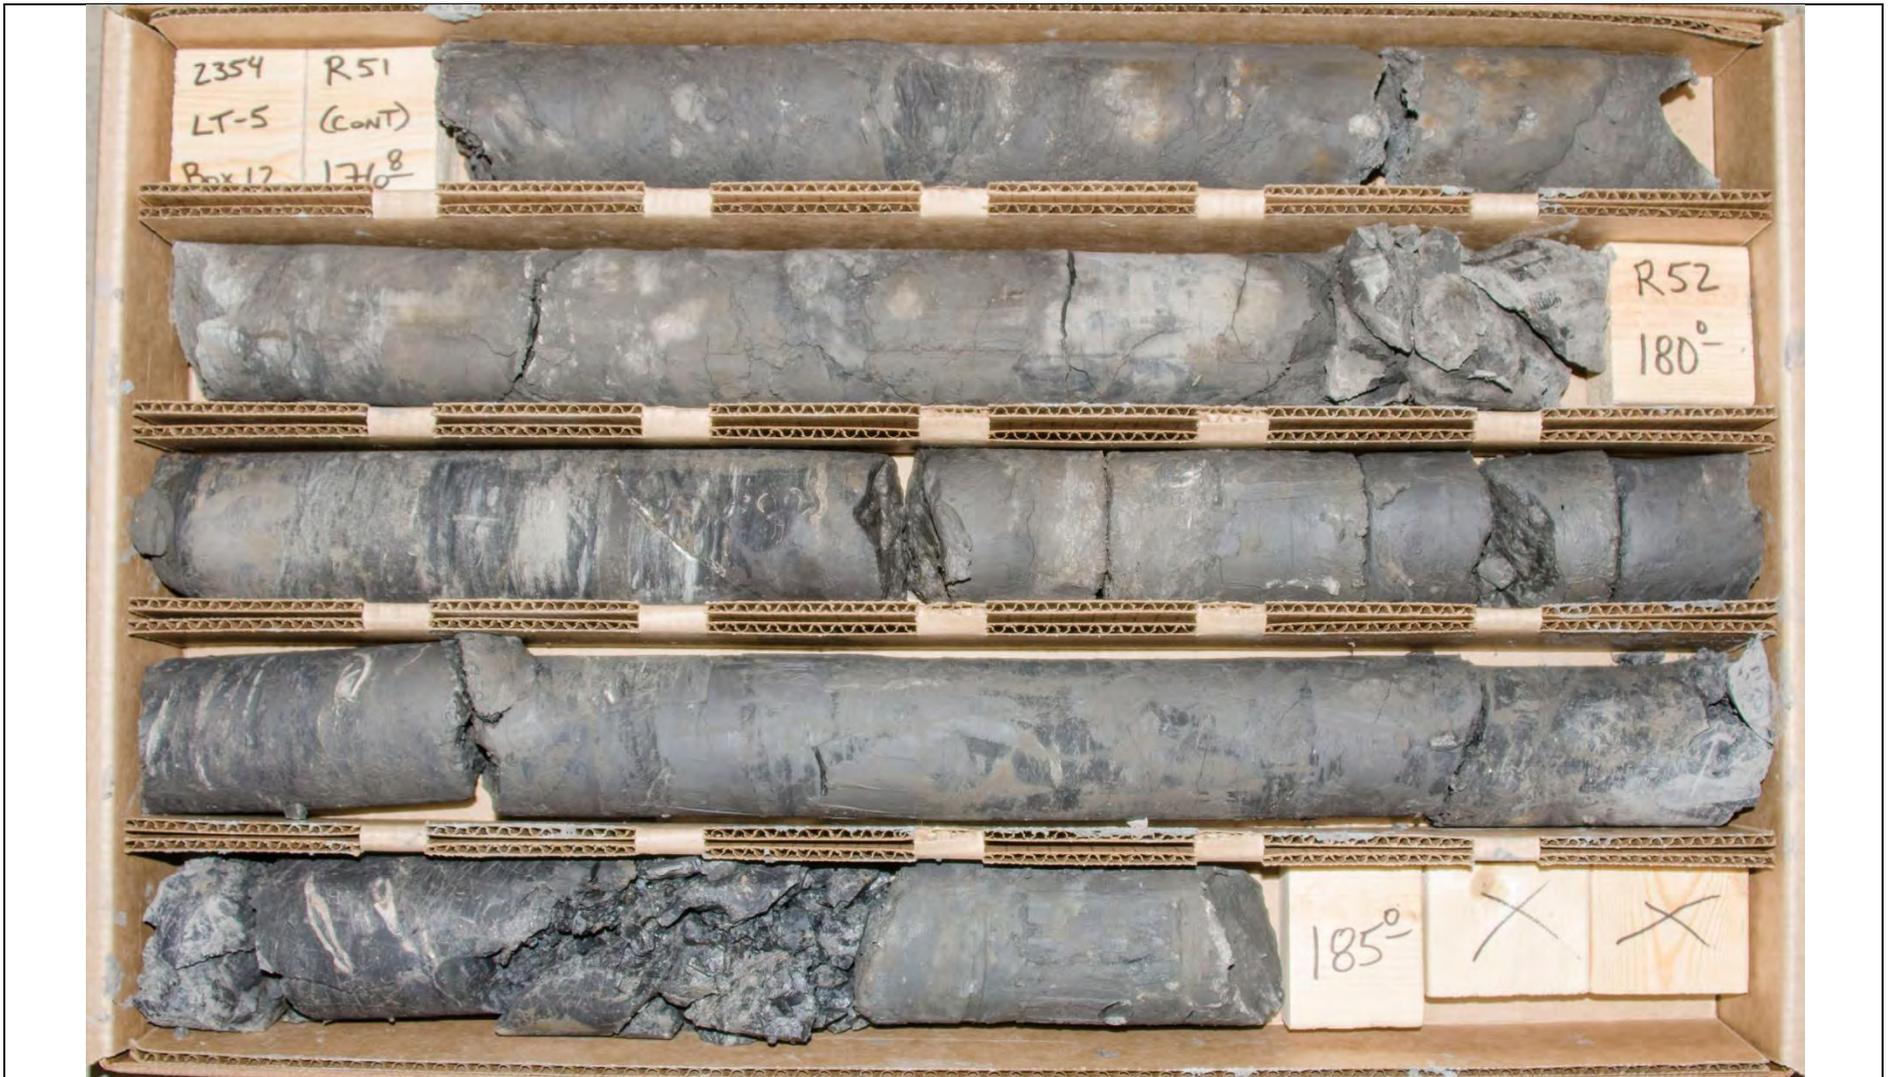
180-185	Dark gray <b>silty clay-claystone</b> with limited evidence of low angle bedding (5 <sup>0</sup> ?). Multiple cross sections of small to large fossil shells (see PHOTO below of core box). Can be scratched with finger nail but is better lithified, even a bit brittle in nature.	100
---------	--------------------------------------------------------------------------------------------------------------------------------------------------------------------------------------------------------------------------------------------------------------------------------------	-----

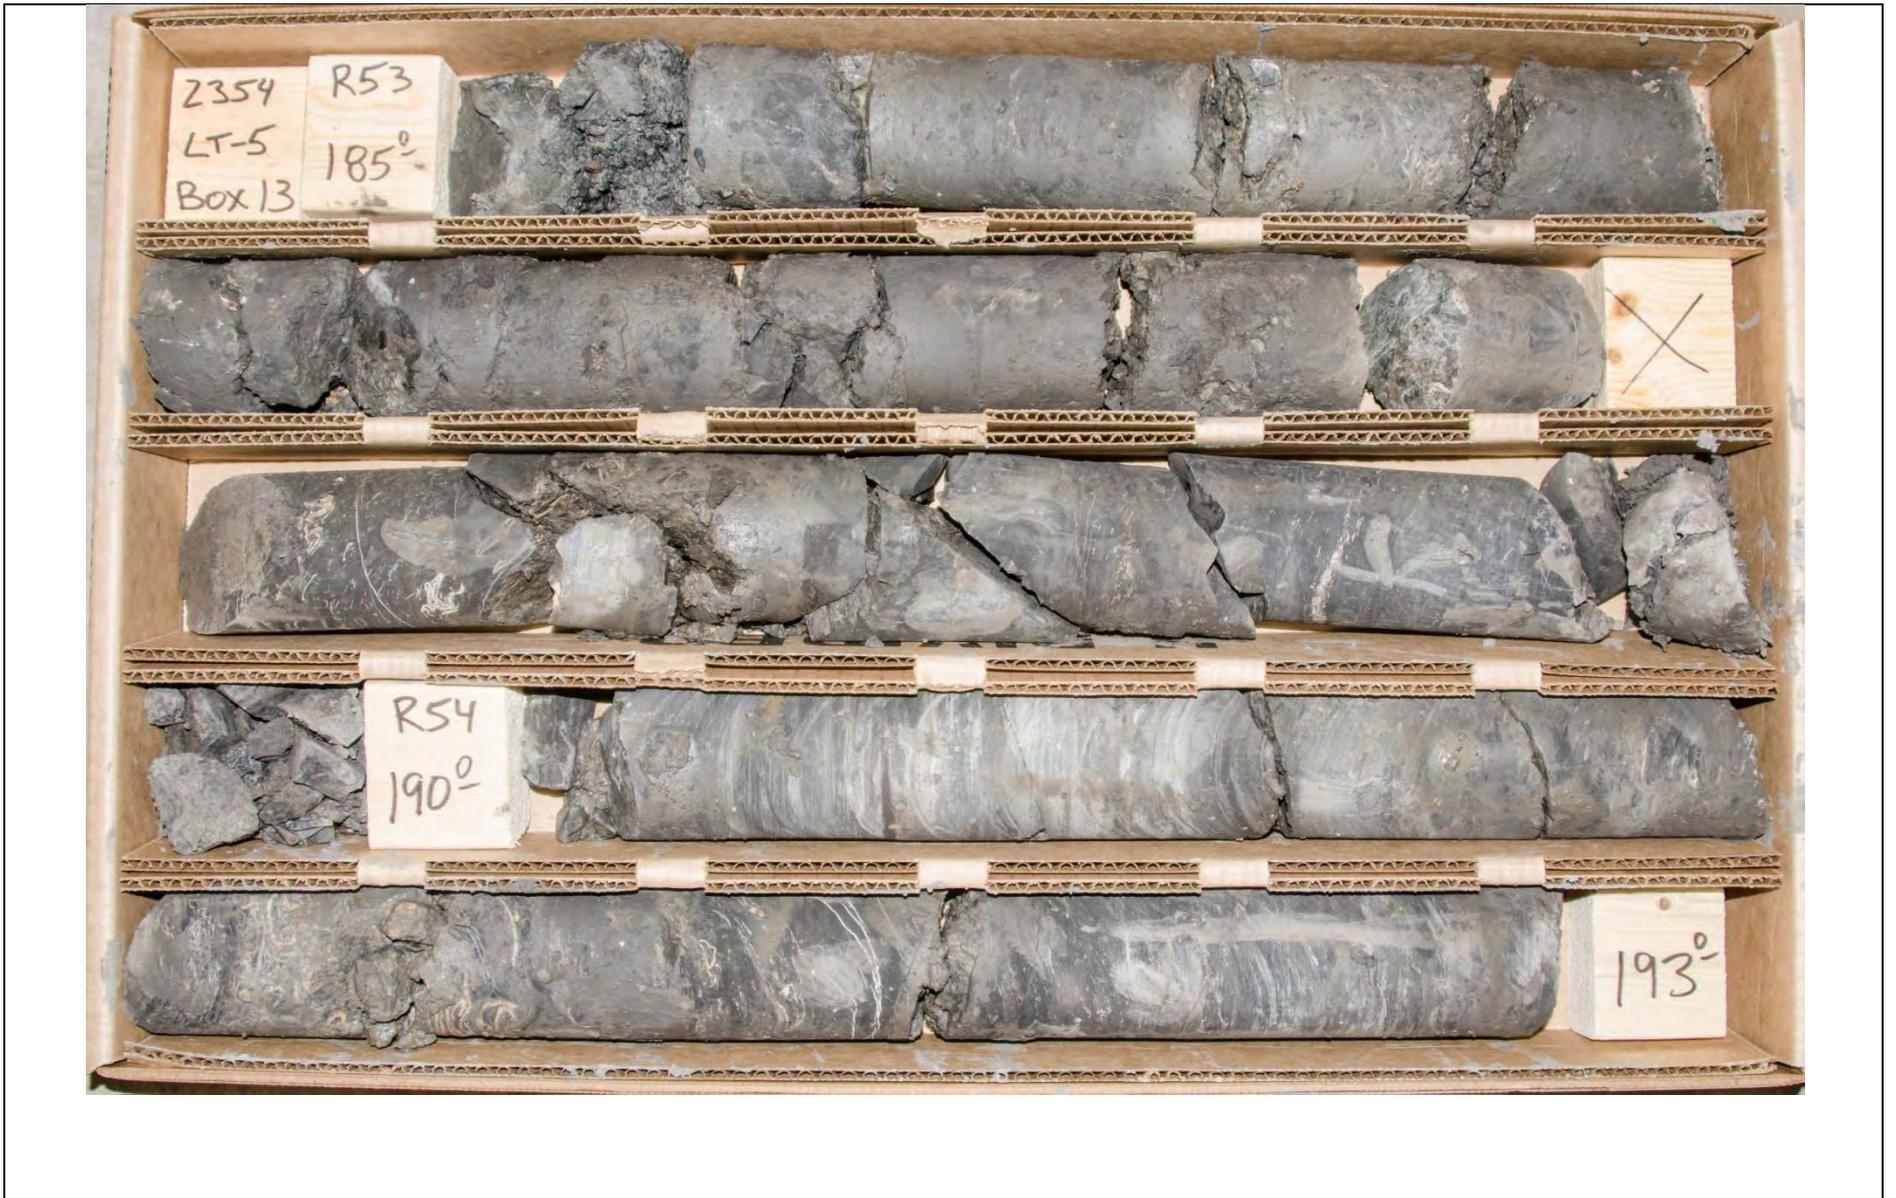
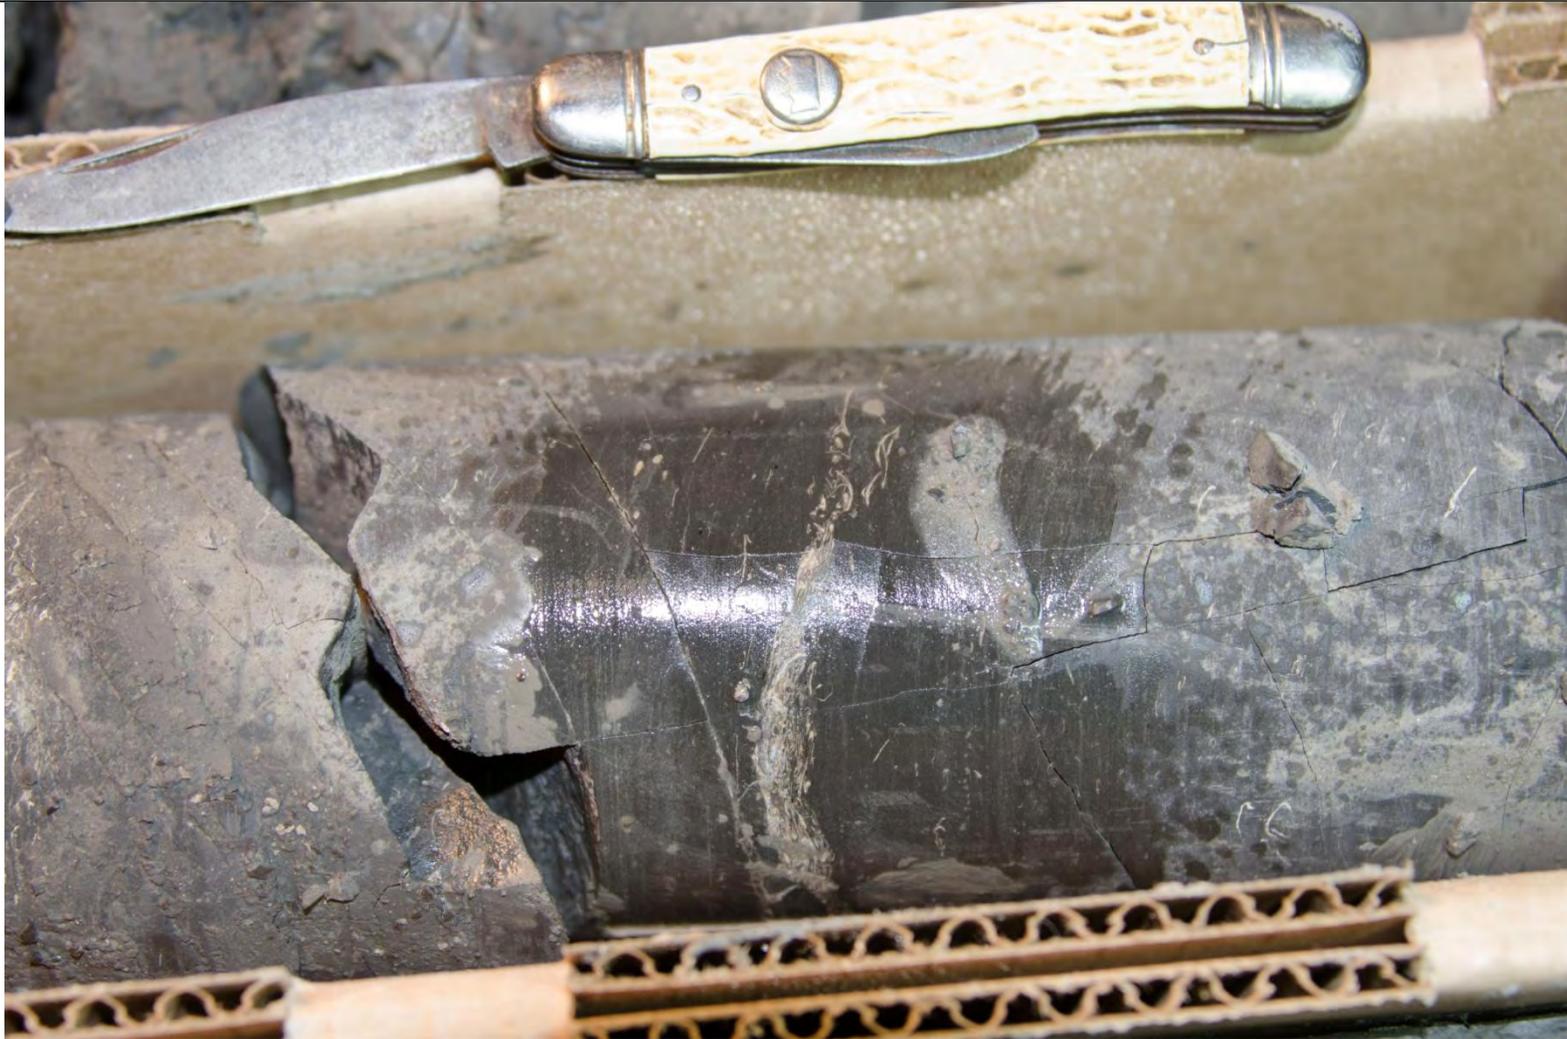
185-190	<p>Dark gray <b>silty clay-claystone</b> with some thin white calcite veins in upper part? There are occasional 1/4" to 1" zones that appear to be a fossil hash, collection of fossil shells and fragments large and small (see core box PHOTO below); bedding appears to be dipping fairly steeply at 20°-30° with respect to core axis (see 2nd photo PHOTO below)</p>	100
---------	---------------------------------------------------------------------------------------------------------------------------------------------------------------------------------------------------------------------------------------------------------------------------------------------------------------------------------------------------------------------------	-----

190-193 Still dark gray **silty clay-claystone** with quite apparent bedding that is dipping fairly steeply at  $20^{\circ}$ - $30^{\circ}$  with respect to core axis (see core box PHOTO above). The visible slightly lighter beds are **siltstone** layers of the same quartz predominant texture and nature. At  $\sim 192'$  there are some beds with abundant fossils, a bit deeper are some layers that appear to have calcite veins in them, parallel to the dipping beds.

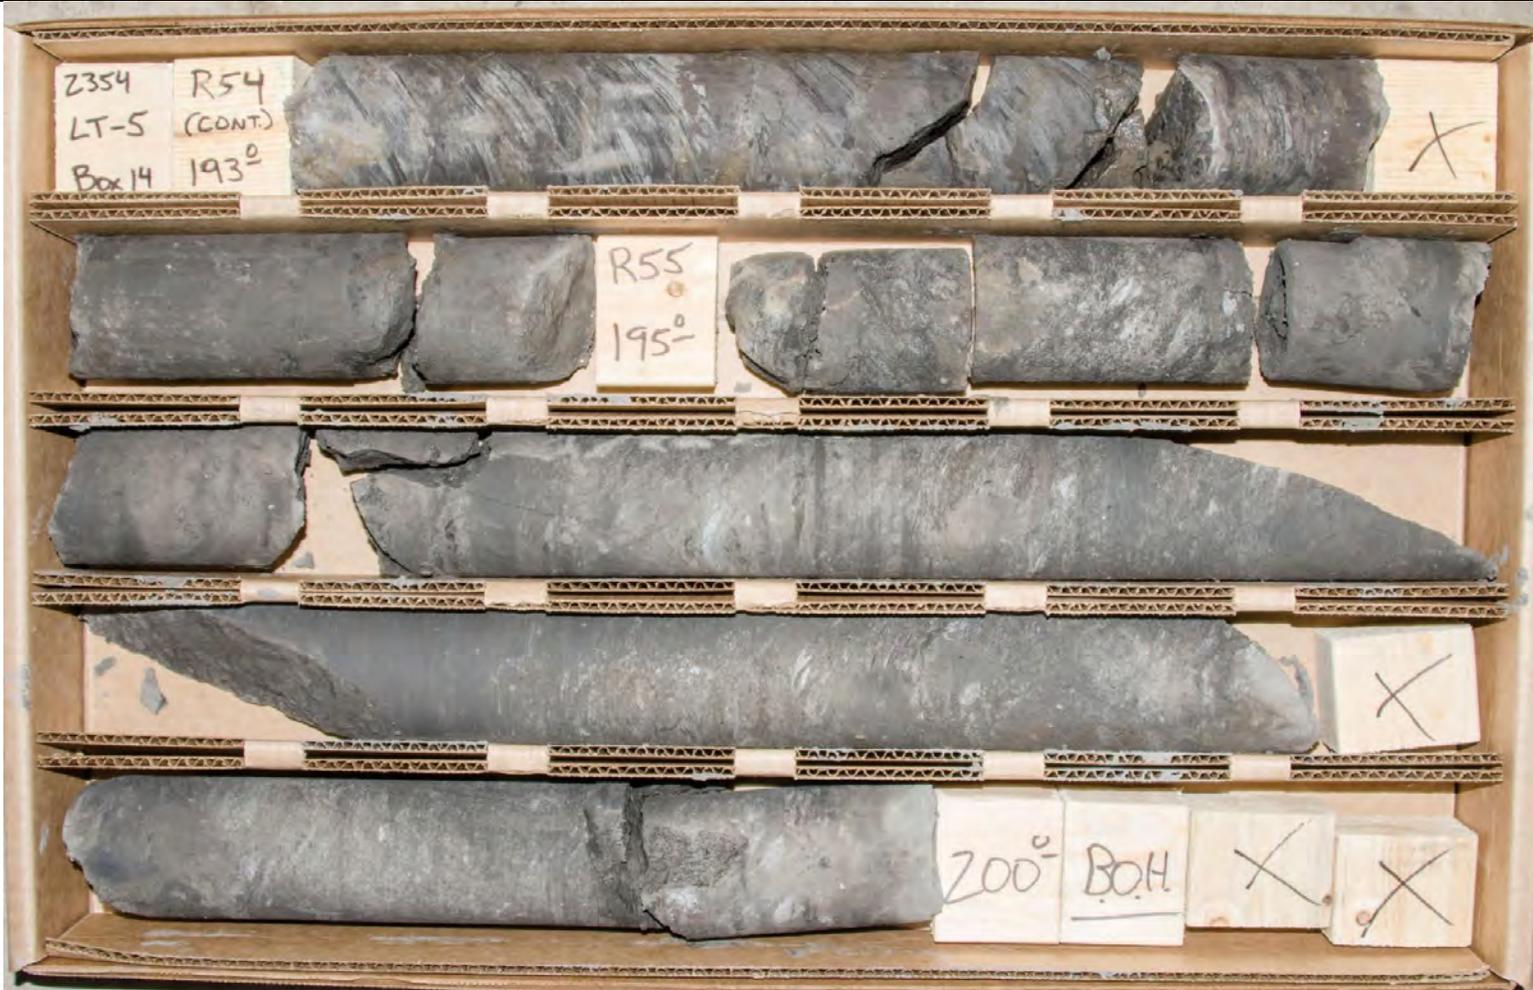
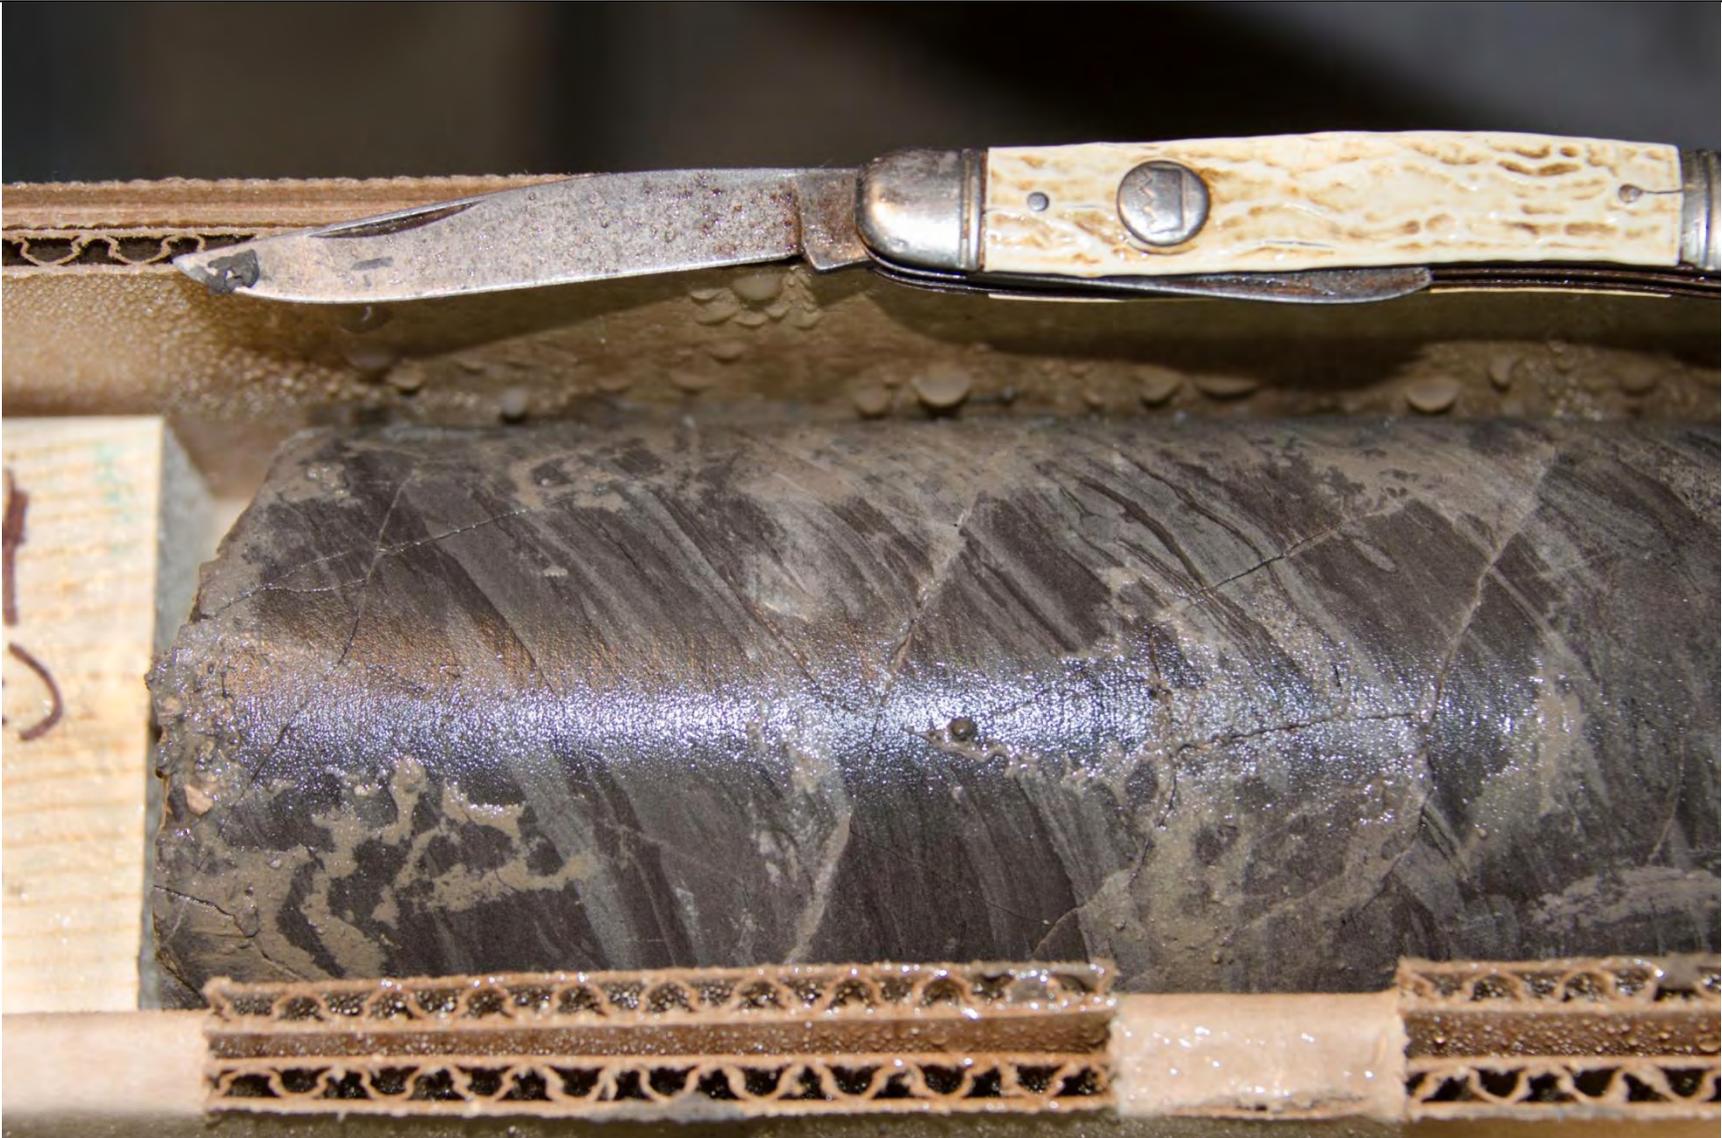
Dark gray **silty clay-claystone** inter-layered with gray **siltstone** (see core box PHOTO below); this is finely bedded and dipping as interval above (see 2nd PHOTO below). In lower 1' the above grades into the gray very fine grained quartz **sandstone** (as in above intervals) to siltstone; same 3-5% black grains, same very well sorted, sub-round to sub-angular.
