Geologic Report on the Slide near Budge Drive, Jackson, Wyoming to the Jackson Town Council by the Geologists of Jackson Hole

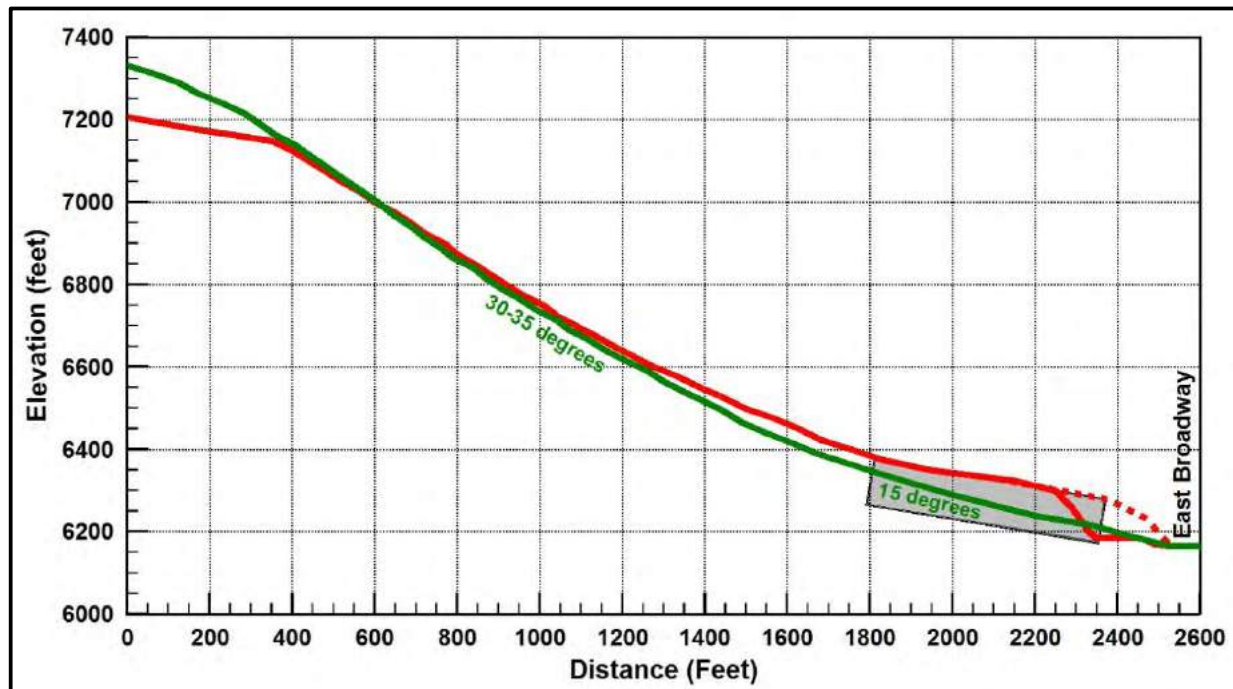
Figure1: Topographic profiles of the south slope of East Gros Ventre Butte north of West Broadway at Virginian Lane (green line) and at Scott Lane (red line). The dashed red line shows the slope north of Scott Lane before extensive quarrying based on the 1963 USGS topographic map. The gray-shaded rectangle shows schematically how a 140-foot thick slab of andesite might underlie the current slope. The locations of the profiles are shown on a map in Figure 2.

The green line in Figure 1 shows a topographic profile of the south slope of East Gros Ventre Butte north of West Broadway at Virginian Lane (green line CD in Figure 2). This profile is typical of the slopes surrounding and within Jackson Hole. The angle of repose is 30 to 35 degrees on the upper slope at distances plotted between 800 and 1200 feet (along the horizontal axis) and decreases to 15 degrees between 1800 and 2200 feet (along the horizontal axis). Near the top of the slope, the angle of repose is determined primarily by the coherency of the soil/rock formation – how well it holds together – how slowly it is eroded. Further down slope, debris accumulates that is less coherent, less consolidated, and the angle of repose is determined more by the support of

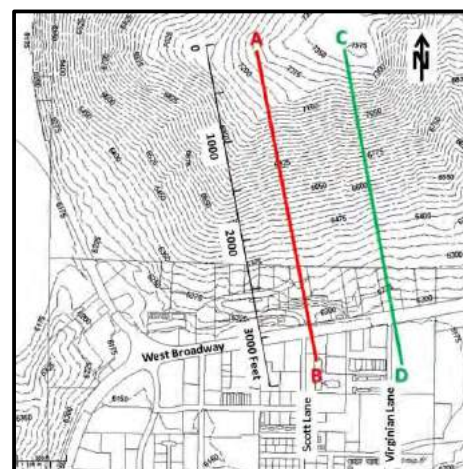
Figure 2: Map of the south end of East Gros Ventre Butte showing the location of the two topographic profiles plotted in Figure 1. Up is to the north.

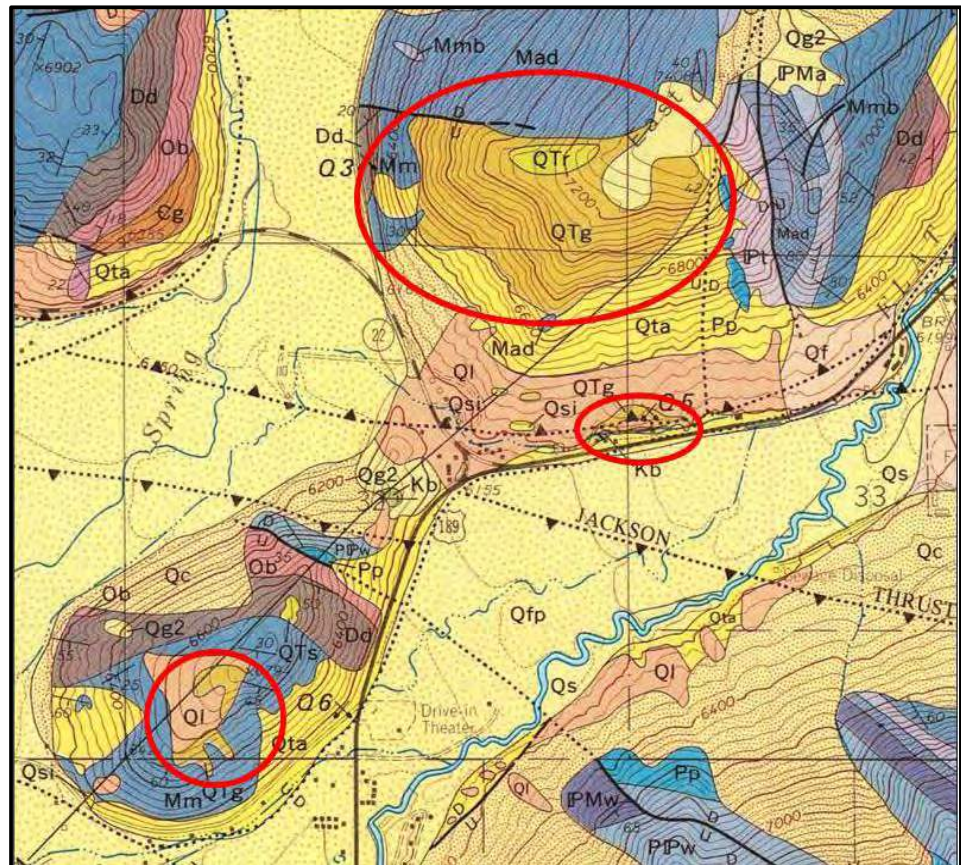
Figure 5: A portion of the Love and Albee (1972) geologic map showing High School Hill in the lower left and the southern part of East Gros Ventre Butte in the upper right. The andesites (QTg) only outcrop in the three areas outlined by the red ellipses.

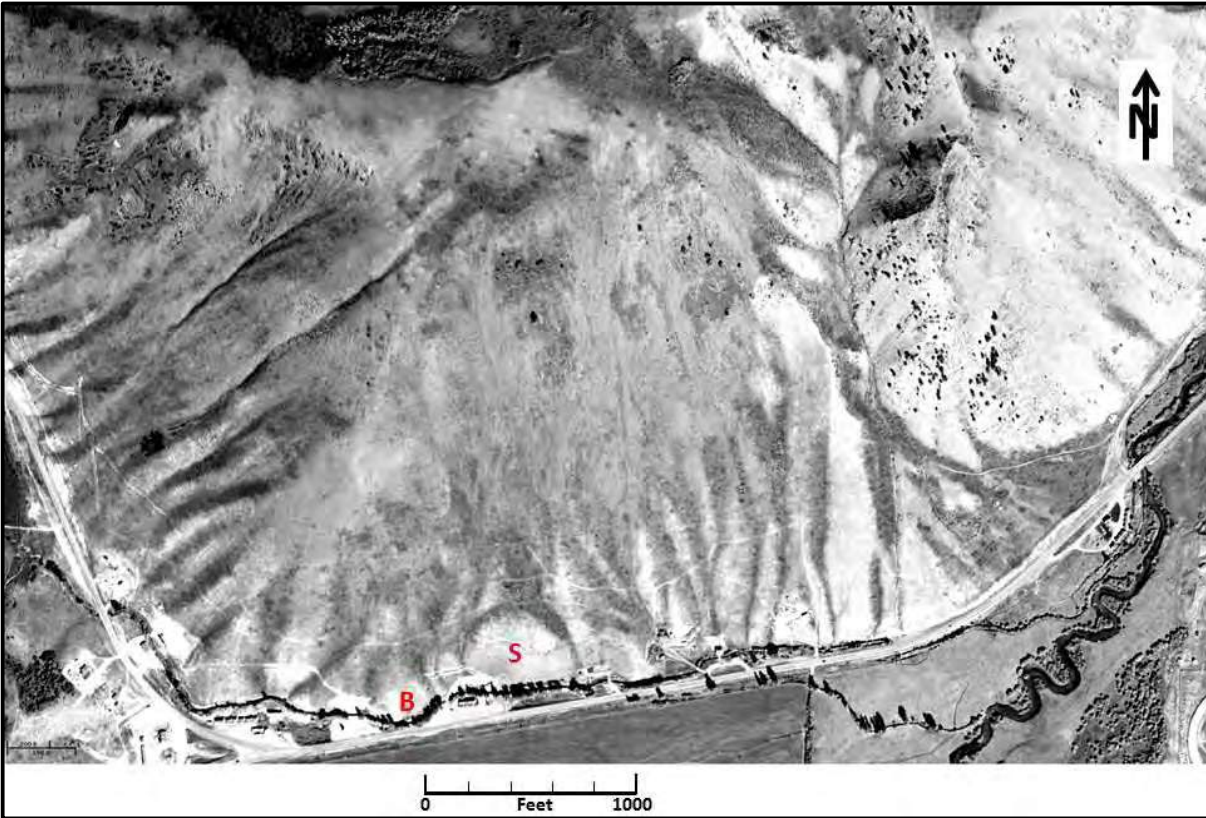
Figure 6: Aerial photograph taken in 1955 showing the south end of East Gros Ventre Butte, the region of the future Budge Slide (S) and the region of the future branch of The Bank of Jackson Hole (B).

Figure 6 shows a 1955 aerial photograph of the south end of East Gros Ventre Butte just west of the town of Jackson. The location where the Budge Drive Slide would later occur, marked with a red “S”, includes most of the land within the light colored circular feature in the lower central part of this image. This circular feature looks like a dish or depression to many eyes, but it is actually an area that is elevated compared to the adjacent slope. The darker areas surrounding it are vegetation showing the primary routes for drainage of water from off the higher slopes of the butte. This circular feature appears much lighter because there is less vegetation on it, and less moisture in its soil. The brightest white areas, such as just southwest of the “S” and further to the west, though which an irrigation ditch can clearly be seen to run (red line Figure 7), are lands that were graded by the summer of 1955 when this photo was taken, for construction or to extract road metal, which is broken rock and sandy soils used in the foundations of roads and buildings.

The bench on the south end of East Gros Ventre Butte, extending from the region north of Virginian Lane to the west of Budge Drive, appears to have been formed by large blocks and related debris sliding down the butte. This bench is a partially consolidated body of landslide debris. The largest block appears to be in the region labeled “S” in Figure 6. This block is more than 400 feet in

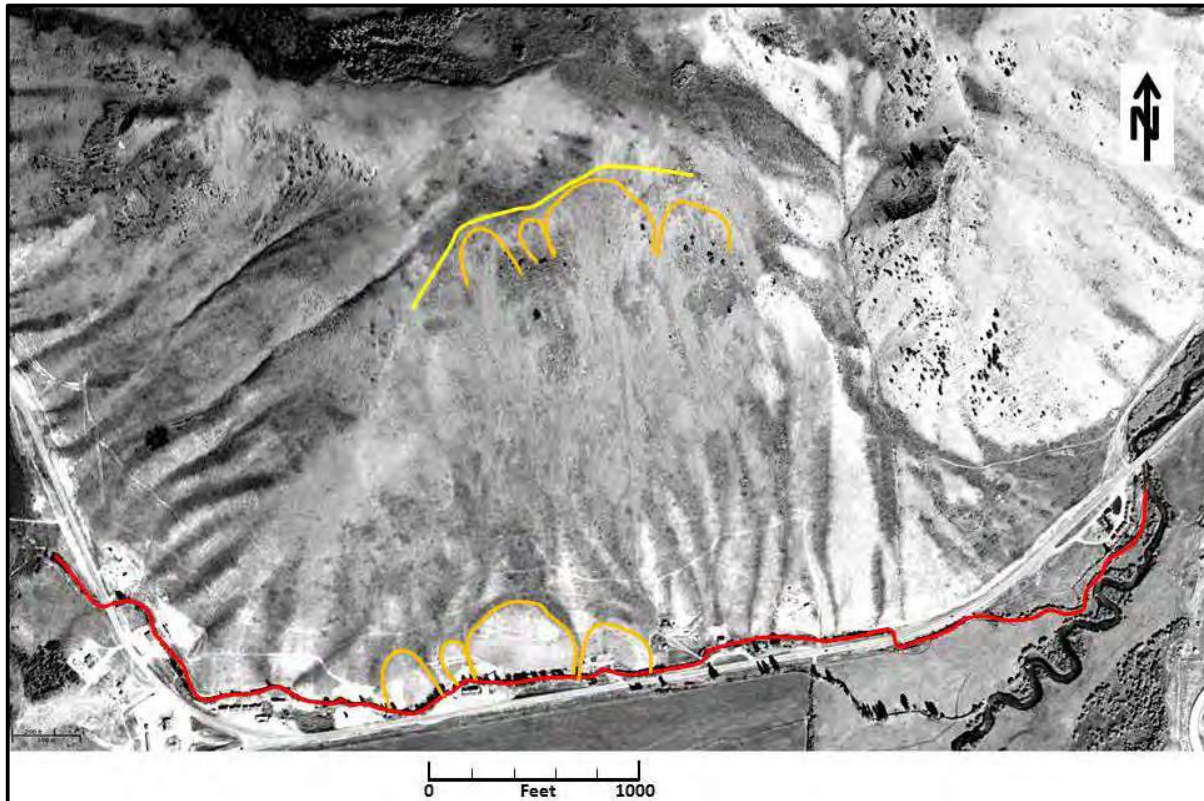
Figure 7: Aerial photograph of the southern end of East Gros Ventre Butte taken in 1955. The lower arcuate orange lines outline the geomorphic anomalies of poorly vegetated parts of the hillside. These are likely to contain the majority but not all of the blocks of andesite and conglomerate that appear to have slid down the butte from somewhere in the vicinity of the upper arcuate orange lines. The yellow line shows a cliff facing southeast. The red line traces an irrigation ditch dug before 1910.

The breadth, shape, and gray shading of the future quarry and later slide area is distinctively different from any other area shown in this photo. There is one area to the east and two to the west shown by orange lines in Figure 7 that are similar but smaller. The primary rock outcropping in these four areas is andesite, a light-gray colored extrusive volcanic rock, and conglomerate that, as described above in the section on geology of the area, is found near the top of East Gros Ventre Butte above the Budge Drive area and near the top of High School Hill to the southwest. The yellow line in the upper part of Figure 7, drawn along the rapid break in slope near the top of the south face of East Gros Ventre Butte, shows where the topographic contours smoothly running northwest-southeast to the left of the line suddenly change direction along a cliff. The lower group of orange lines has been duplicated and moved without rotation up the butte and slightly east to show where these blocks of andesite could have come from, and likely why the yellow line has the deflection in it. The blocks may have slid down the slope together or separately. The upper orange lines merely show the simplest of many possible points of origin and possible number of slide blocks. What is clear from the geology is that these andesite blocks must have slid down the butte in the past. Love and Albee (1972) described the quarry in the main block as “Q5. – County quarry ... Rock quarried is highly shattered by Quaternary faulting and breaks into angular fragments commonly less than 6 inches in diameter; used in road construction.”

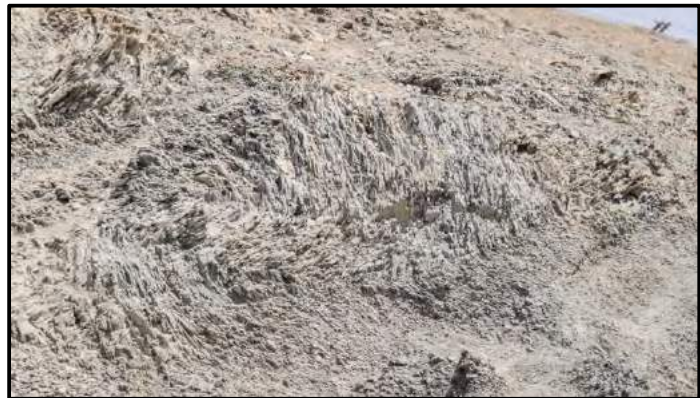
Figure 8: Flow-foliated andesite in the cliff just north of the entrance to the upper parking lot for Sidewinders.

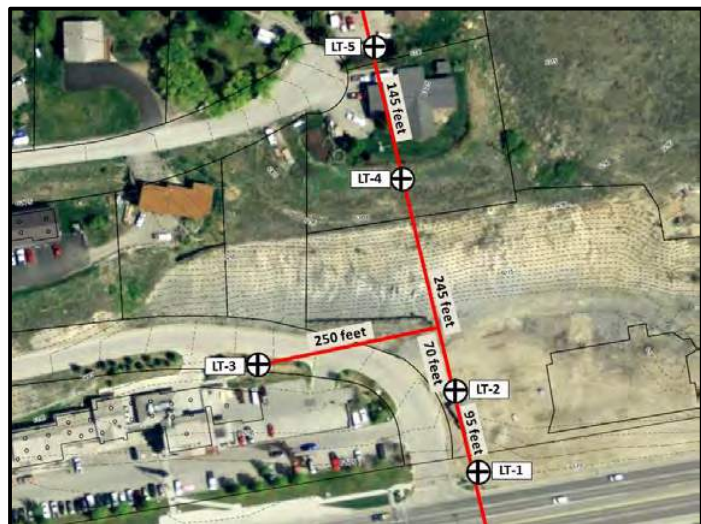
Figure 9: Location of drill holes LT-1, 2, 3, 4, 5, and the nearly north-south cross section (solid red line) on an air photo taken in 2013. Lot and parcel lines are shown in black including an outline of the Walgreens store completed in late 2013.

on these core data, data observed at the surface, and known geologic history. The cross-sections are in a location (Figure 9, red line through LT-1, LT-2, LT-4, LT-5) similar to that shown in Figure 4 extending from the intersection of the east side of Budge Drive with West Broadway, through the cliff, past the house on the hill at 1045 Budge Drive that was destroyed by the landslide.

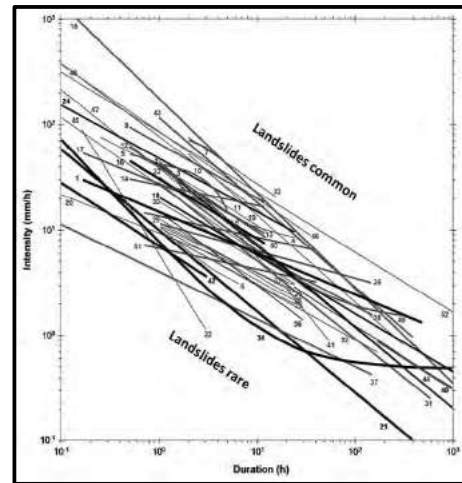
Landslides worldwide are typically associated with a rapid increase in rainfall that results in saturated soils and slopes, and increased hydraulic pressure at depth. These are all factors that are highly likely to have contributed to landslide initiation. Figure 17 shows the intensity of rainfall plotted as a function of the duration of the rainfall for 124 regions around the world (Guzzetti et al., 2007). The details of line thickness and the numbers are described in that paper. What is important for this report is that very high intensity rainfall for a short duration or more moderate intensity rainfall for a longer duration than normal often triggers landslides typically by increasing the fluid pressure in incipient slip zones and thus decreasing the friction. Rainfall that runs off a slope without penetrating the surface has little effect. But rainfall penetrating the surface by flowing down cracks or ponding in low, poorly drained regions can have major effects in changing the balance of forces of an incipient landslide.

Figure 17: Landslides are more common when the intensity of rainfall is very high for a short duration or more moderate for a longer duration. A logarithmic plot of intensity in millimeters per hour as a function of duration is in hours.

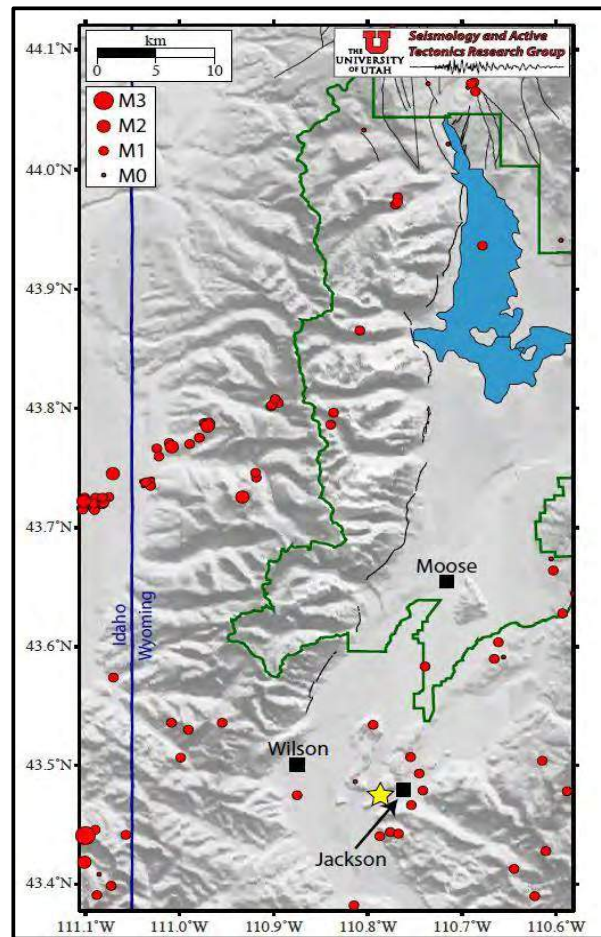
Figure 21: Local Earthquakes, 2011 to present.

None of the seismic events within miles of the Budge Drive landslide are larger than magnitude one (M1), and the Michigan Tech table demonstrates that even a magnitude 2.5 earthquake (M2.5) is commonly not felt. Note that a magnitude 2 (M2) earthquake would release approximately 32 times as much energy as a magnitude 1 (M1) earthquake. Therefore the M1 earthquakes near Jackson between 2011 and the present would have released approximately 1/32 of the energy of a quake that is "Usually not felt".
